28 August 2019

**PROPOSED DISABLED ACCESS INCLINATOR THRESHOLD STRUCTURE
159 Riverview Road Avalon**

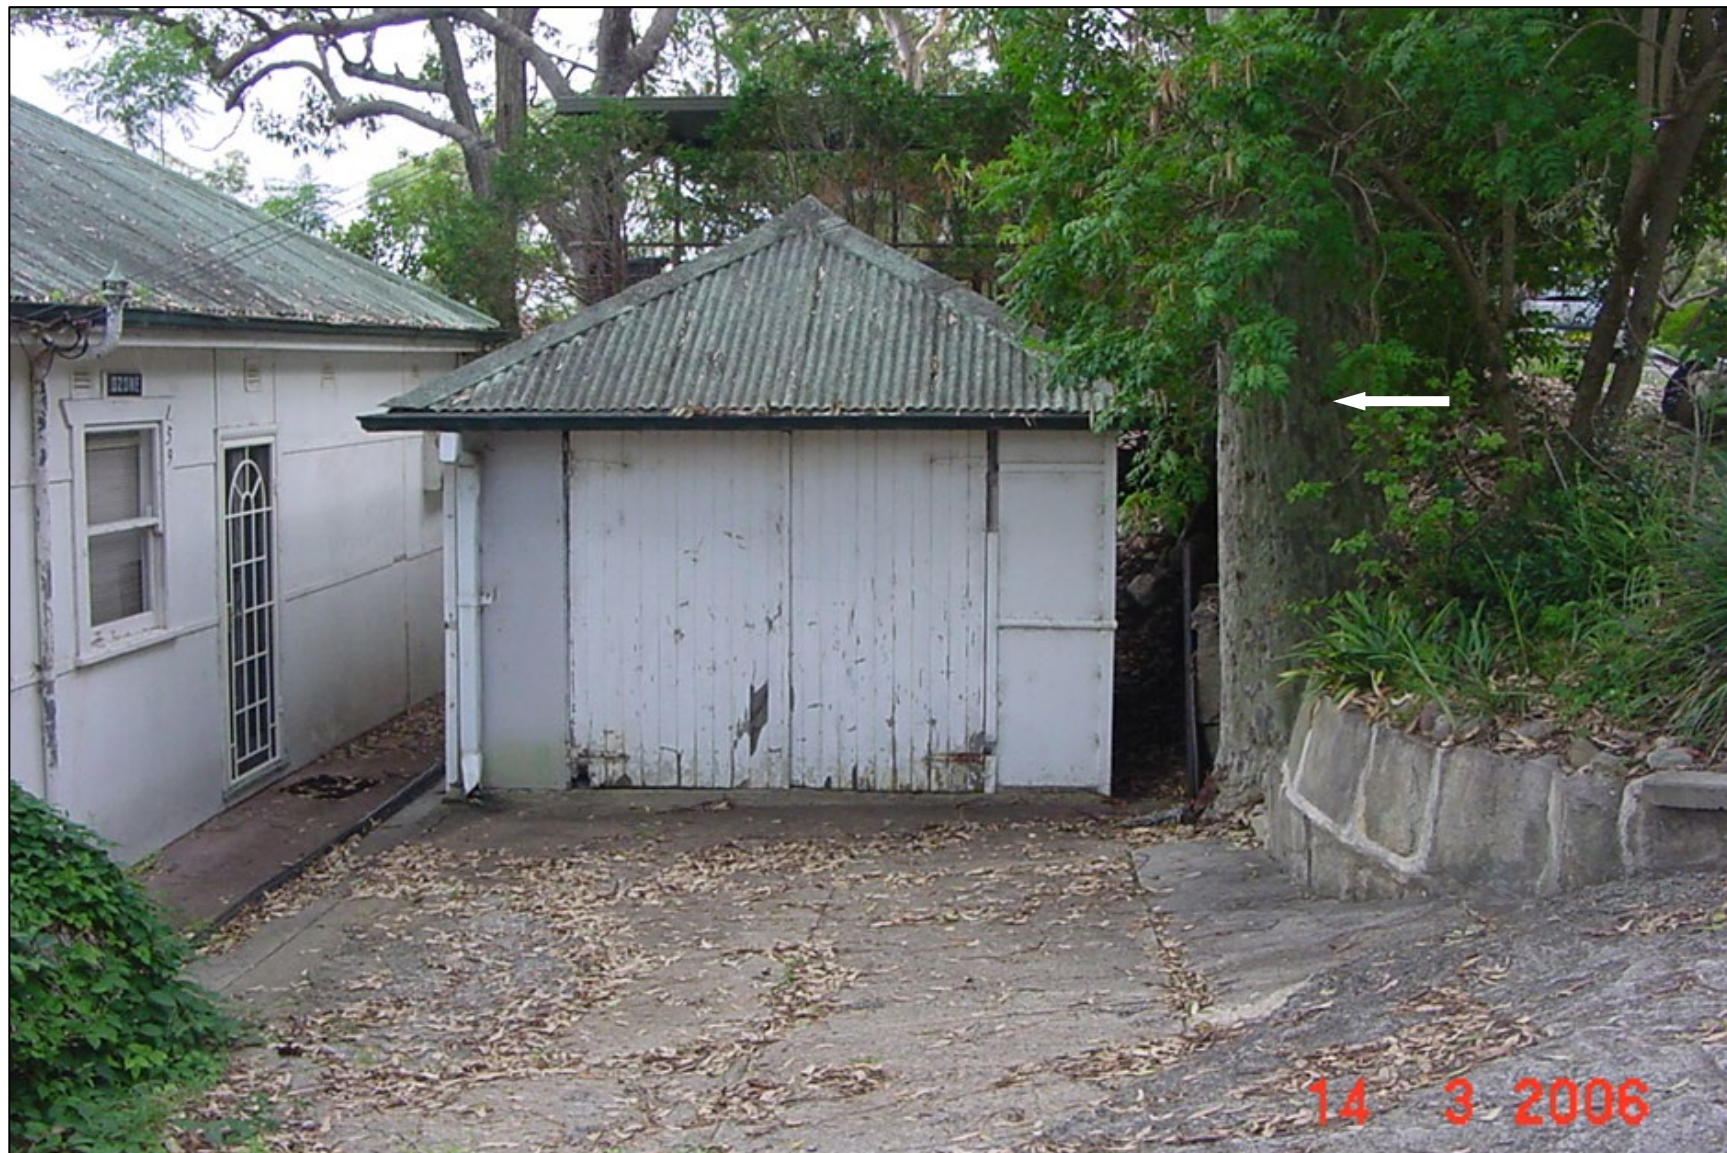
The tree was located at the base of a stone retaining wall along the site's east boundary. The site topography was originally (and still is) quite steep falling from the road level around RL 35 to the Mean High Water Mark at Pittwater to the west. The original garage and driveway were located directly adjacent to the tree and the original ground level here was clearly altered by adding fill material and consolidating it to support the structures (Plate 1).

Plate 1—Illustrates the location of the original dwelling, garage and driveway prior to the more recent construction of the new dwelling. Note the levelled areas supporting the structures. The soil beneath these was consolidated over time. The tree (arrowed) at the base of the original retaining wall.
Photo C. Mackenzie. March 2006.

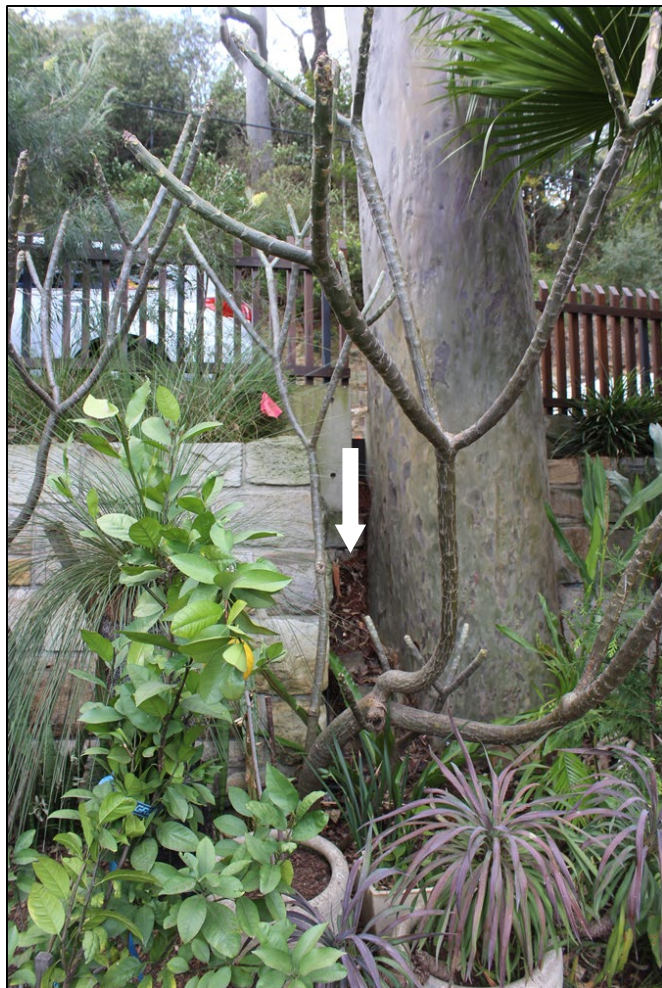
The pit was dug at approximately 4m west of retaining wall behind the subject tree. The pit was moved to be just outside the notional 3.4m Structural Root Zone radius, and to also avoid an existing irrigation line between the proposed column location and the tree.

Plate 2—Illustrates the point where the pit location was measures from, i.e. 4m from this retaining wall behind the tree.

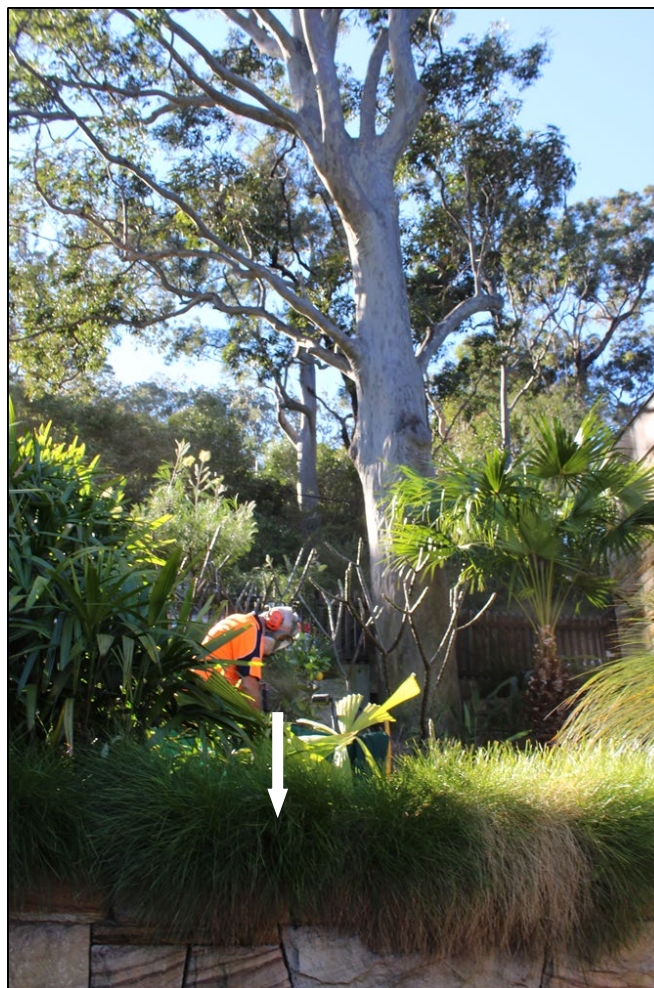
Plate 3—View of root mapping contractor using the AirSpade® to excavate the pit for the proposed column. Arrow illustrates approximate location of pit in relation to the tree.

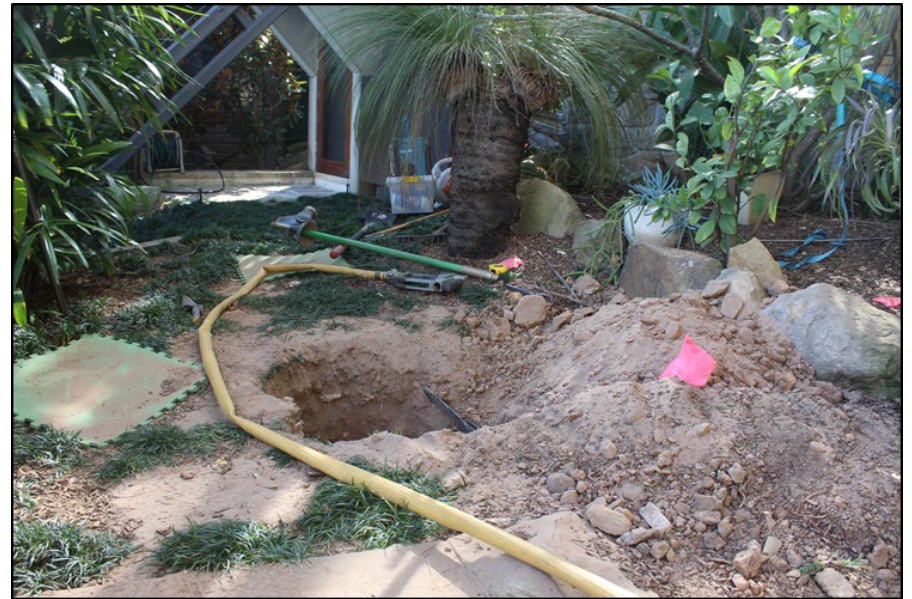
Plate 6 (right)
Illustrates the location of pit in relation to the existing inclinator structure (background)

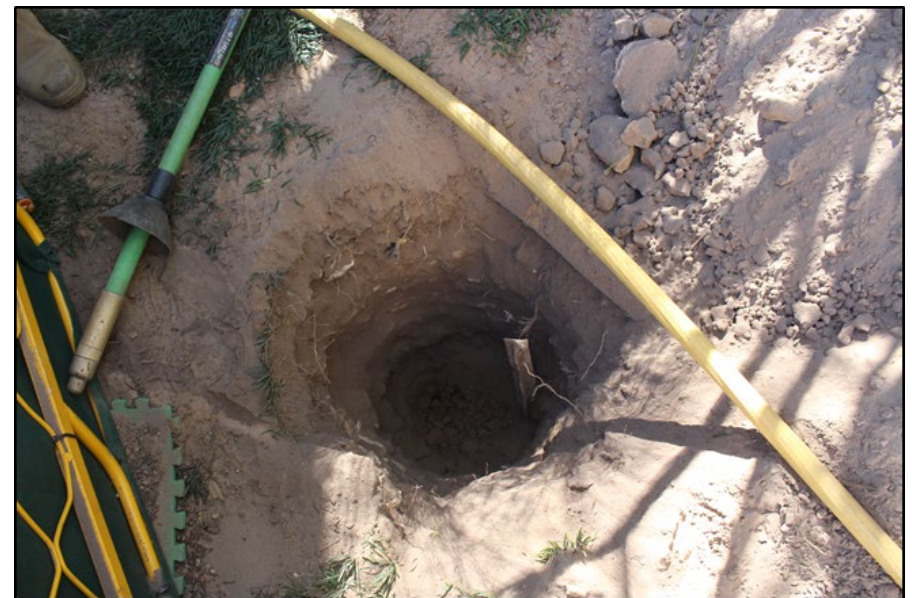
The pit was approximately 500mm in diameter and dug to an average depth of 600mm.

- The topsoil was removed by hand and put in a separate pile.
- The soil was generally consistent with introduced planting media with some soil and bark chips, etc.
- A steel star spike was encountered about 200mm below ground level. The star spike was firmly embedded in the soil and was left in situ as it proved too difficult to pull out.
- Small roots less than 5mm diameters were found only in the upper 100 - 200mm of the soil profile
- Three woody roots of around 12mm diameter were encountered at a depth of approximately 200mm. These roots were well spaced apart around the pit edge.

Plate 6 (right)
Illustrates the depth of the pit to a minimum of 600mm. Note presence of star picket in pit.

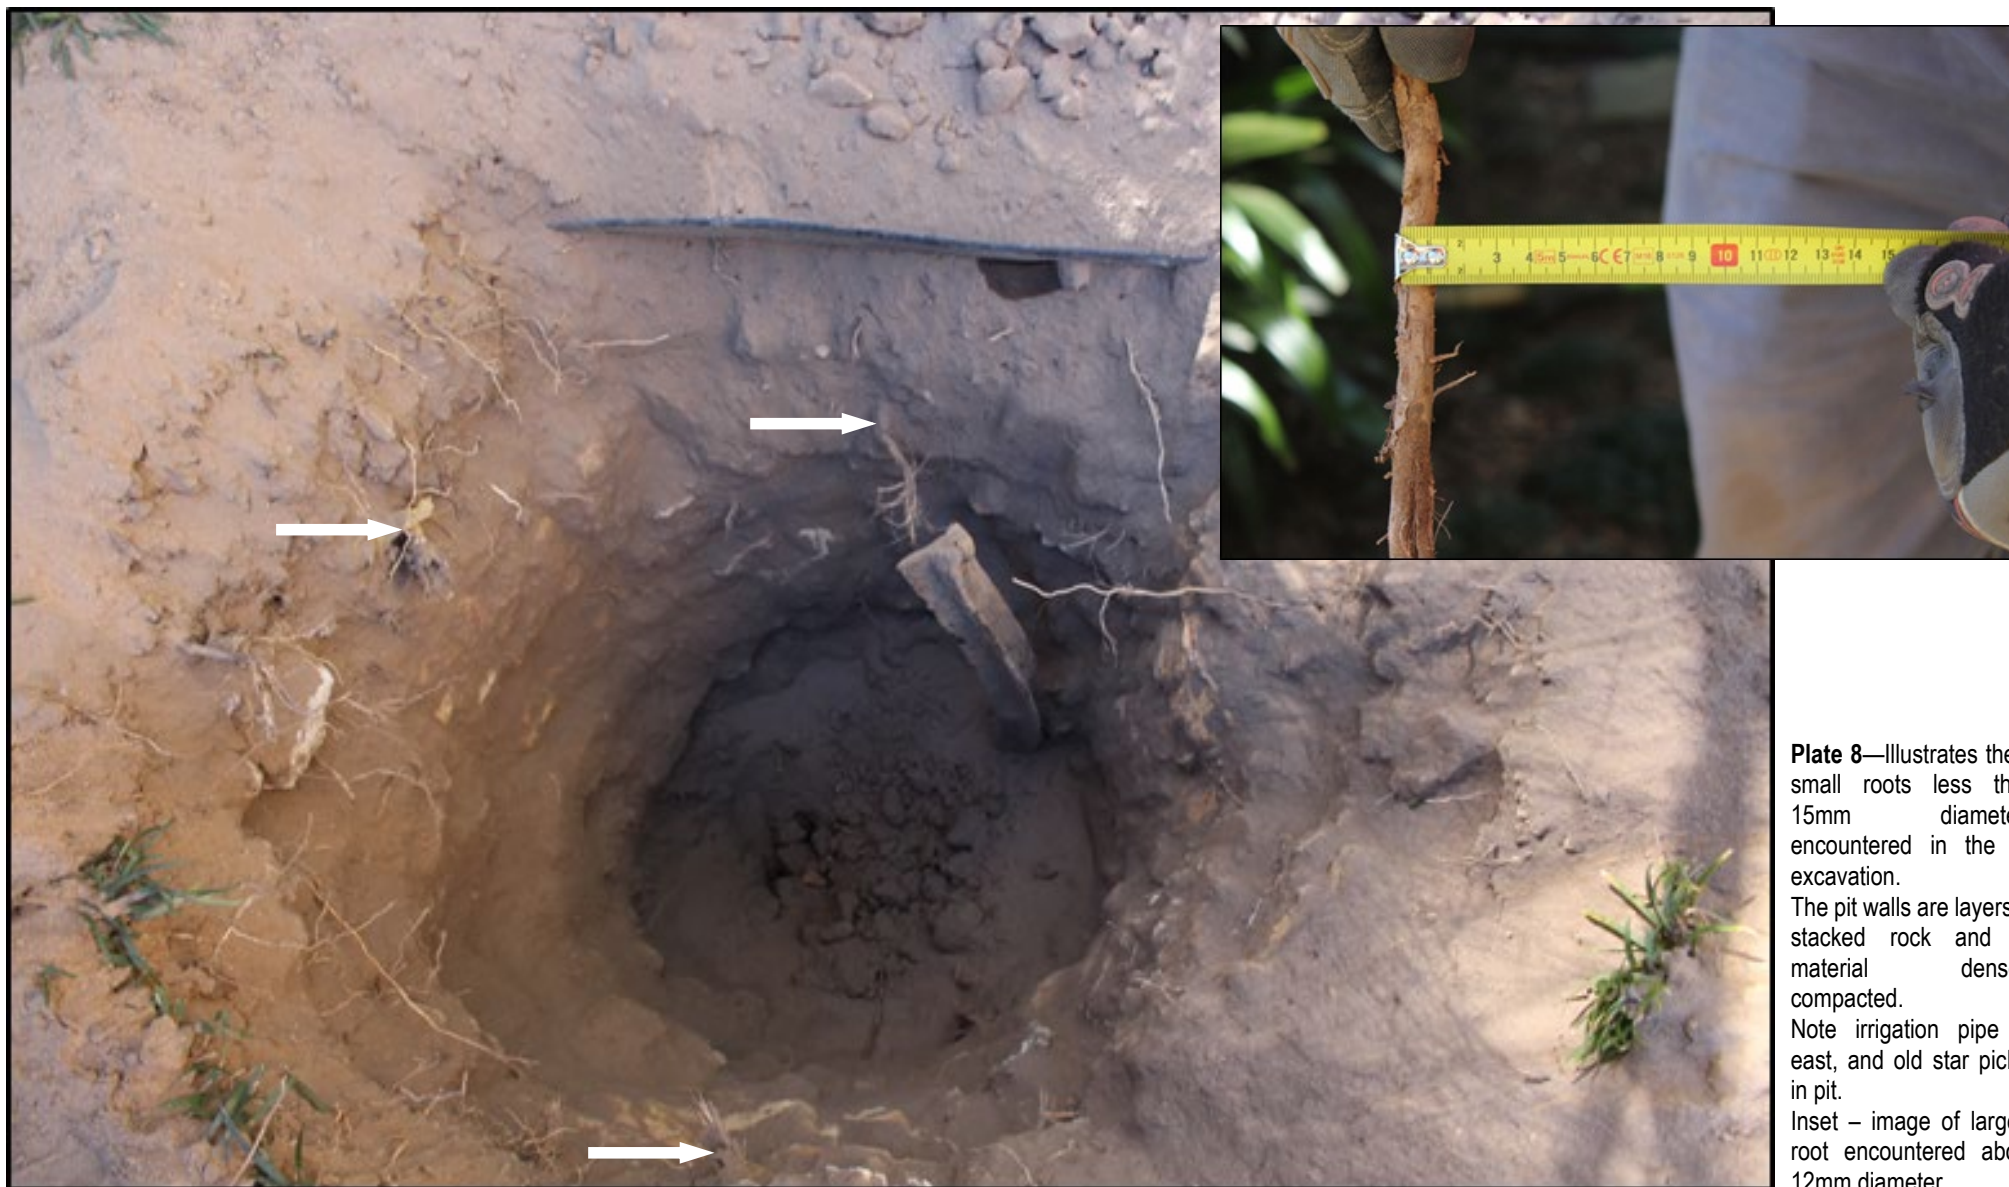
Based on the root mapping investigation for the location of the proposed column, it is my opinion it is highly unlikely any significant woody tree roots belonging to Tree 1 will be disturbed or damaged during piercing and installation of the southern column.

Plate 8—Illustrates the 3 small roots less than 15mm diameters encountered in the pit excavation.

The pit walls are layers of stacked rock and fill material densely compacted.

Note irrigation pipe to east, and old star picket in pit.

Inset – image of largest root encountered about 12mm diameter.
