## Acid Sulphate Soils Preliminary Assessment

Property: 38 Parkland Rd, Mona Vale 2103

Report Author: Will Townsend BEng (CivEng)

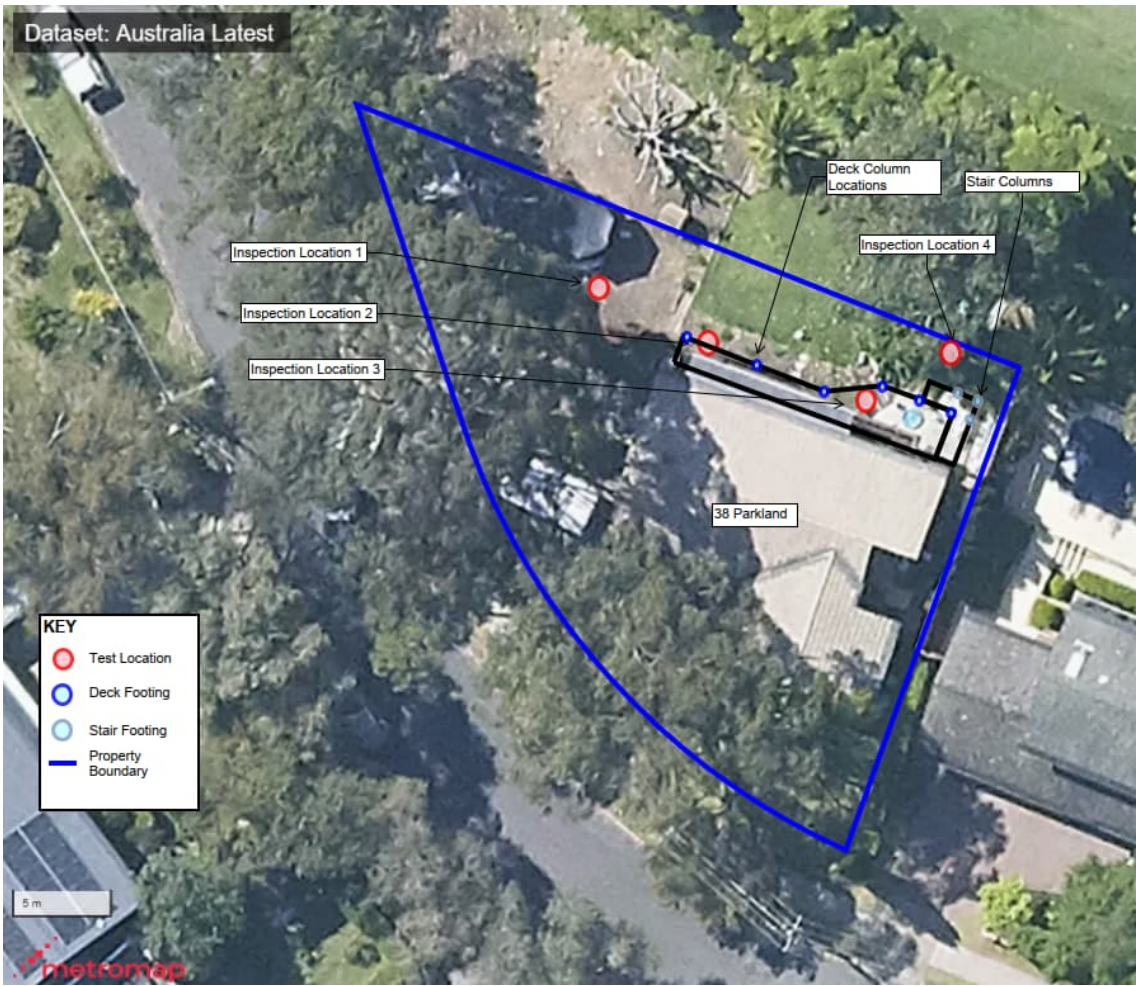
Site Soil Inspection Locations

Site test excavations were completed to check subsoil conditions, one test pit in the natural ground area and three test pit/inspections in the landscaped garden area where the columns footings will be located. The eastern 3 footings are positioned over an existing concrete slab in an area that is retained by a hardwood sleeper wall that was built at the same time as the house. Test logs and photos can be found in **Appendix 1**

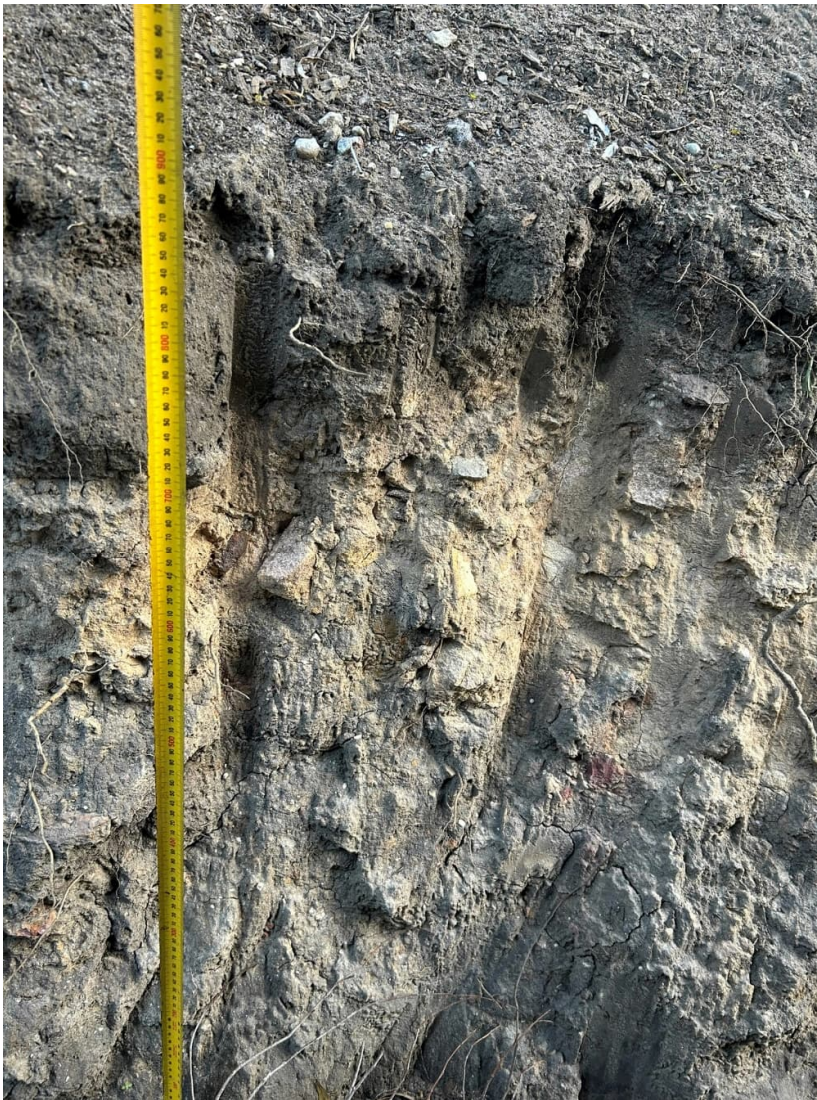
### 1. Test Pit 1 – Natural Landscaped Area

This 900mm deep test excavation was completed in a natural area of the garden that has been mulched only and is some distance from the house and balcony footings. The mulch layer was not included

0mm-200mm Natural Topsoil

200-500mm Firm dry sandy soil and clay, orange, yellow and reddish colours

500-900mm firm/stiff dry clay, some silt stones, blue grey colours

Water table not found at this depth

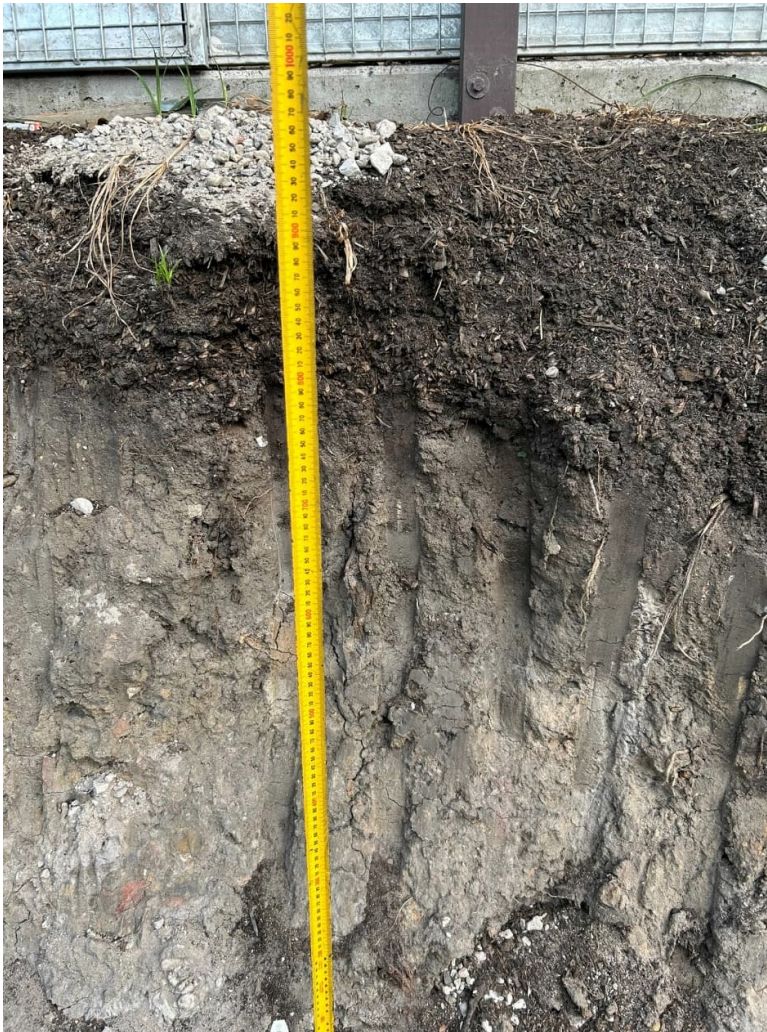
## 2. Test Pit 2 – Planted Garden Area

This 900mm deep test excavation was completed in an improved area with a steep sloped garden bed that has been mulched and planted with low shrubbery. This is where the 3 western most deck columns will be founded.

0mm – 100mm Organic Mulch

100-600mm Improved topsoil and some sandy soil and firm clay chunks

600-900mm – stiff dry clay and some silt stones

Water table not found

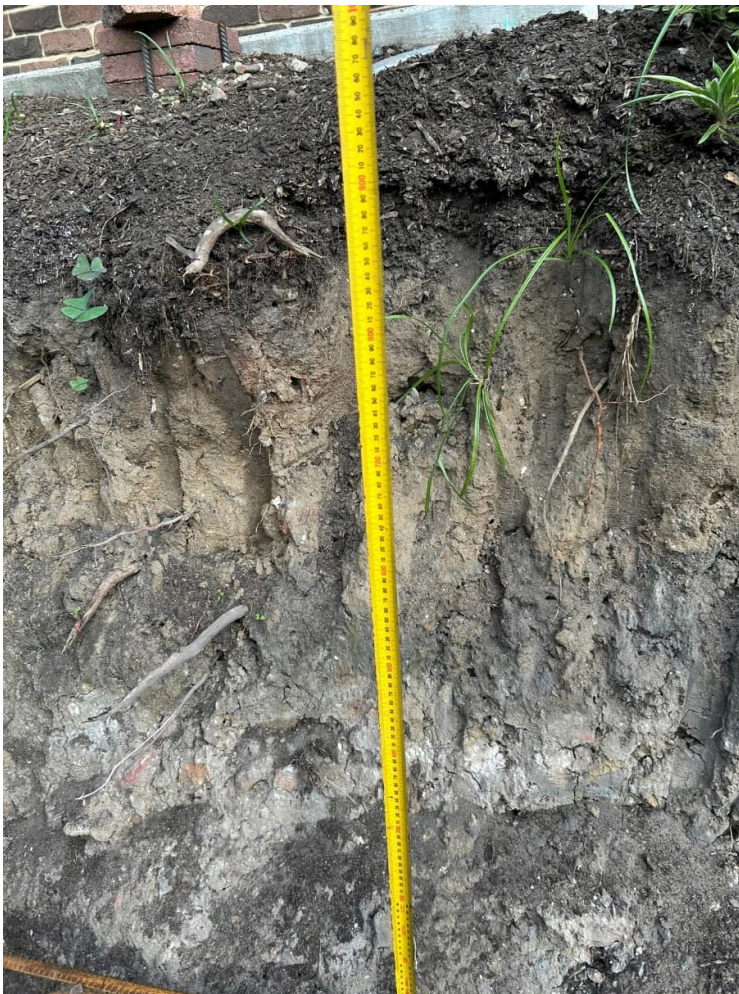
### 3. Test Pit 3 – Planted Garden Area 2

This 900mm deep test excavation was completed in an improved area with a steep sloped garden bed that has been mulched and planted with low shrubbery. This is closer to where the 2 centrally located deck columns will be founded.

0mm – 100mm - Organic Mulch

100-500mm - Improved topsoil and some sandy soil and firm clay chunks

500-900mm – stiff dry clay and some silt stones

Water table not found

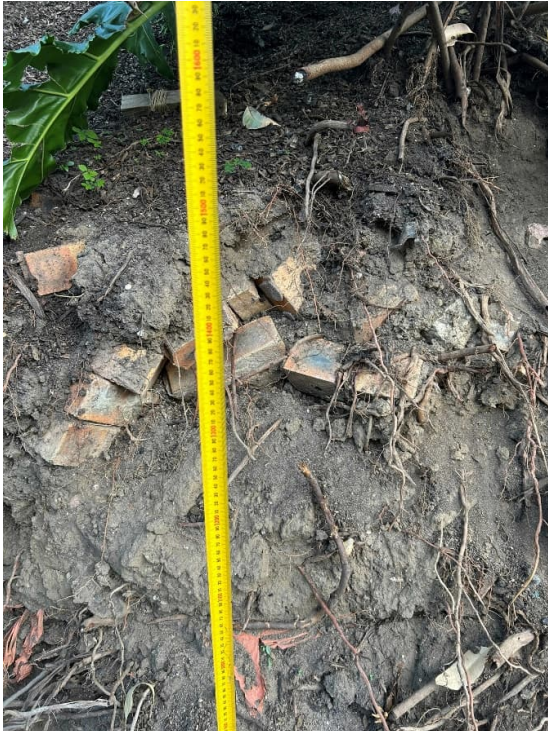
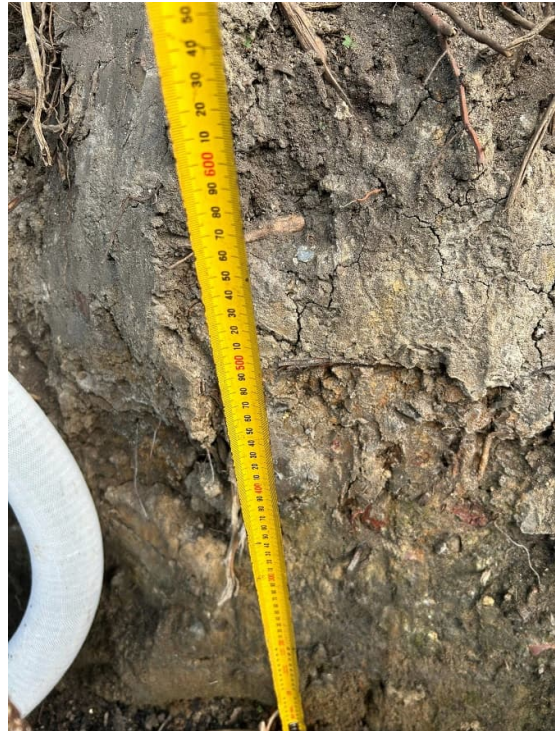
#### 4. Test Pit 4 – Retained Planted Garden Area

This 1.5 m deep soil inspection was completed in an improved area with a steep garden bed retained by rotted hardwood sleepers. This is a few metres to the north of where the 3 eastern most deck and all stair columns will be founded. It may be indicative of what might be found under the existing concrete slab. Inspection required removal of some of the failing sleepers and hand digging to remove a large amount of rubble and non-natural fill. The area also includes some 2-3m high non native shrubbery and some large >8m palm trees.

0mm – 100 Organic Mulch

100-900mm topsoil - mixed natural and unnatural fill – concrete pieces, bricks, some soil and some clay, tree roots

900-1500mm – firm and stiff dry clay and some silt stones

Water table not found at this depth – suspect it is at least another metre deeper given the level of the stream located on the golf course nearby is at least 2m lower
