10th November, 2020 **J4379**

Re: 8 Forest Road, Warriewood

RE: Bush Fire Advice Letter 8 Forest Road Warriewood, NSW

RE: Ecological Advice Letter 8 Forest Road Warriewood, NSW

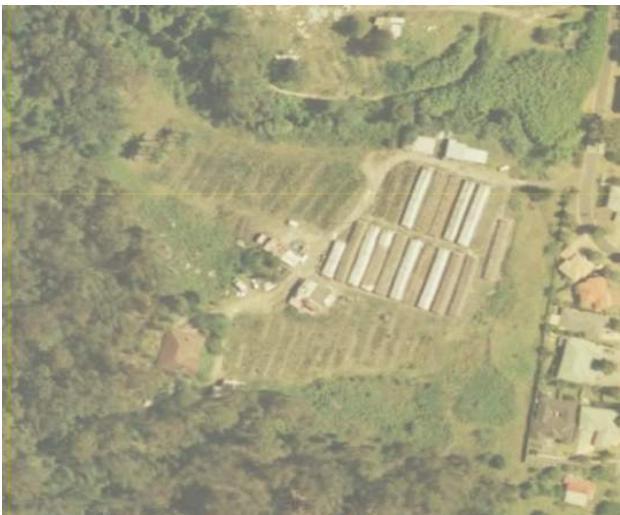
Figure 2. The house and land in 2000. Note the increase in bush regeneration.

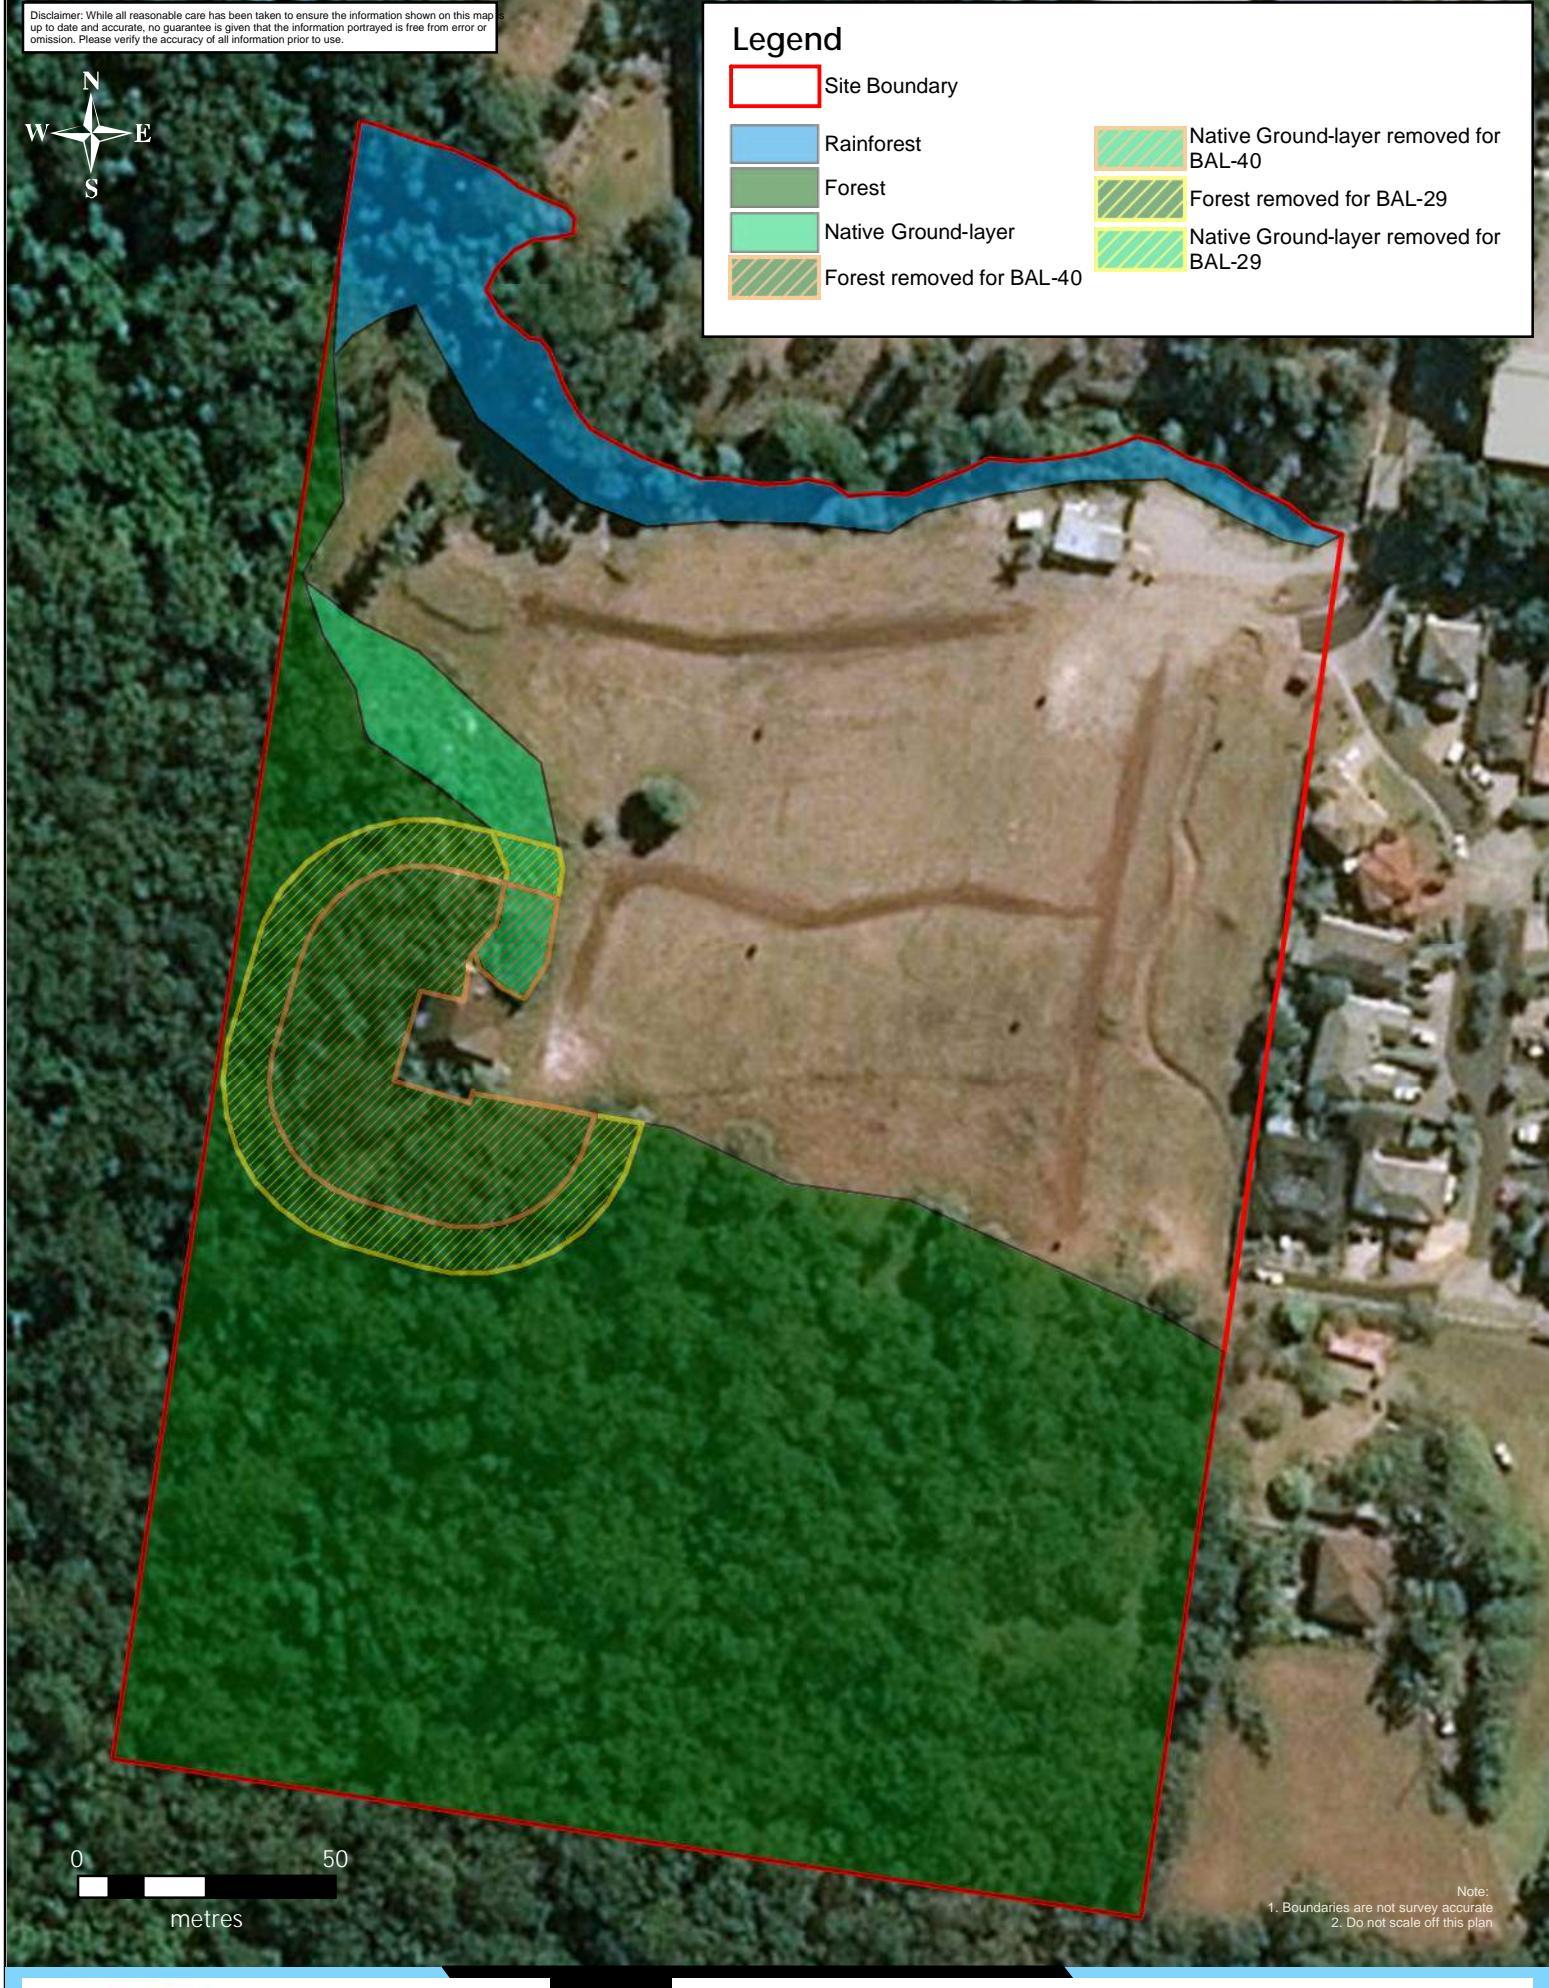
Figure 1: Existing Dwelling Hazard Vegetation Location: Warriewood, NSW

- Predominant Vegetation Forest
- Effective slope Flat/ upslope
- Required Minimum APZ 24m

Figure 1 depicts the vegetation types and also demonstrates that areas of native vegetation that would be require to be removed to meet Asses Protection Zones (APZs).

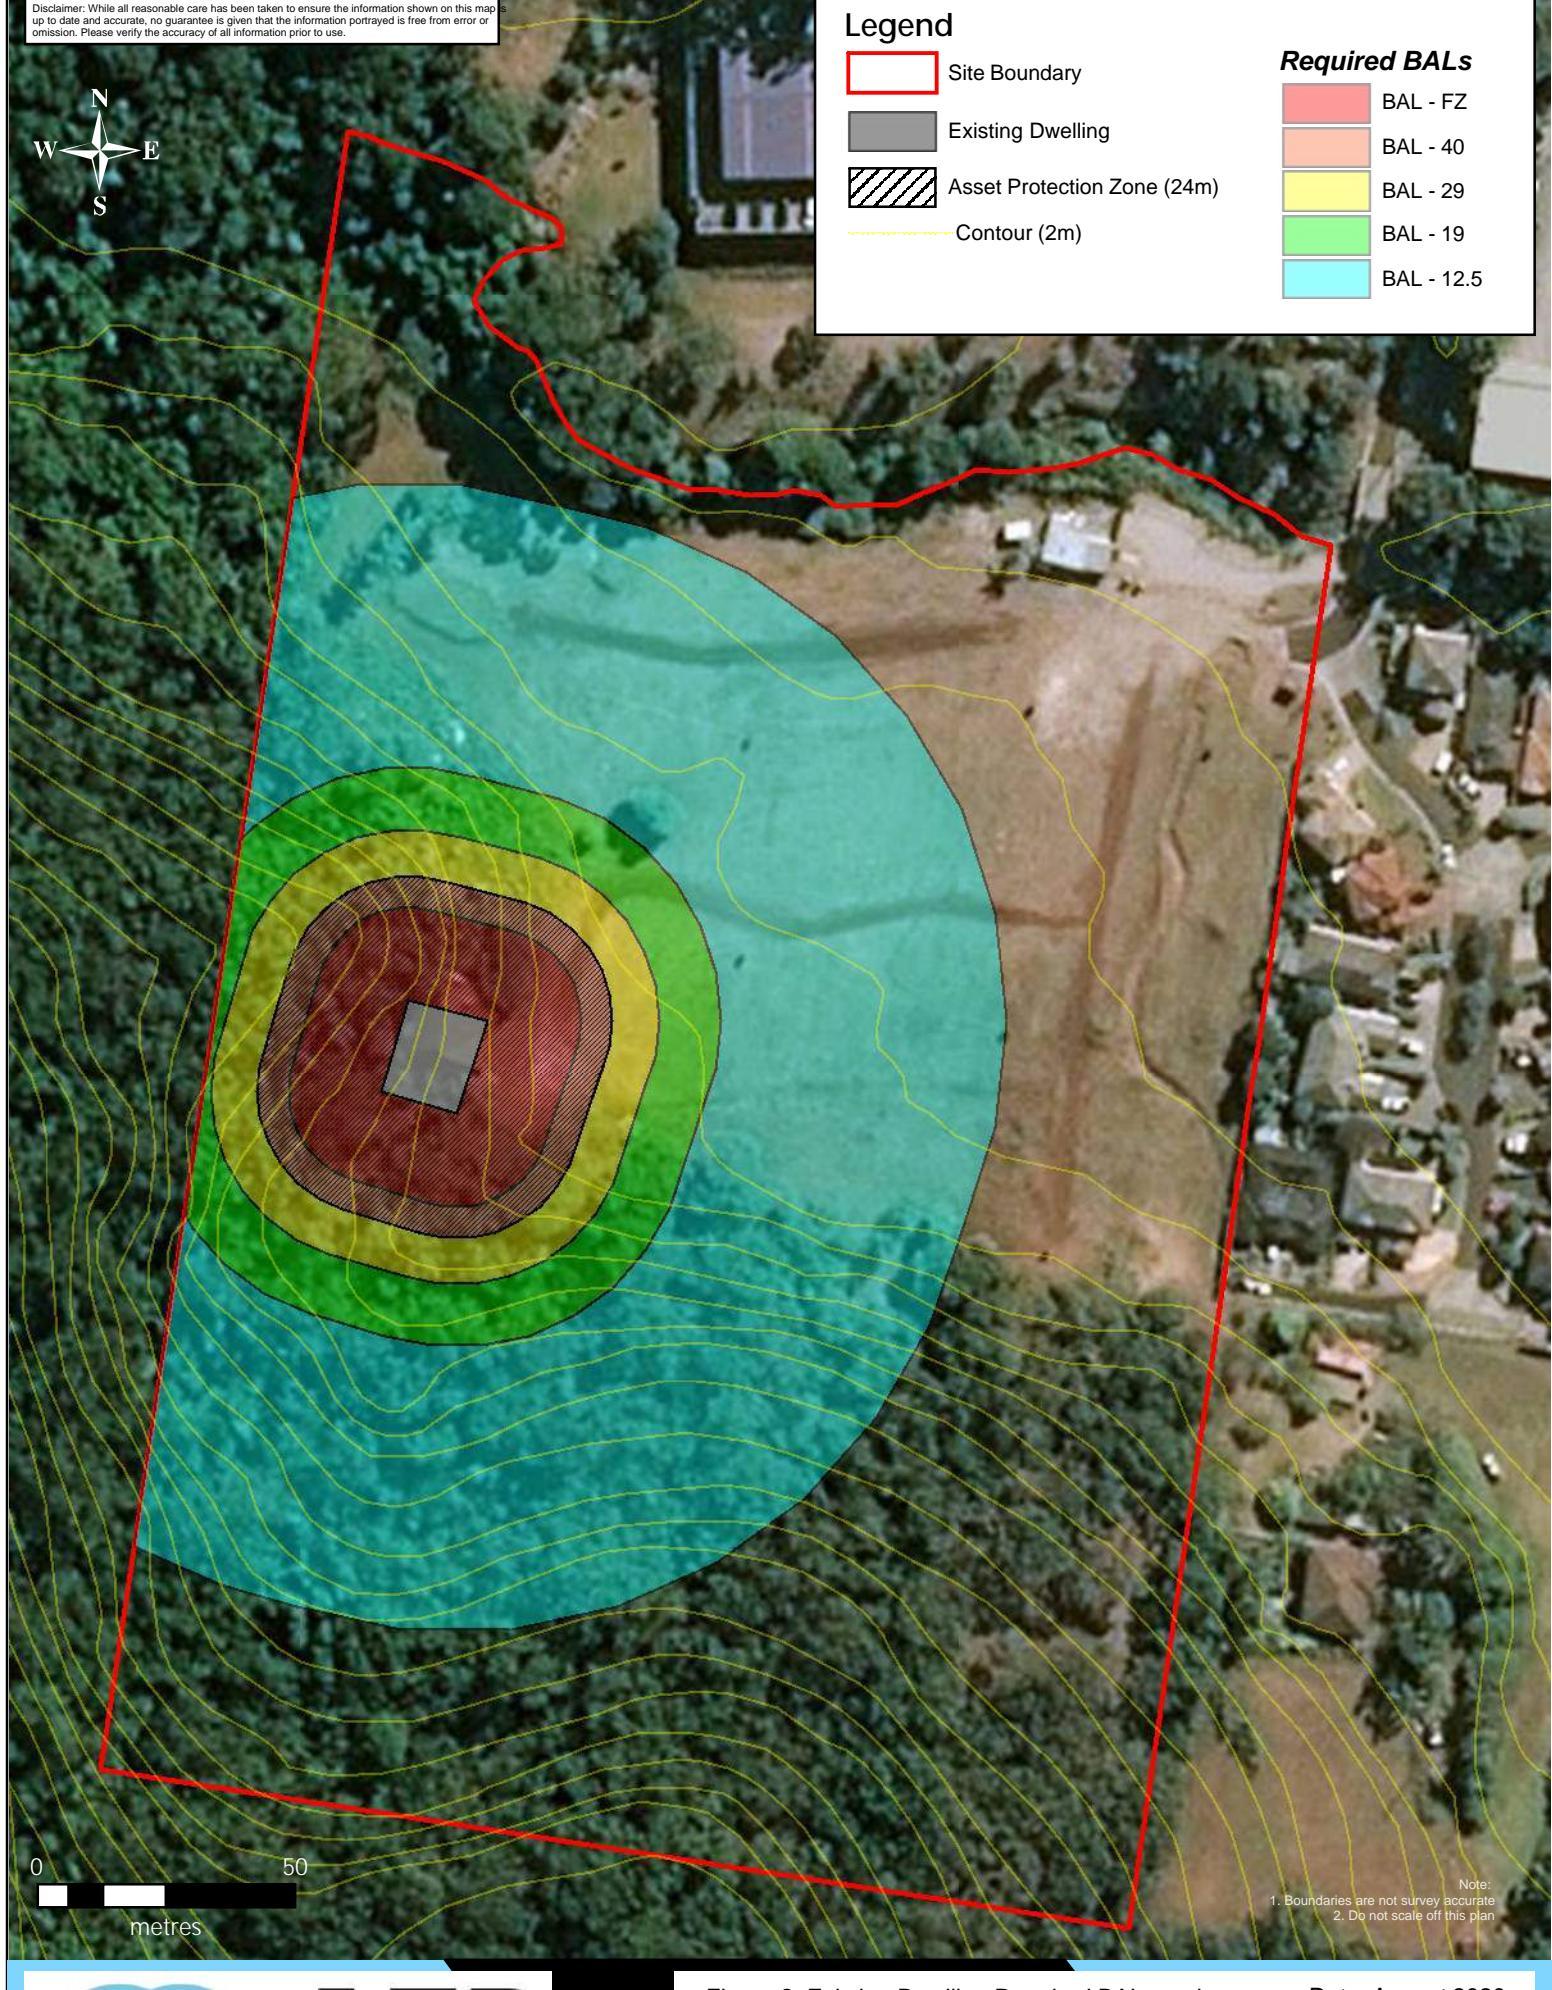
Figure 2: Existing Dwelling Required BALs and

- <18m: BAL Flame Zone
- 18 to <24m: BAL 40
- 24 to <33m: BAL 29
- 33 to <45m: BAL 19
- 45 to <100m: BAL 12.5

Figure 2 depicts the required BAL construction standards applicable for the proposed development.

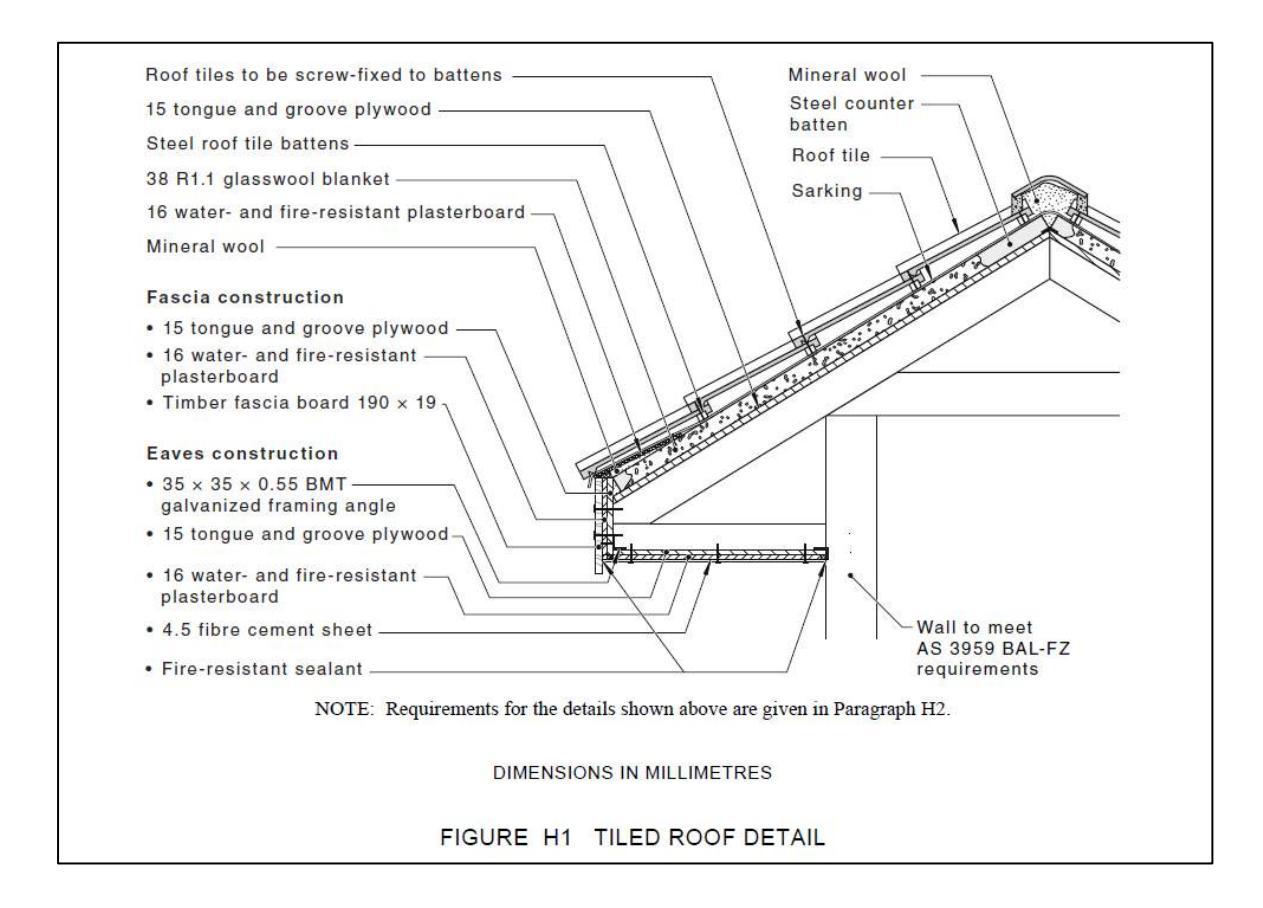
• **Recommendations**: The roof will require extensive work to meet the requirements in Appendix H of AS 3959.2018, the diagram below has been extracted from Appendix H summarises the requirements.

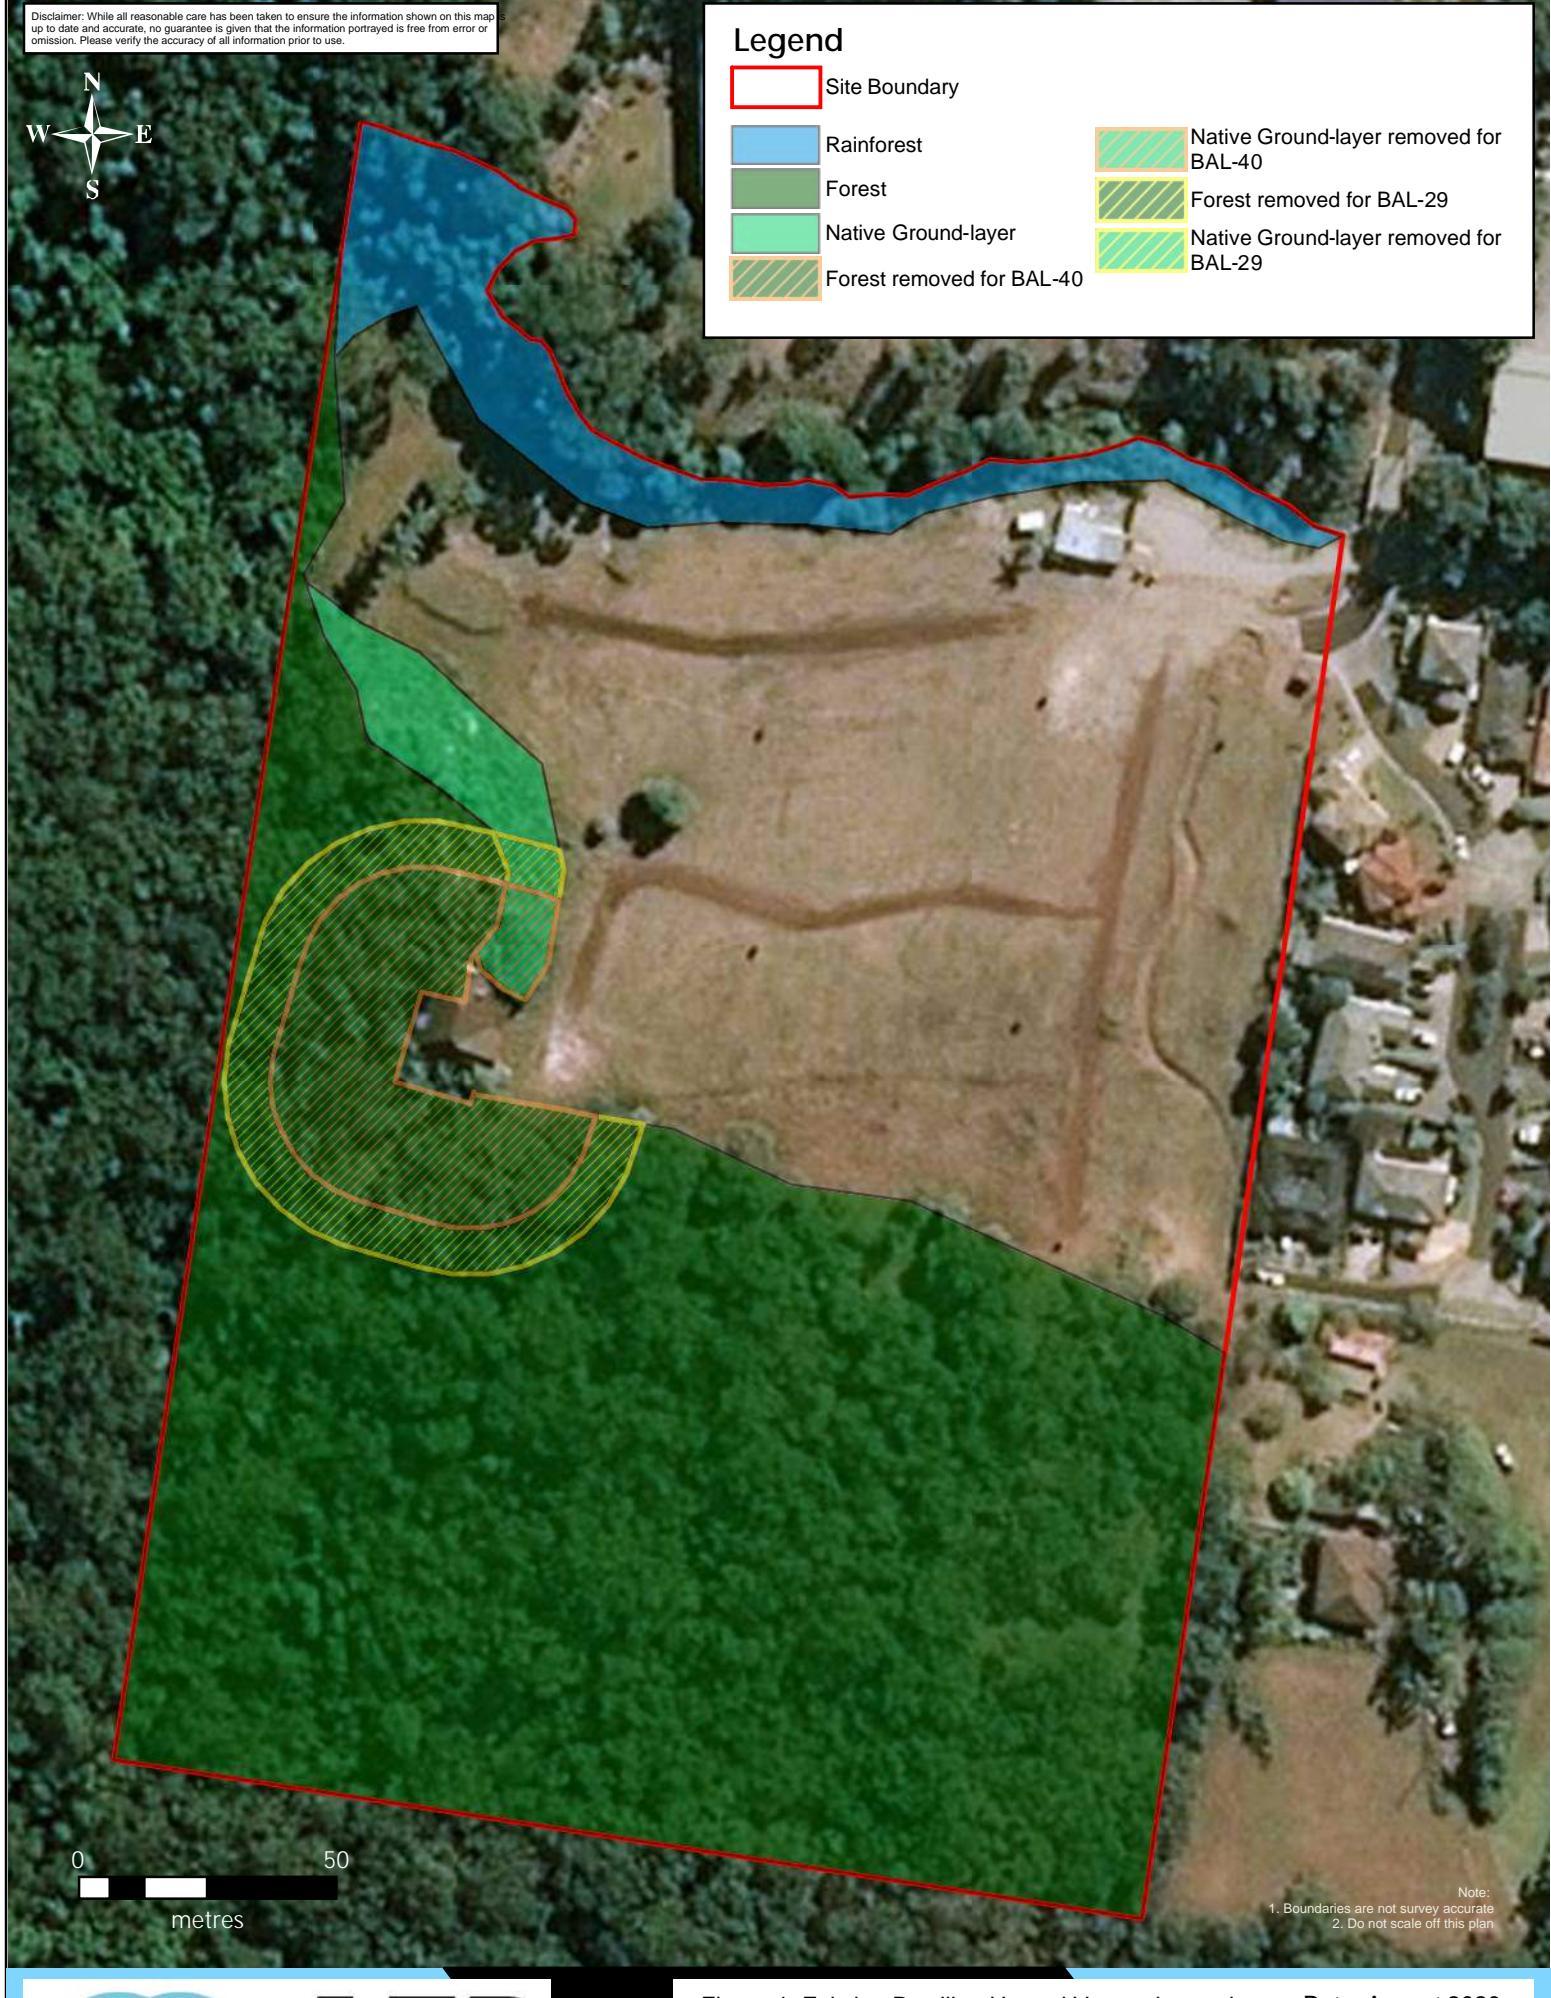
Figure 1: Existing Dwelling Hazard Vegetation and Clearing Location: Warriewood, NSW Date: August 2020

To achieve the required APZs and BAL 40 construction standards 0.2ha of native forest would need to be required. If the proposal was to clear APZs for BAL 29 construction standards clearing 0.4ha of native forest would be required. This report has not investigated further clearing to reduce construction standards for BAL 12.5 as this would require clearing on adjoining land.

Figure 1 depicts the vegetation types and also demonstrates that areas of native vegetation that would be require to be removed to meet Asses Protection Zones (APZs) for BAL 40 and BAL 29 construction standards.

It is recommended the vegetation be retained and other options be considered for the existing dwelling to preserve the vegetation within the site.

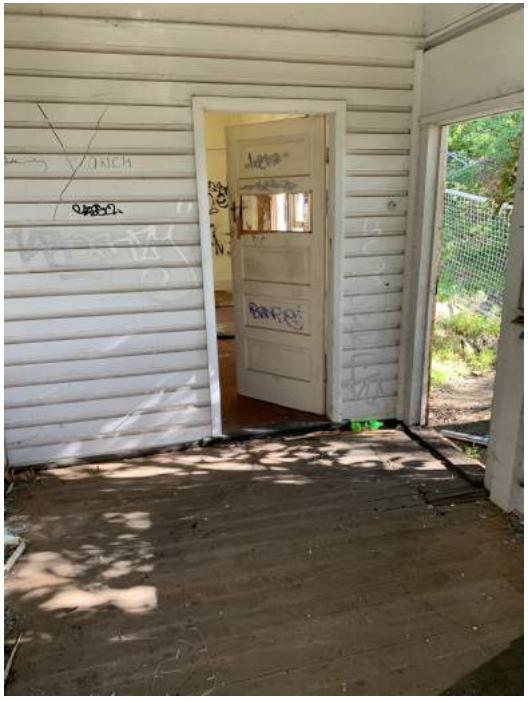
The house is dilapidated and has been extensively vandalised. From its period of construction, considerable asbestos contamination is anticipated. Given the level of dilapidation, in conjunction with the restraints outlined below, restoration of the house is not considered viable or desirable.

Figure 3: Typical interior.

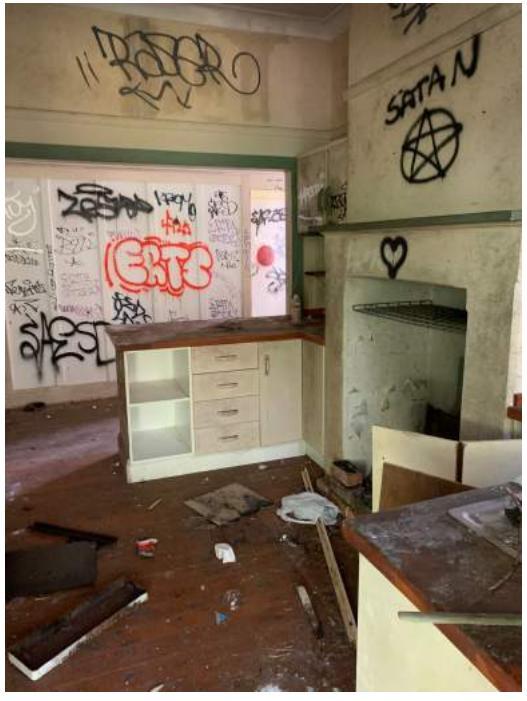
Figure 4: Kitchen.

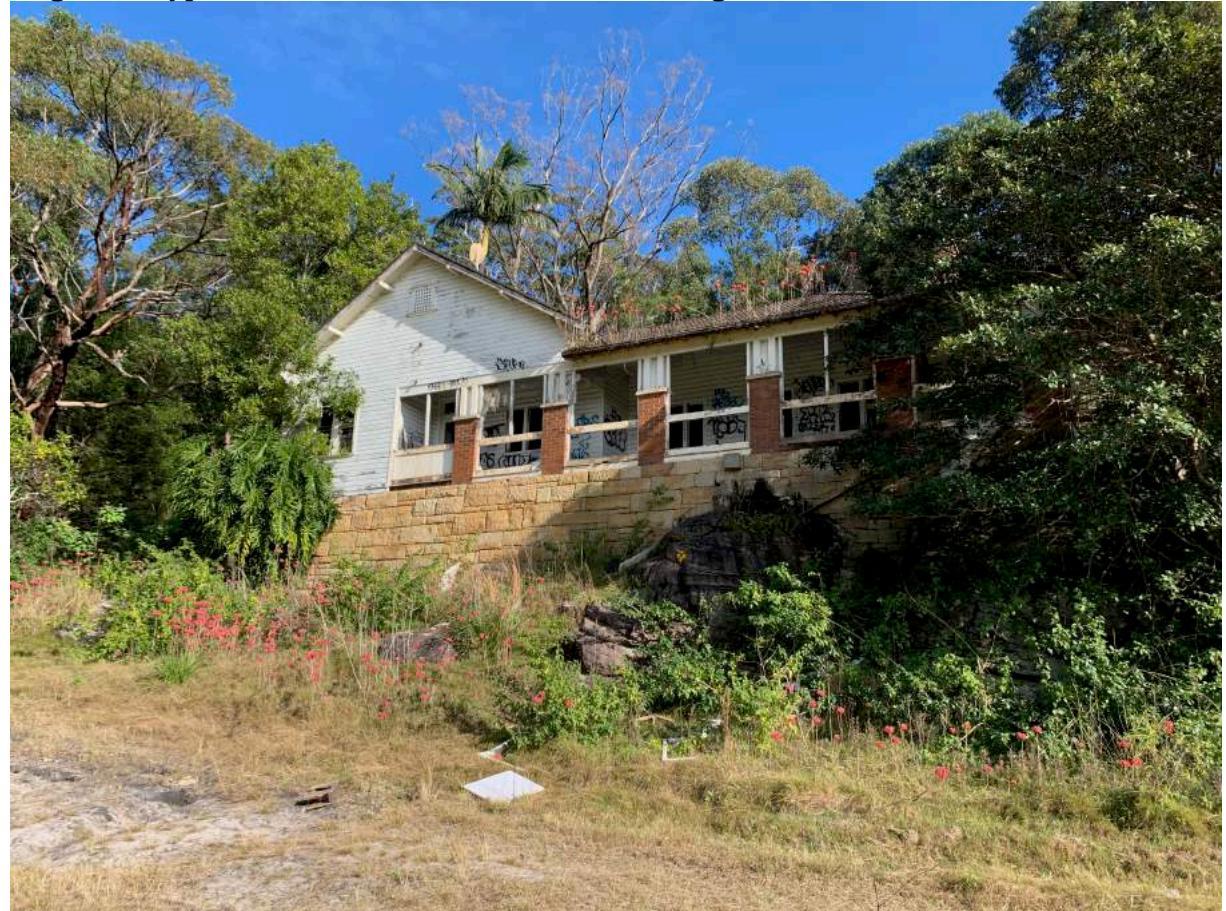
It is noted that the house is in very poor condition having been left vacant for some time.

Figure 5: The existing house.

It is proposed to remove the house from the site and to retain the sandstone foundations that surround it to create a benched area for passive recreation as part of the overall development.
