Date: 21st December 2020 **No. Pages:** 3 **Project No.:** 2020-265

Brad Sugar 29 Donegal Road, Killarney Heights N.S.W.

Preliminary Landslip Assessment for 29 Donegal Road, Killarney Heights

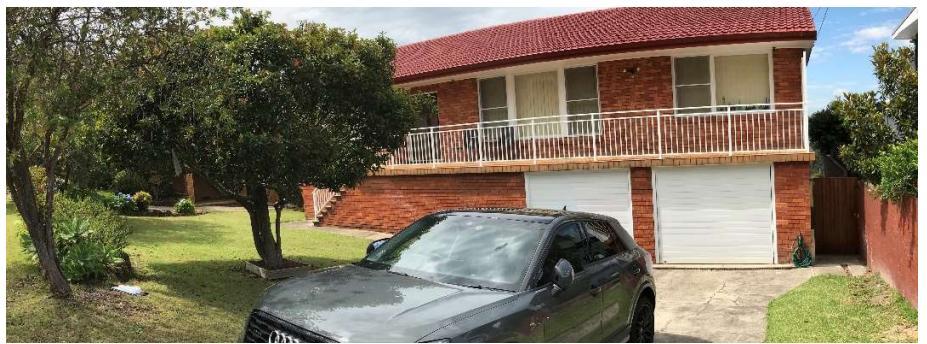
The front (north) of the site comprises a gently to moderately south sloping lawn with scattered immature trees, and concrete driveway adjacent to the western shared boundary. The site residence comprises a twostorey brick dwelling which appeared in good condition with no cracking observed in the brickwork. A view of the front of the property is provided in Photograph 1.

Photograph 1: View of the site looking south from Donegal Road.

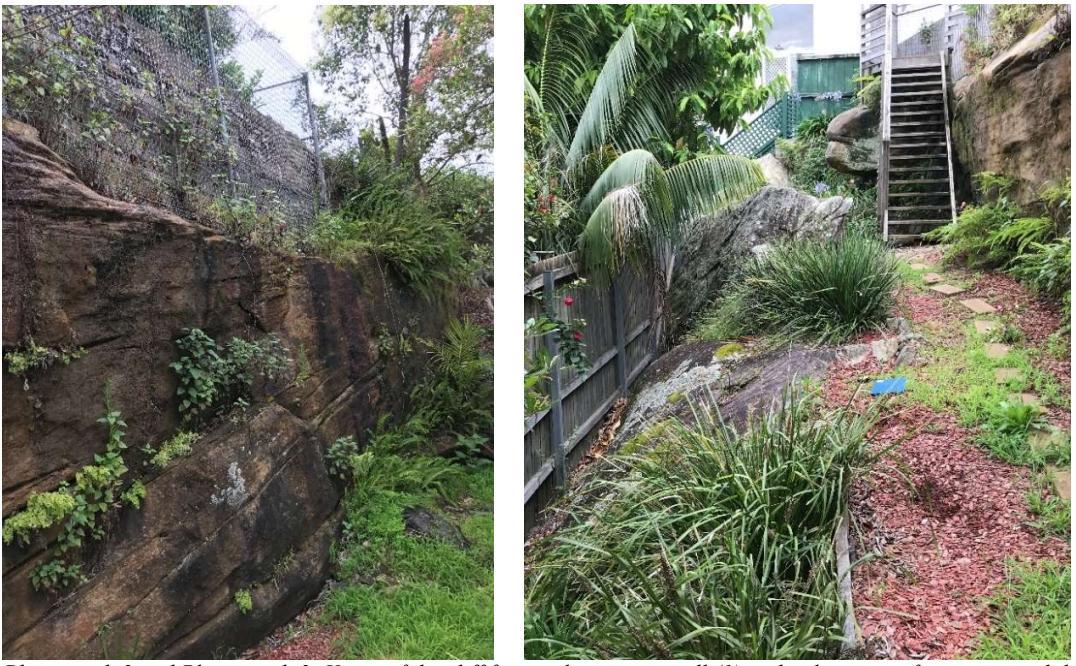
The rear of the site contains a gently to moderately south dipping lawn and terrace to the rear of the existing residence. Within the south end of the rear garden bedrock outcrops and evidence of previous (likely ancient) rockfalls were observed. In addition, a vertical cliff line trending broadly east-west and up to approximately 3.0m in height is present.

At the crest of the cliff line, a retaining wall approximately 2.0m in height has been constructed. Evidence of recent instability or a potential mechanism for future instability was not observed within either the cliff face or overlying retaining structure.

Photograph 2 and Photograph 3: Views of the cliff face and retaining wall (1) and indications of ancient instability (2) at the south end of the site.

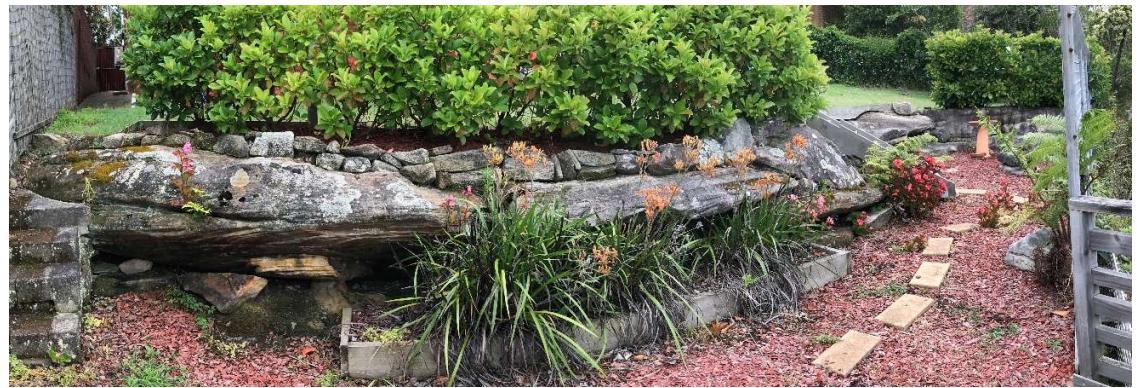
It appears that bedrock is outcropping in the vicinity of the pool excavation (see Photograph 4) and comprises sandstone bedrock of at least low to medium strength.

Photograph 4: View of sandstone bedrock outcropping in the vicinity of the proposed pool excavation

All footings should bear on sandstone bedrock of at least low strength which offers allowable bearing capacities of approximately 1000kPa.

Construction of safe batter slopes, at a recommended angle of 1.5H:1V for the fill soils (steeper where bedrock is encountered), are considered suitable to maintain stability to the excavation whilst protecting neighbouring boundaries.
