Statement of Heritage Impact

Residential Flat Building, "Hilder Lea Flats"

Montreaux, 7 Commonwealth Parade, Manly 2095

Structural Repair and Window Sash Replacement to the Southern External Wall, Façade Painting

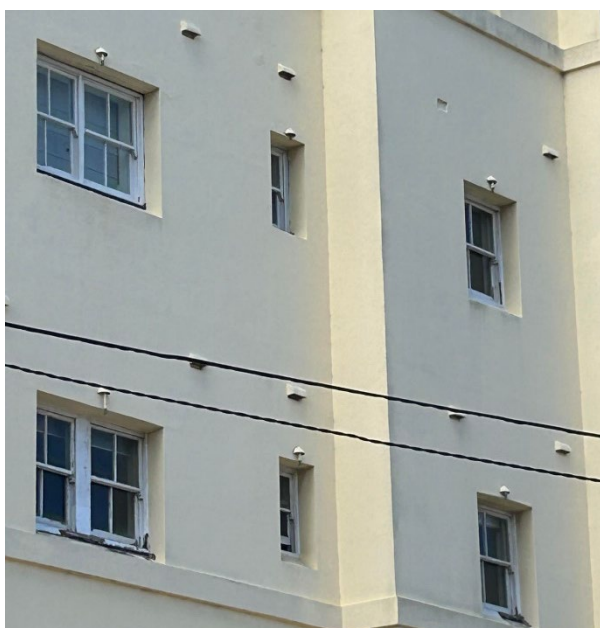
The exterior walls are of thick loadbearing cavity brickwork rendered on the outside and painted in a uniform pale yellow colour. (Figure 3, 4, 5) Most of the exterior windows are double hung box frame, timber windows, each sash divided in by a single vertical glazing bar. The only decorative treatment is the stepped shaping of the horns on the upper sash. There is considerable damaged to the box frame sections caused by cockatoos (Figure 6 and 7). Also, the lead flashing underneath the timber sill is being lifted by the cockatoos.

Figure 3 – Southern Façade – Showing Damaged Softwood Window Sills and Frames – Source: Hector Abrahams Architects

8. *There is damage caused by cockatoos, which is ongoing. It was observed that external edges of timber frames has been broken off, paint edges torn, and the lead flashing under the sill of an original window torn upwards. One timber box lining was broken away as to expose the weights.*

9. *The original timber sills are worn*

The works comprise of the replacement of all lintels in all masonry openings, the replacement of timber box frames in hardwood (to resist cockatoo damage), reinstatement of 26 original and replacement of 22 non-original sashes with new hardwood sashes to the original design. Finally, the elevation is to be painted in the existing paint type and colour scheme.

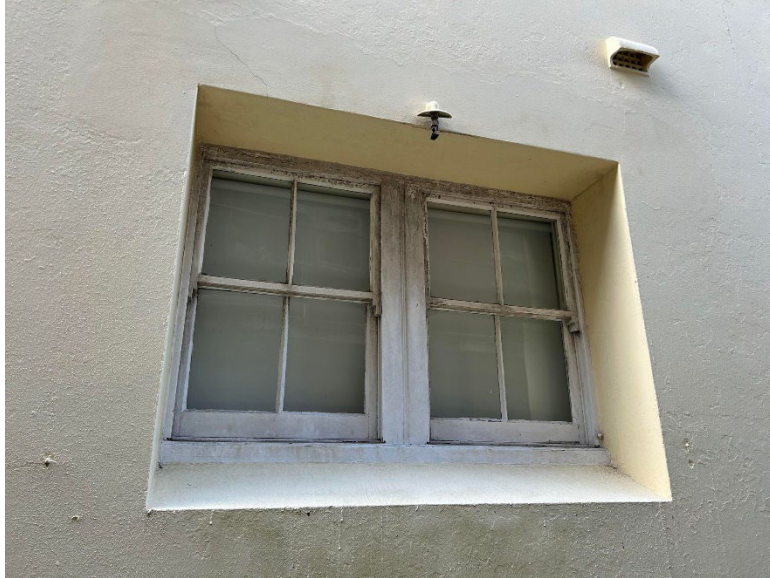
Figure 4 – Example of an original Window – Source: Hector Abrahams Architects

- 4. As well as the comprehensive replacement of lintels, the current specification of works includes for the wholesale replacement of the majority of the windows in the south elevation appear to be timber box framed double hung windows, hung on sash ropes. They have a distinctive stepped horn detail on the upper sash, and are likely to be part of the original construction. The sills are made of hardwood and the remainder of Californian Redwood, it would appear.*

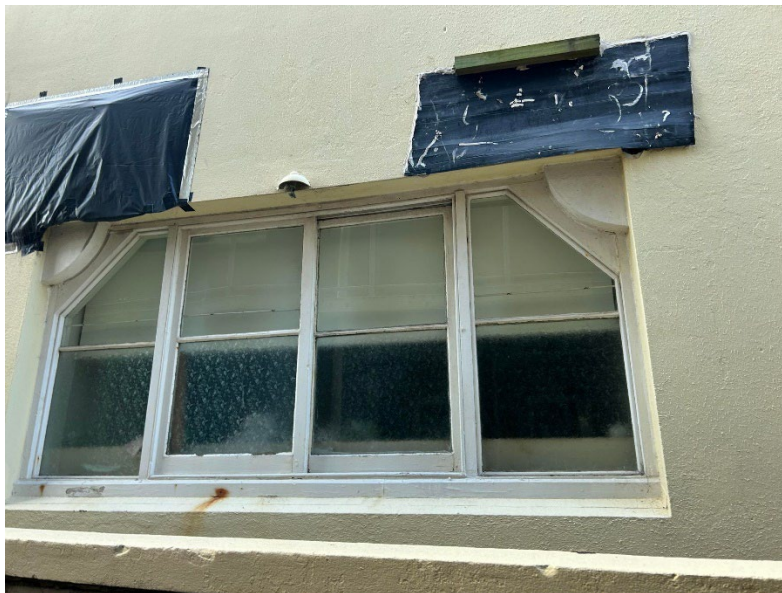
Figure 5 – Example of a replaced Window (non-original frames) – Source: Hector Abrahams Architects

6. *Other windows are timber framed double hung sashes, suspended on spiral balances, with chamfered outer horns. The style of these suggests a construction of the 1960s or later.*
