Arboriculture Assessment & Hazard Management Statement

March 2021

Site: Lot 1 in DP 571975
48-50 Lawrence Street
FRESHWATER, NSW

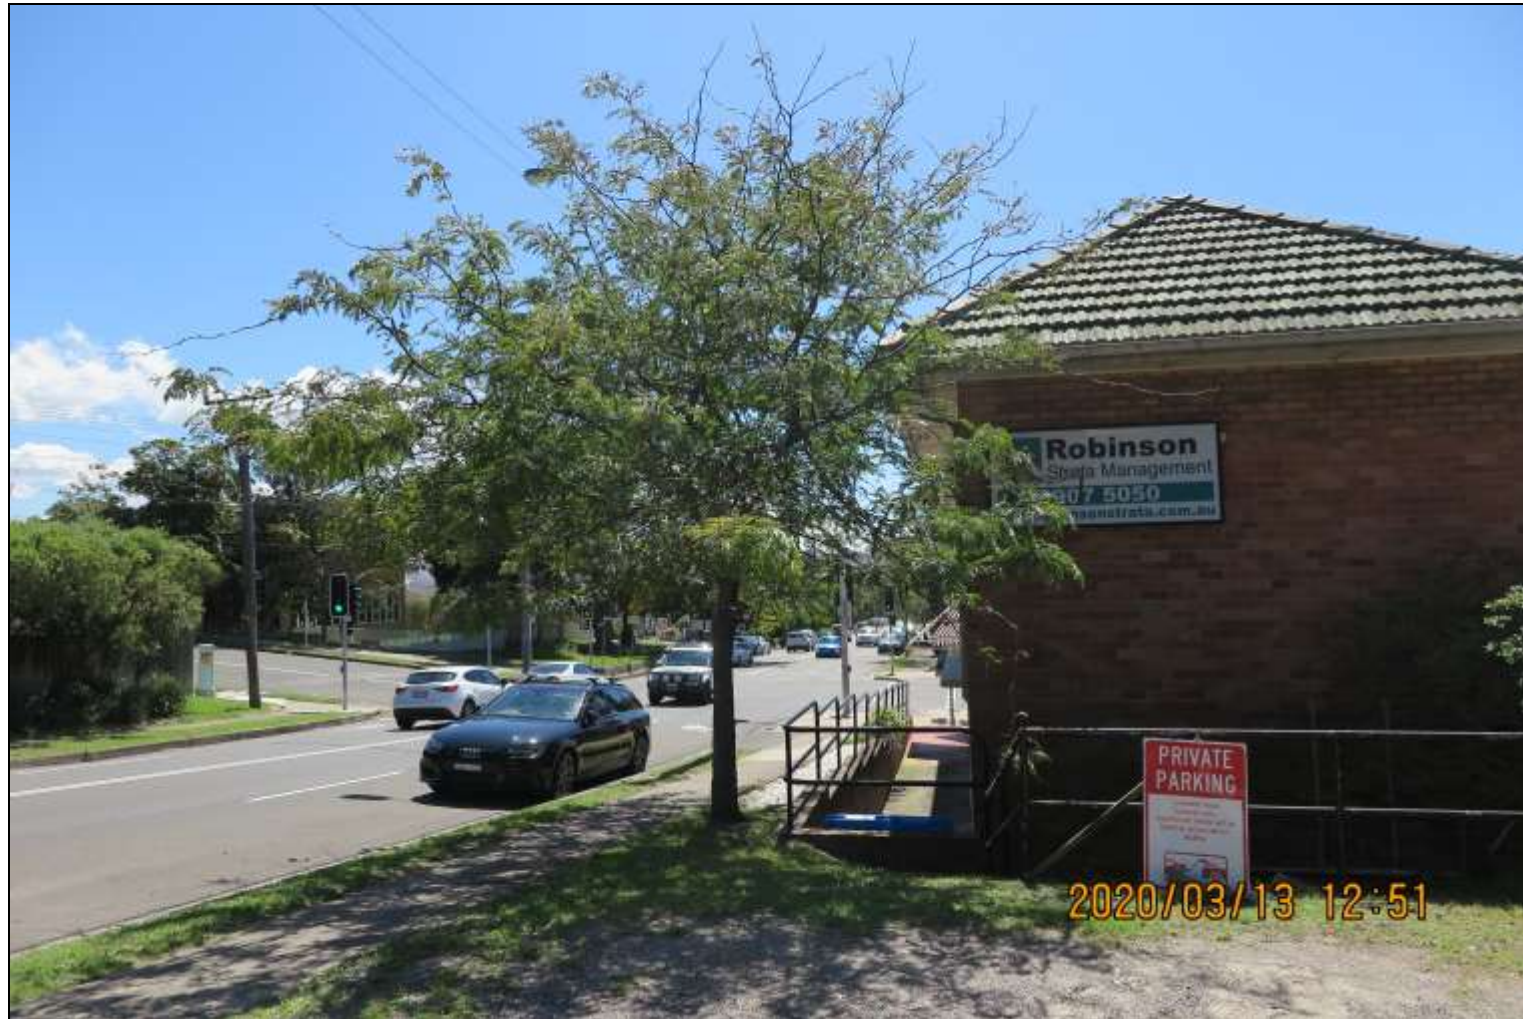
Figure 3: Illustrates Tree #1 location & canopy outline.

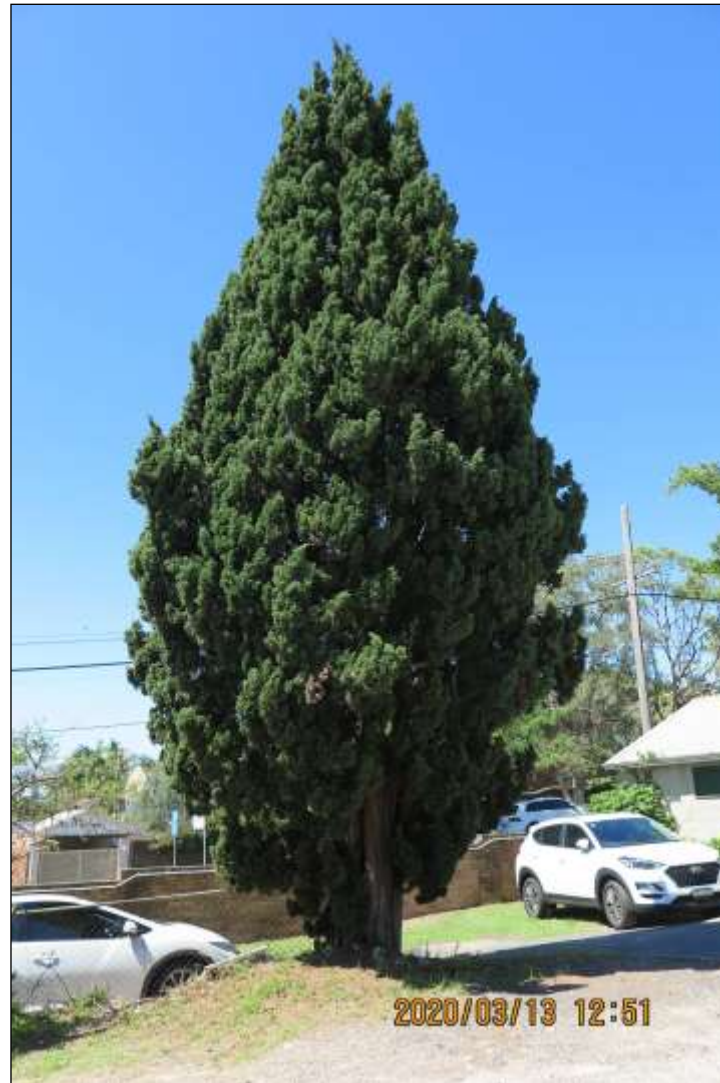
Figure 4: Illustrates Tree #2 location & canopy outline.

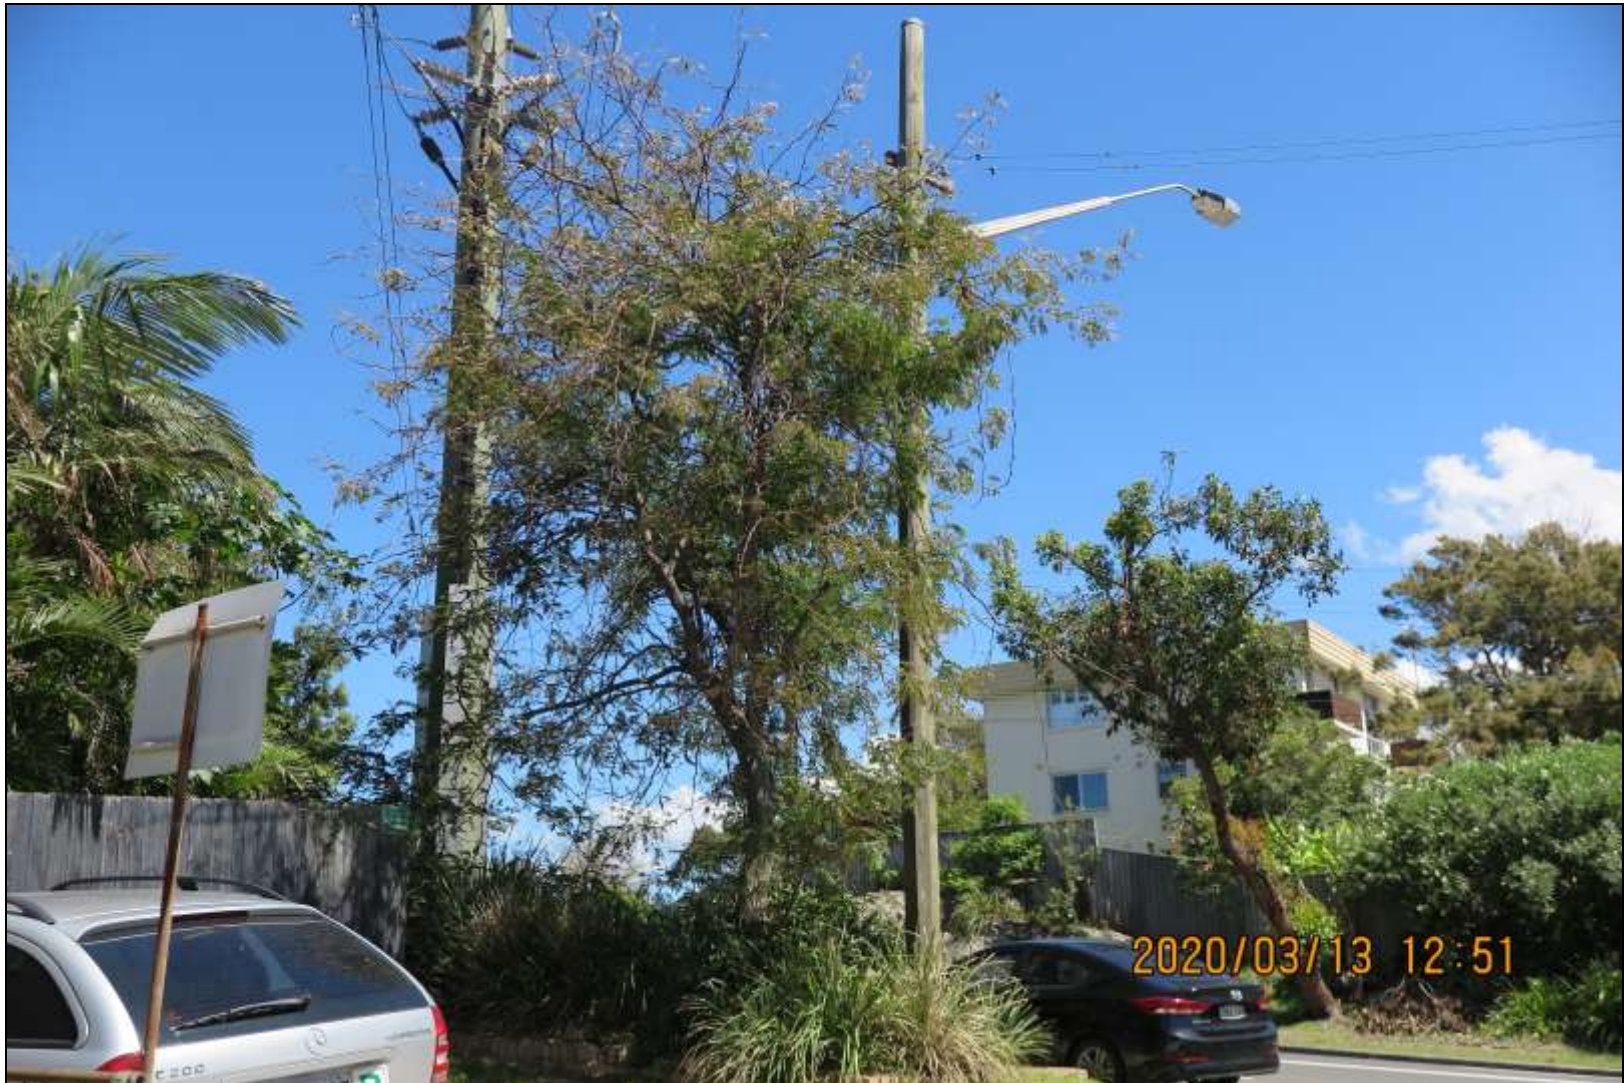
Figure 5: Illustrates Tree #3 location & canopy outline.
