HIS ANNEXURE A - 67 EUROBIN AVENUE PHOTOGRAPHS
INTERIOR PHOTOGRAPHS

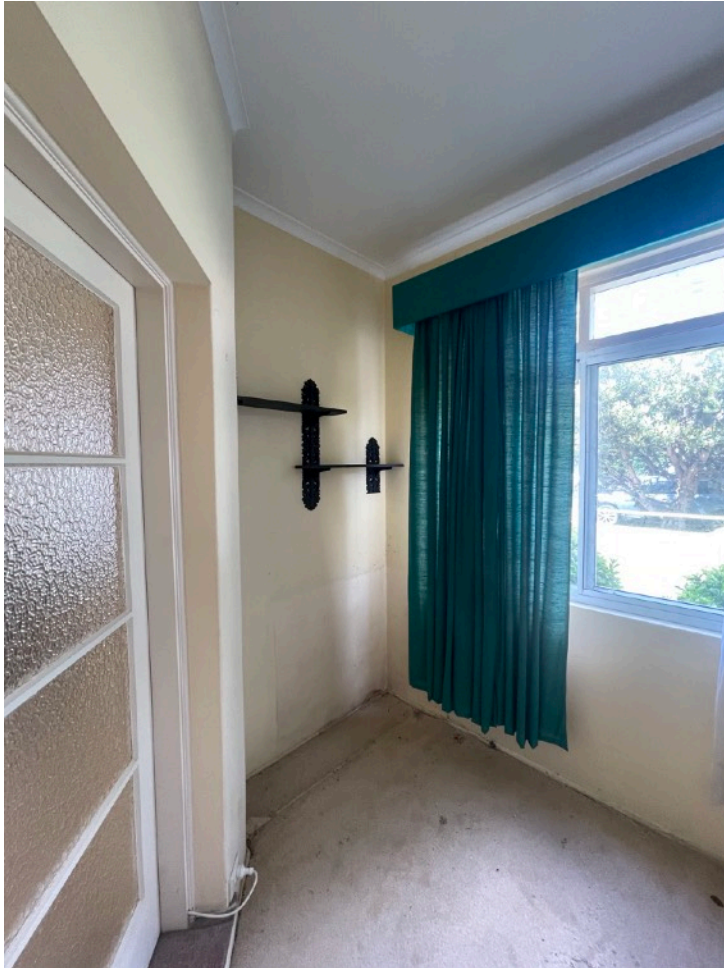
1. View of the sunroom in the ground floor unit.

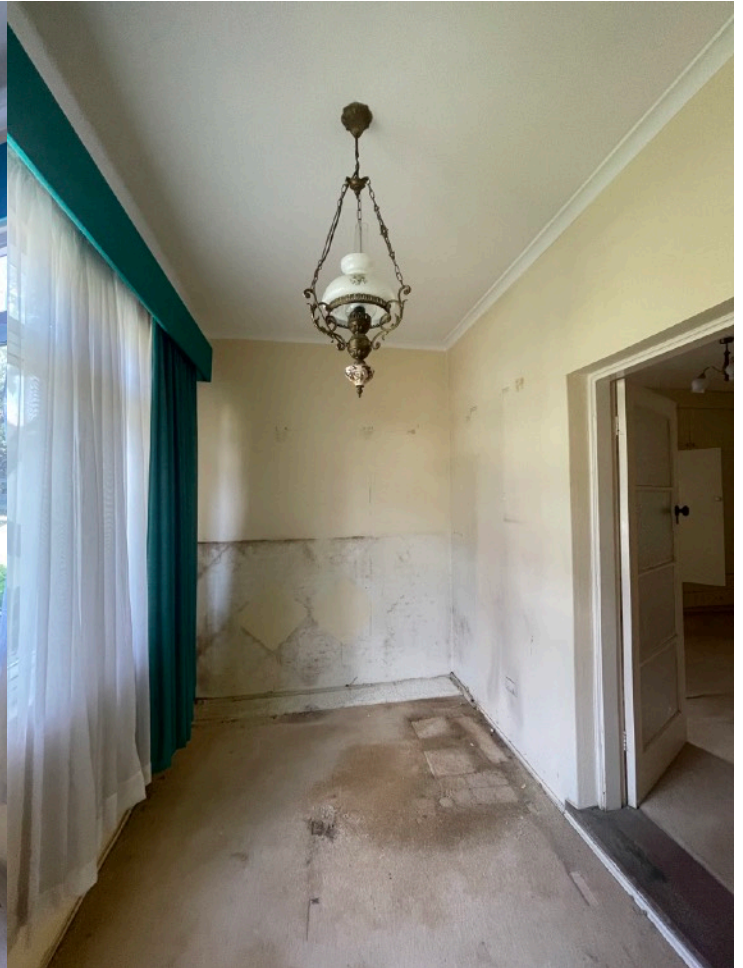
2. View of the sunroom in the ground floor unit showing damp present on the carpet and in the walls.

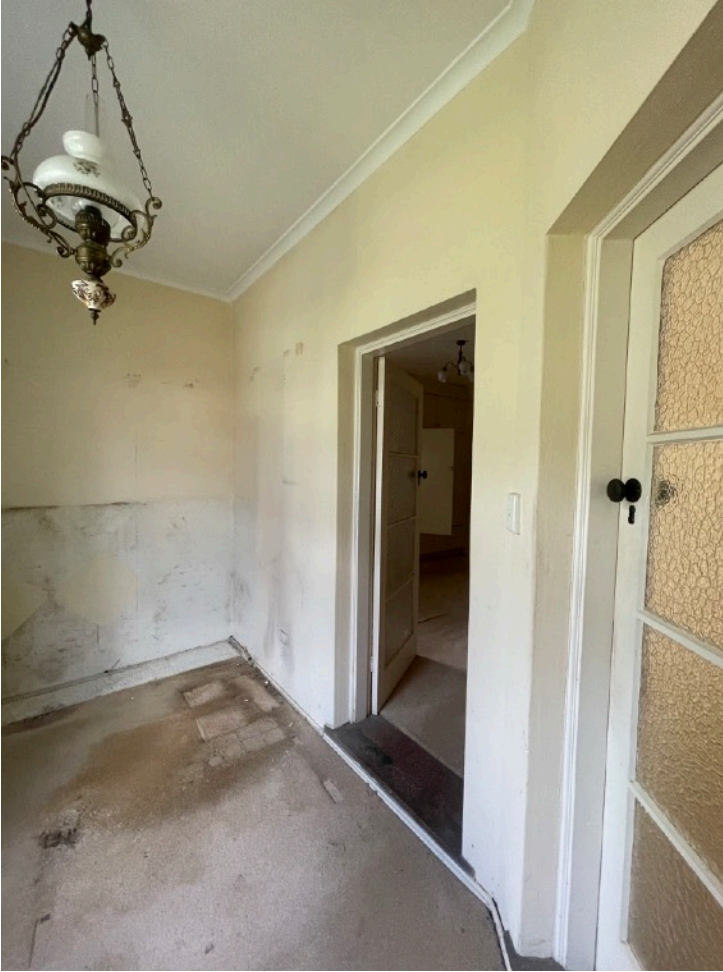
3. View of the doors to the sunroom in the ground floor unit.

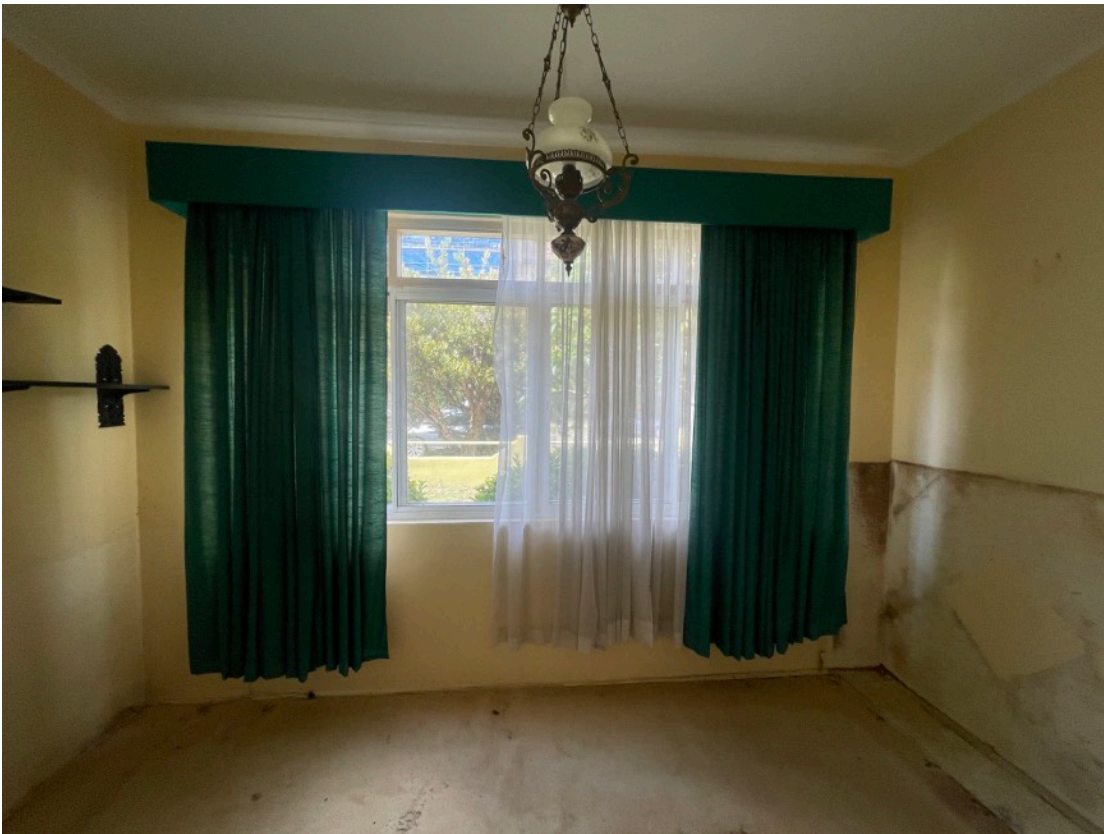
4. View of the front bedroom in the ground floor unit.

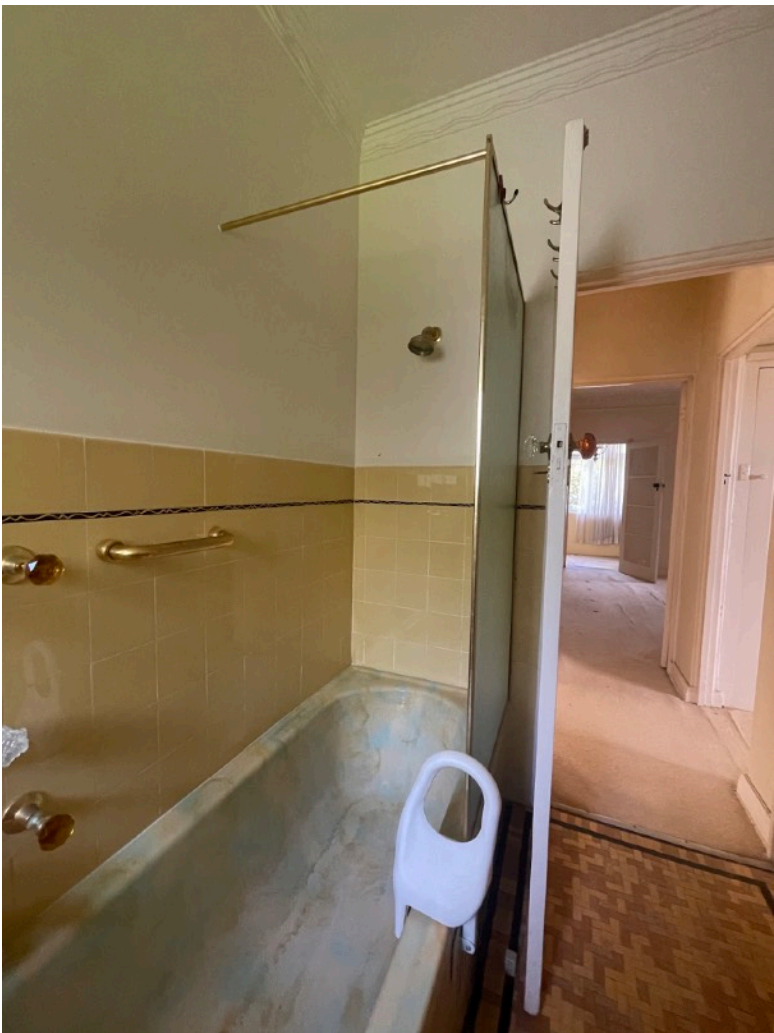
5. View of the bathroom in the ground floor unit.

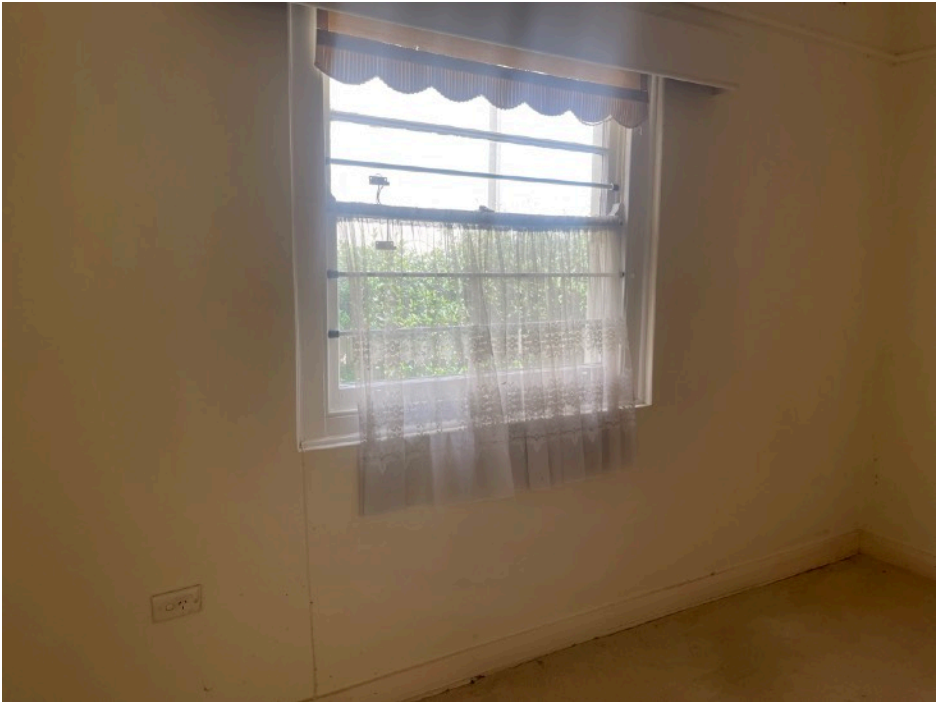
6.View of a typical window.

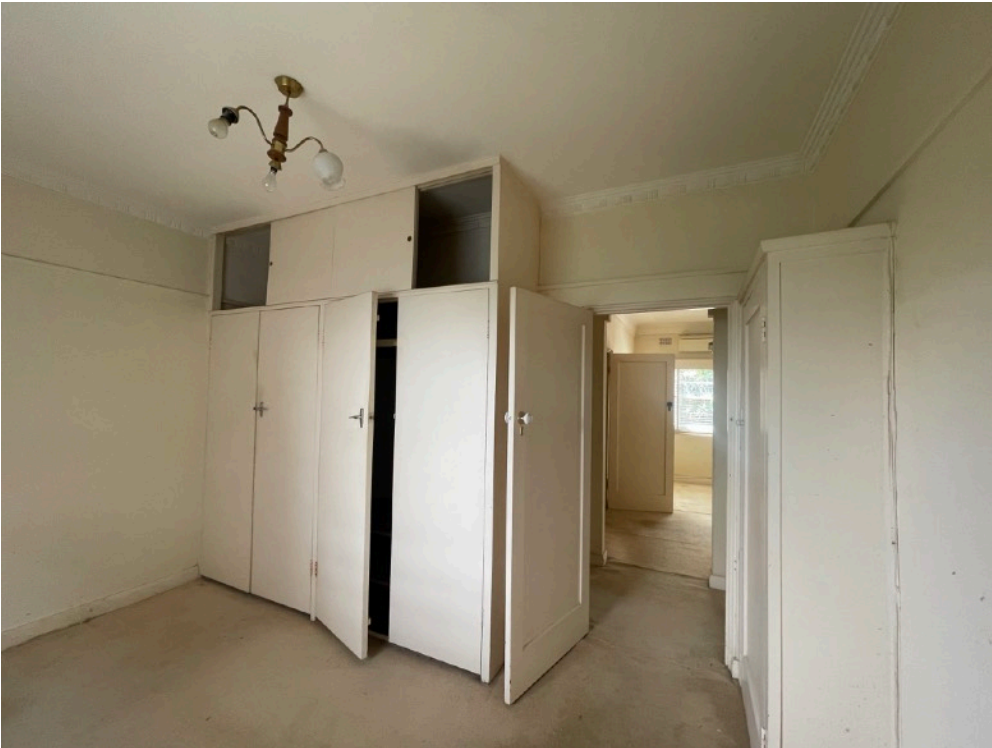
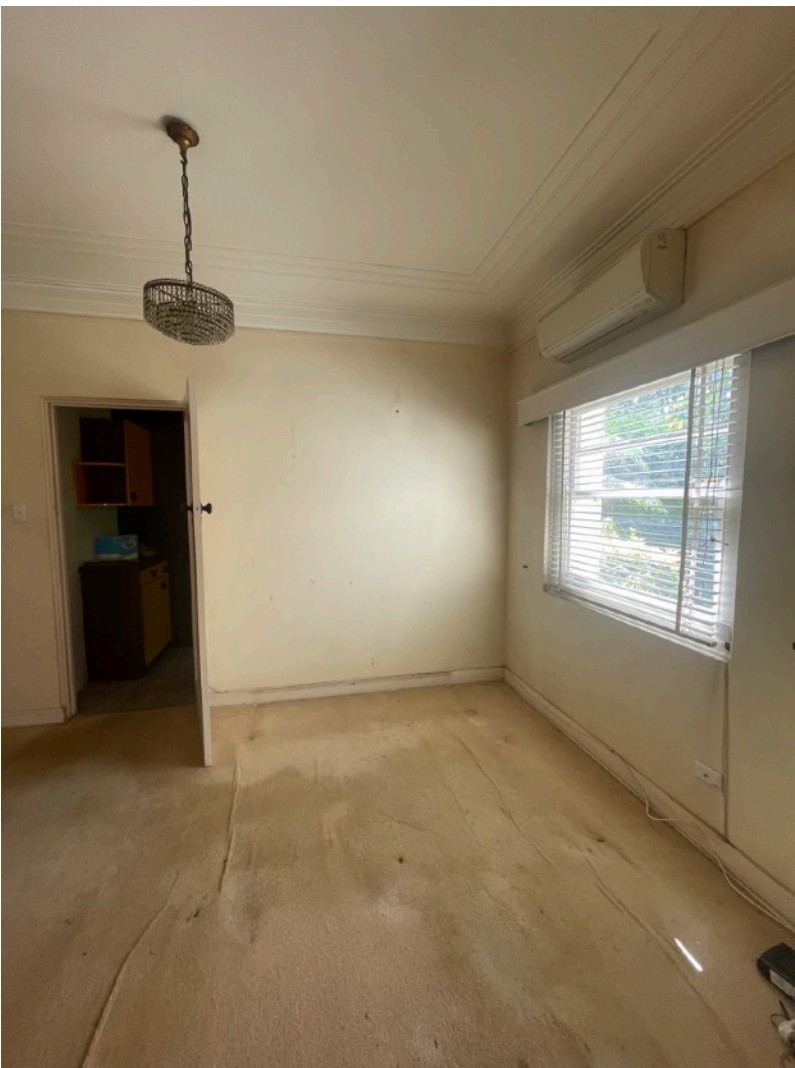
7 & 8. View of the rear ground floor bedroom.

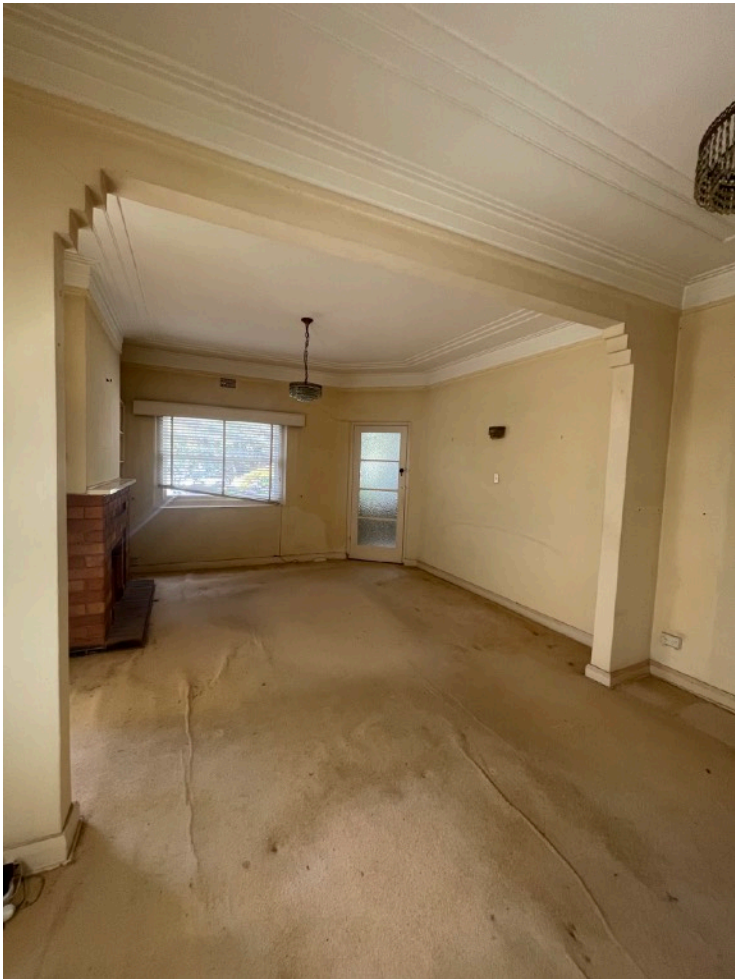
9. View of the living and dining room of the ground floor unit.

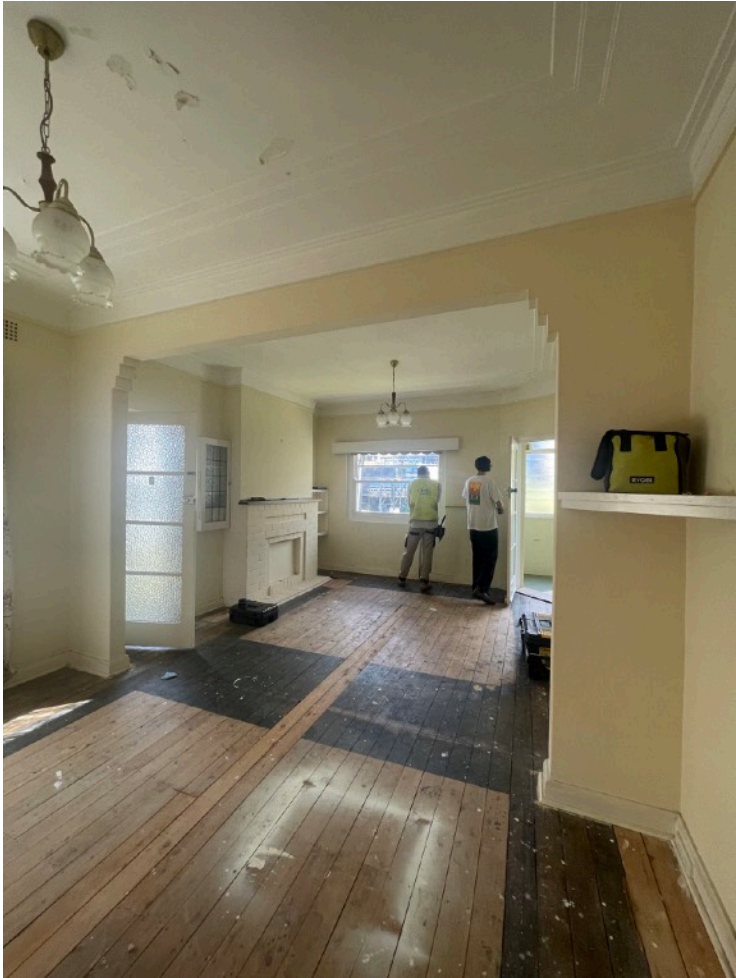
10. View of the living and dining room of the first floor unit.

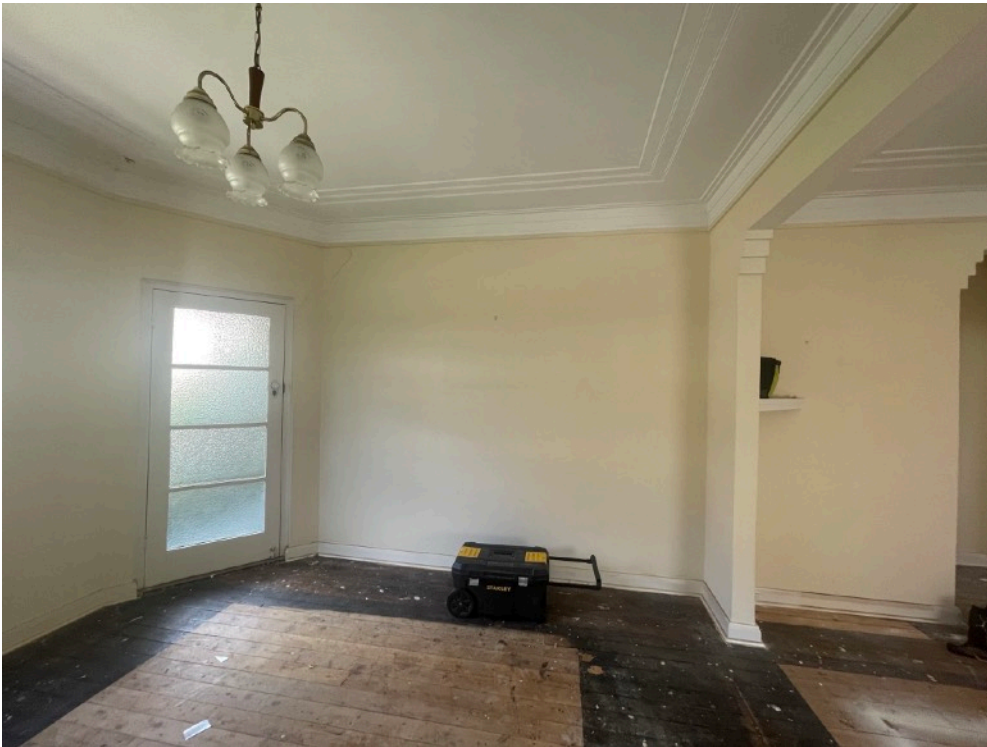
11. View of the living room of the first floor unit

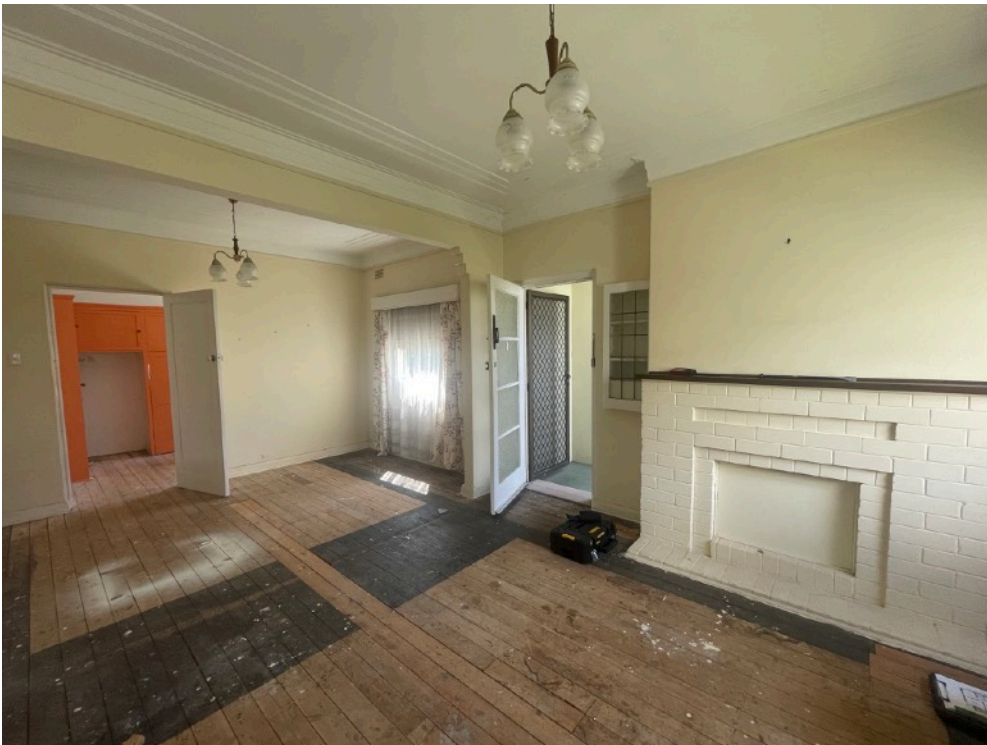
12. View of the living and dining room of the first floor unit

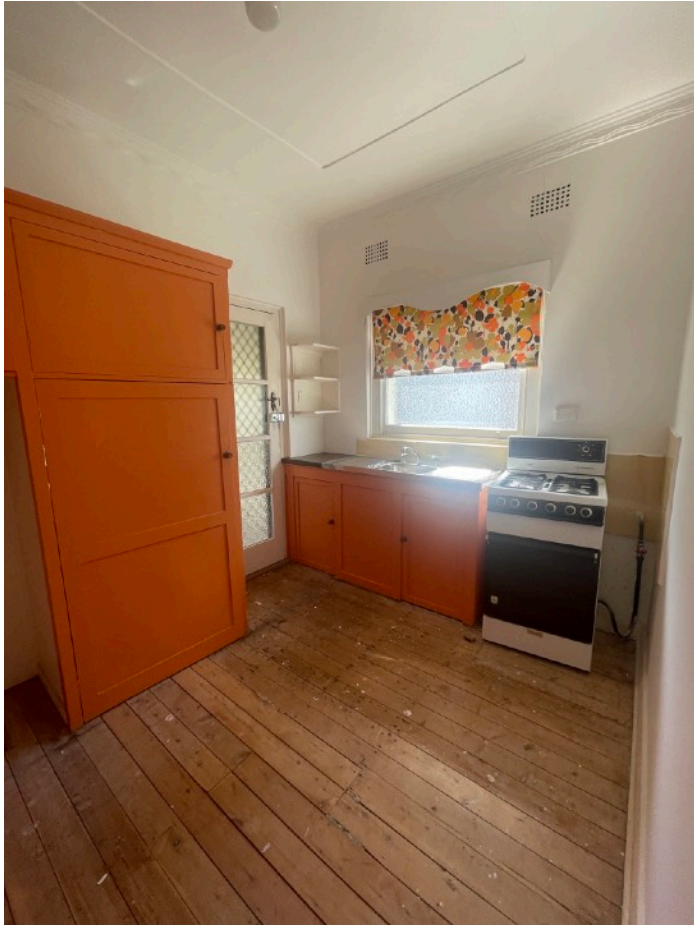
I 3. View of the kitchen in the first floor unit.

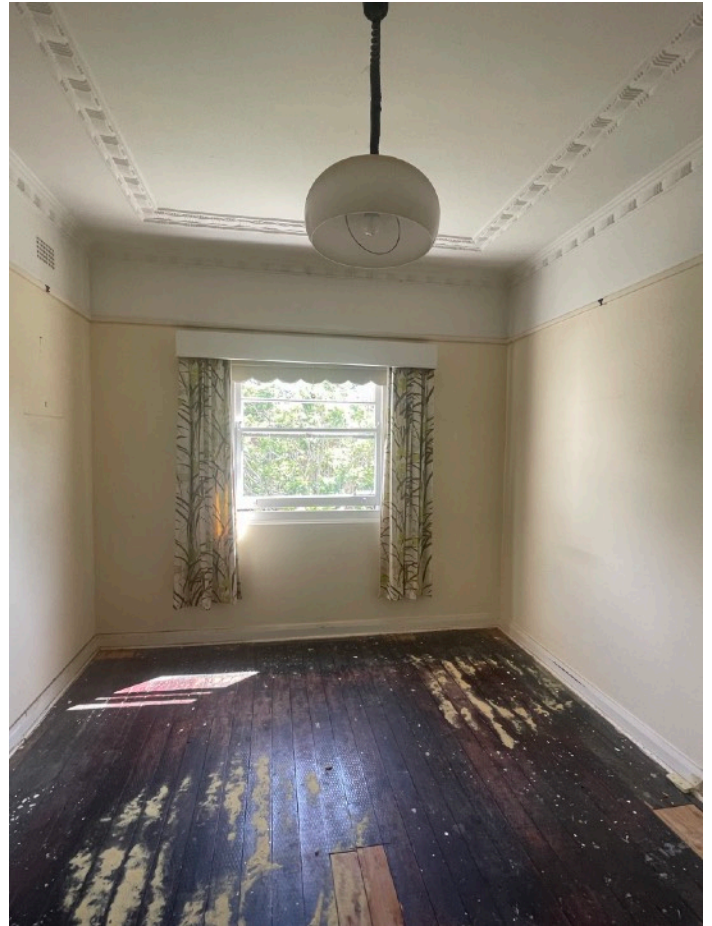
I 4. View of a first floor bedroom showing the typical details.

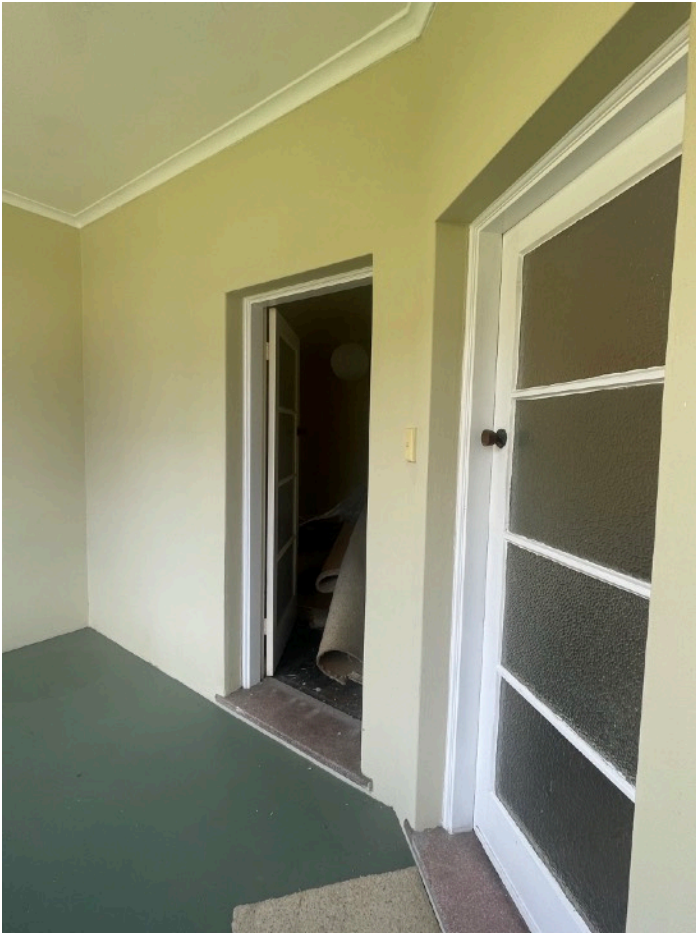
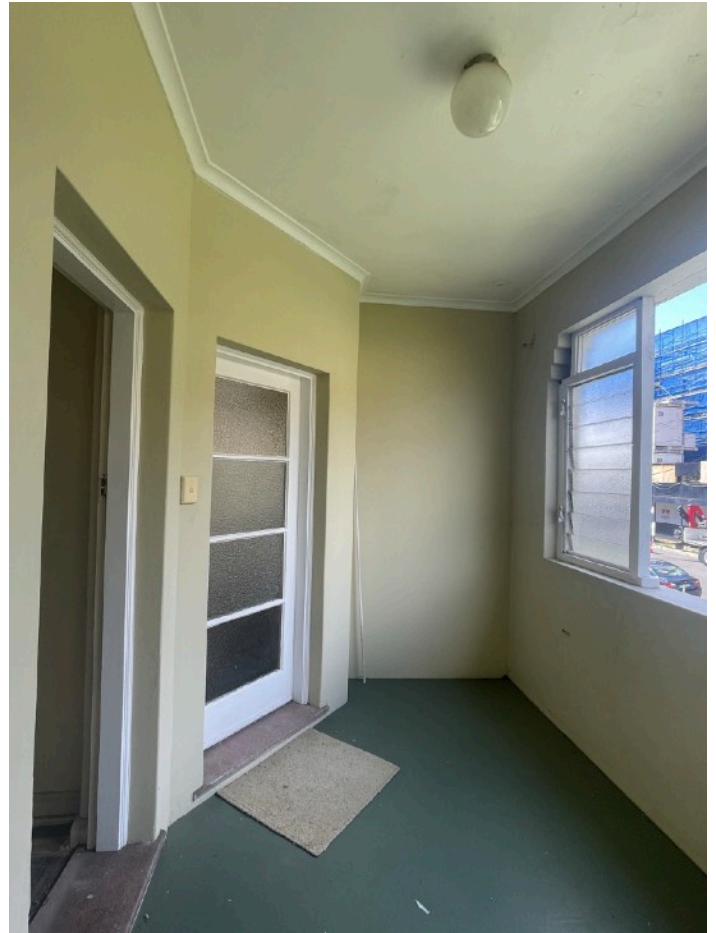
15 and 16 showing the first floor sunroom that was originally an open verandah on the first floor facade.

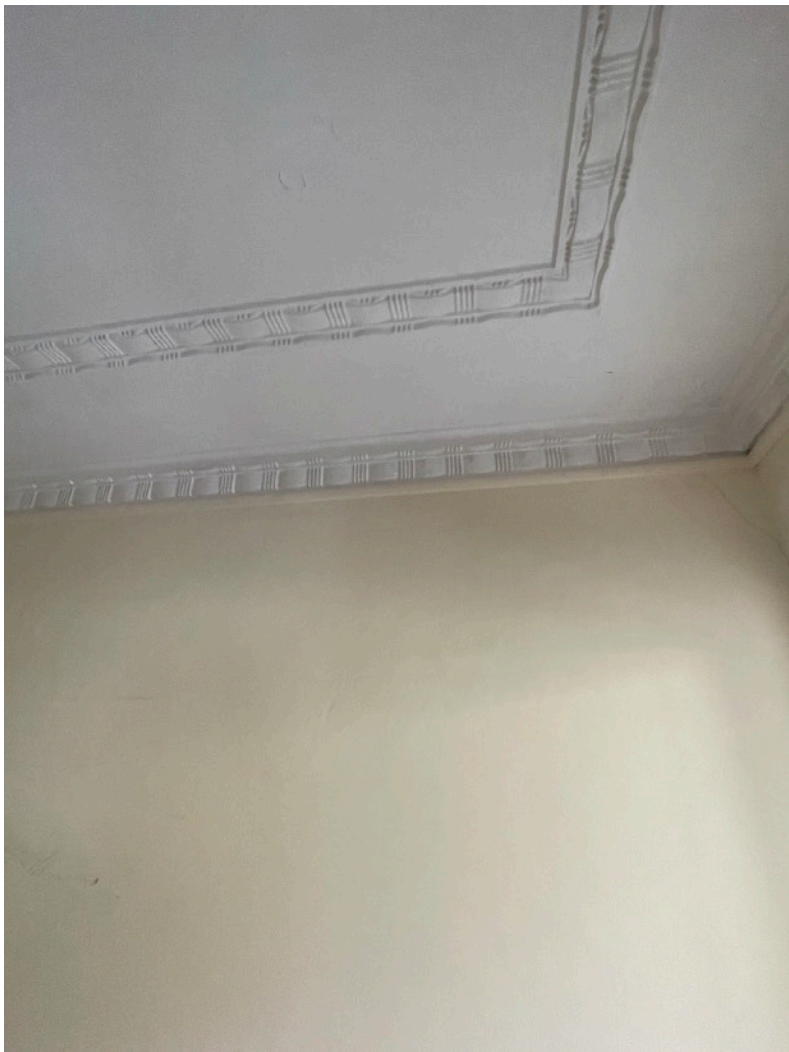
17.View of the detail on the first floor ceiling.

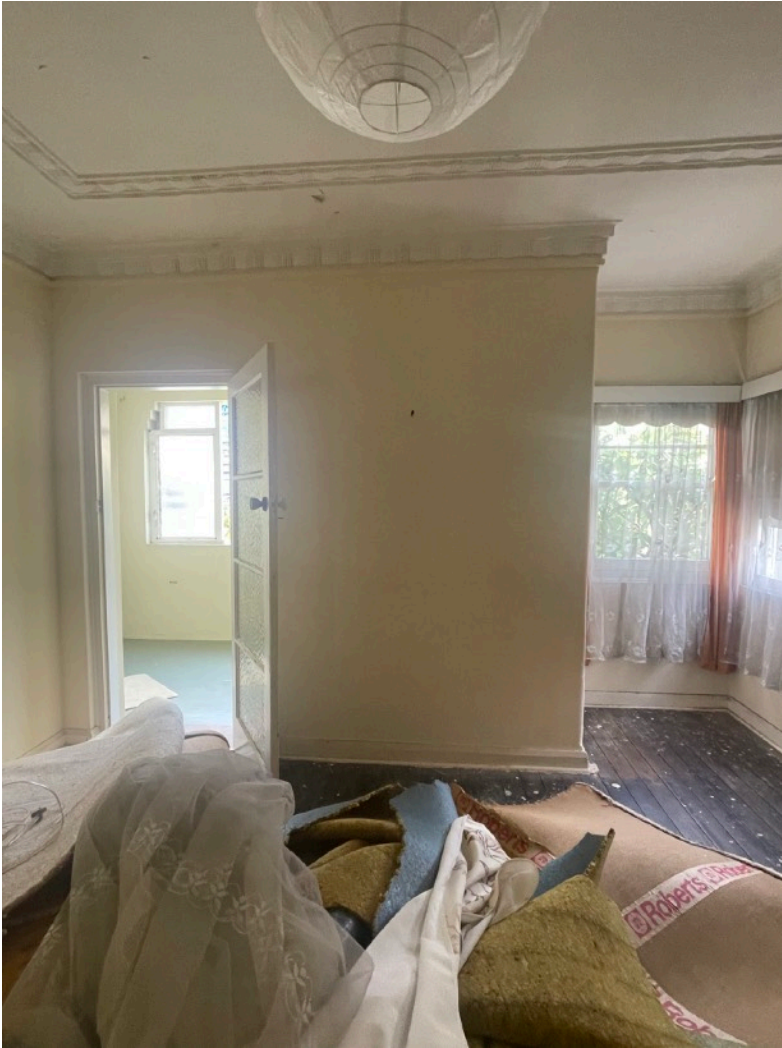
18. View from the living room to the sunroom on the first floor.

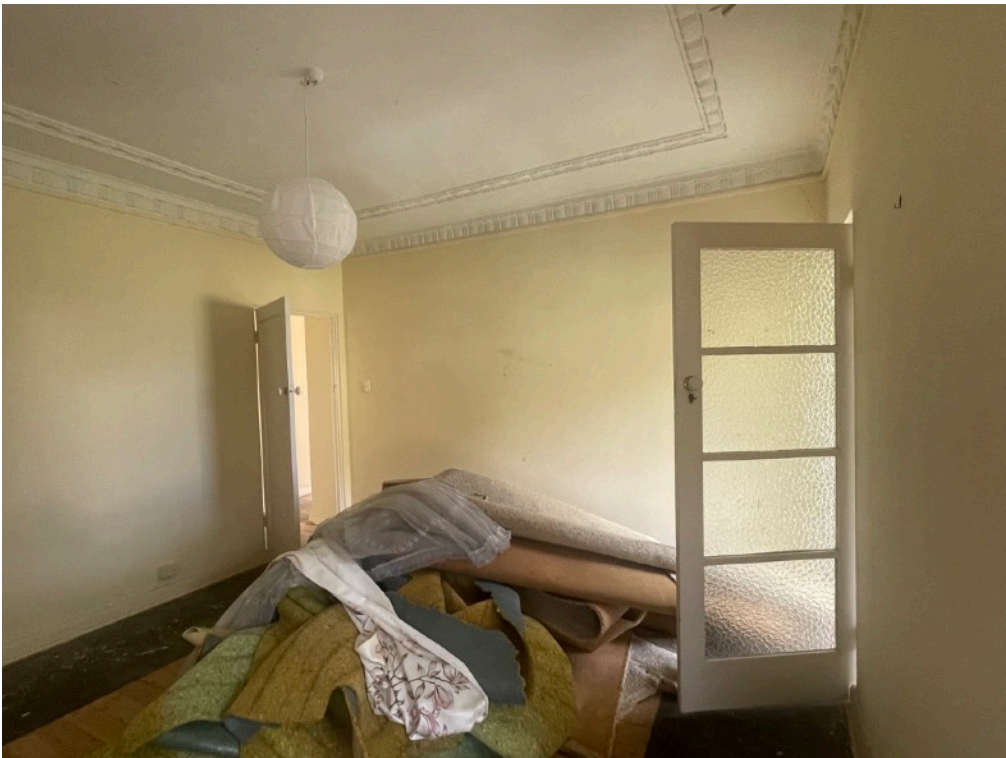
19. View of the front bedroom on the first floor.

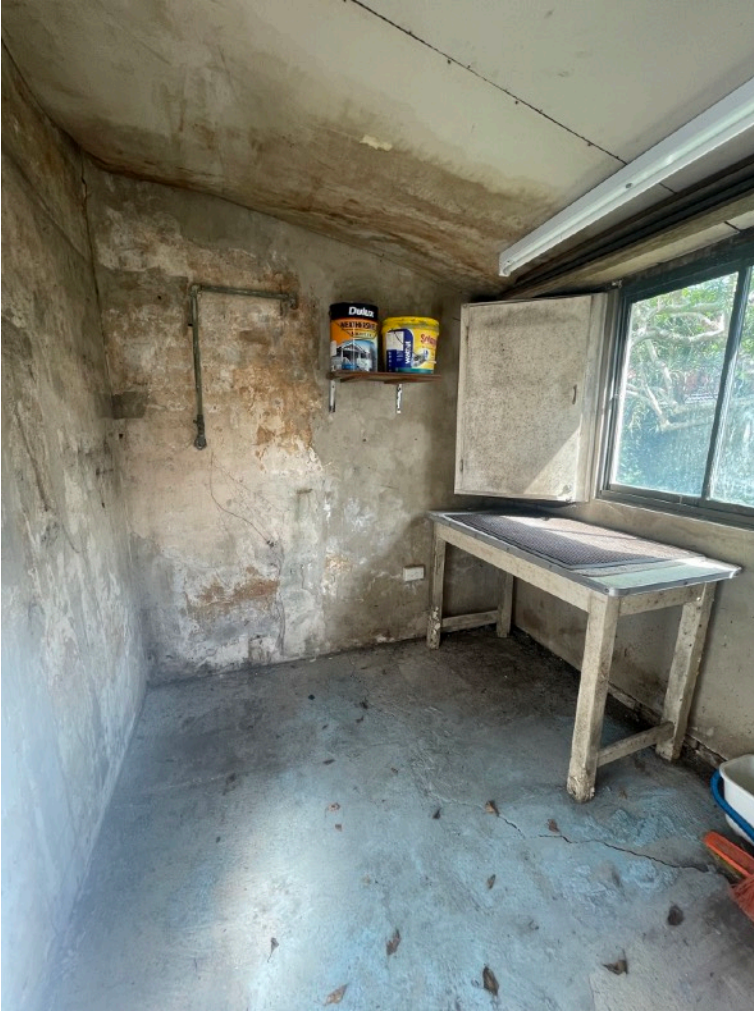
20. View of the room under the single storey lean-to at the rear:
