Geotechnical Assessment

Project: New Dwelling
79 Gondola Road, North Narrabeen NSW

Prepared for:
Arclab Pty Ltd

Ref: AG 24552
21 March 2025

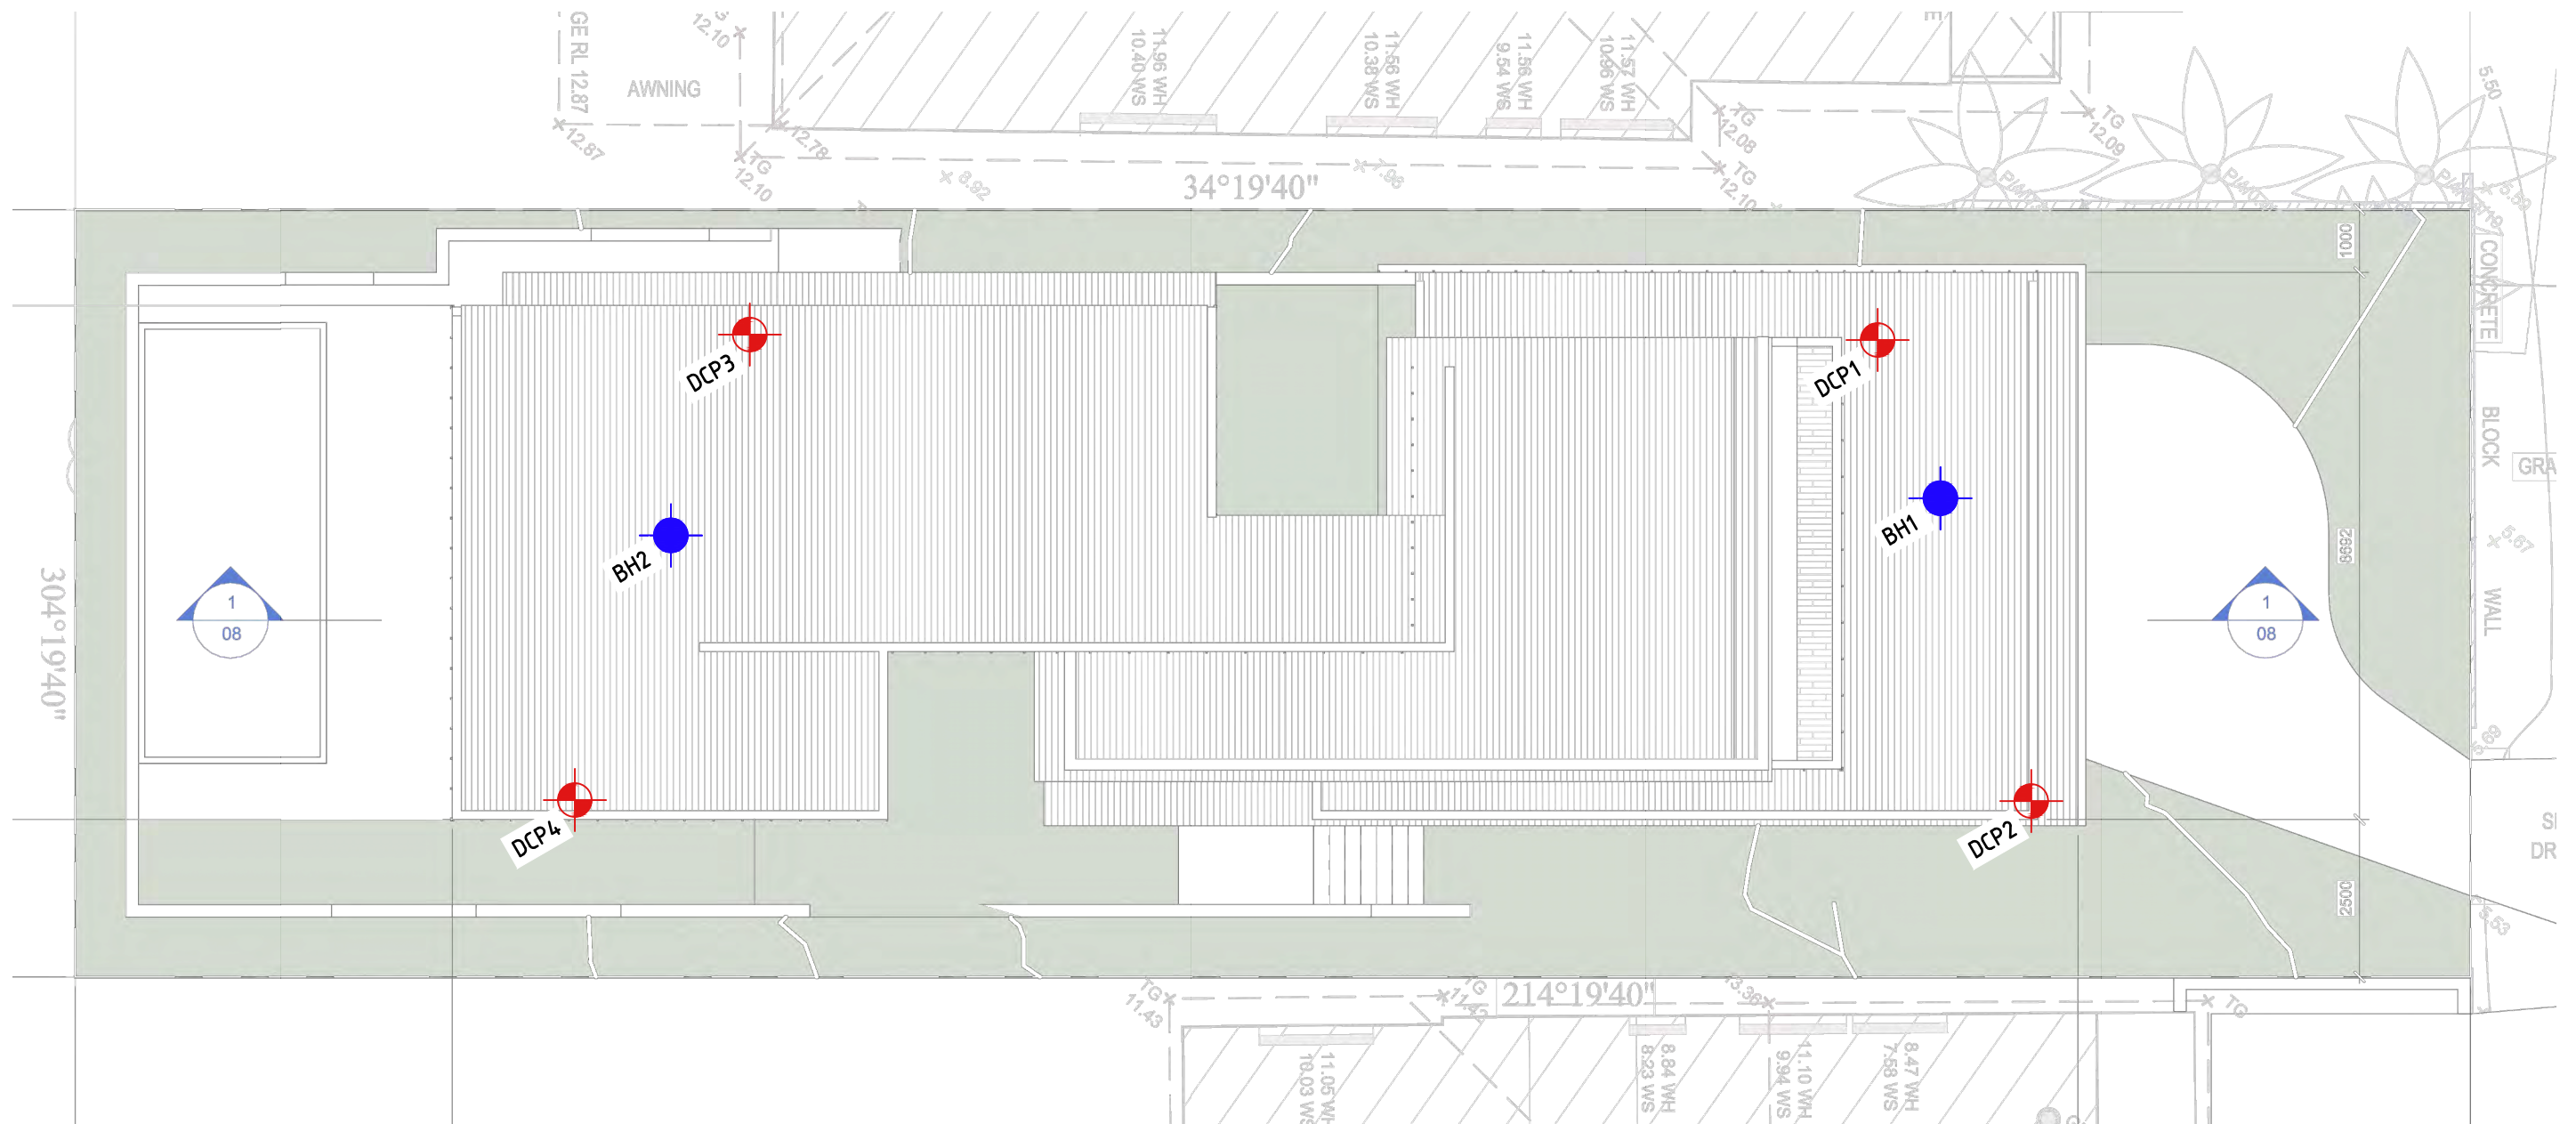
SITE PLAN/GROUND TEST LOCATIONS
SCALE NTS

Test	DCP 1	DCP 2
Summary	Practical refusal @ 3.90m. Slow progression through cemented sand. Brown sand on moist tip.	End of test @ 4.20m. Terminated at equipment maximum depth. Brown sand on moist tip.
Test	DCP 3	DCP 4
Summary	End of test @ 4.20m. Terminated at equipment maximum depth. Brown sand on moist tip.	End of test @ 4.20m. Terminated at equipment maximum depth. Brown sand on moist tip.

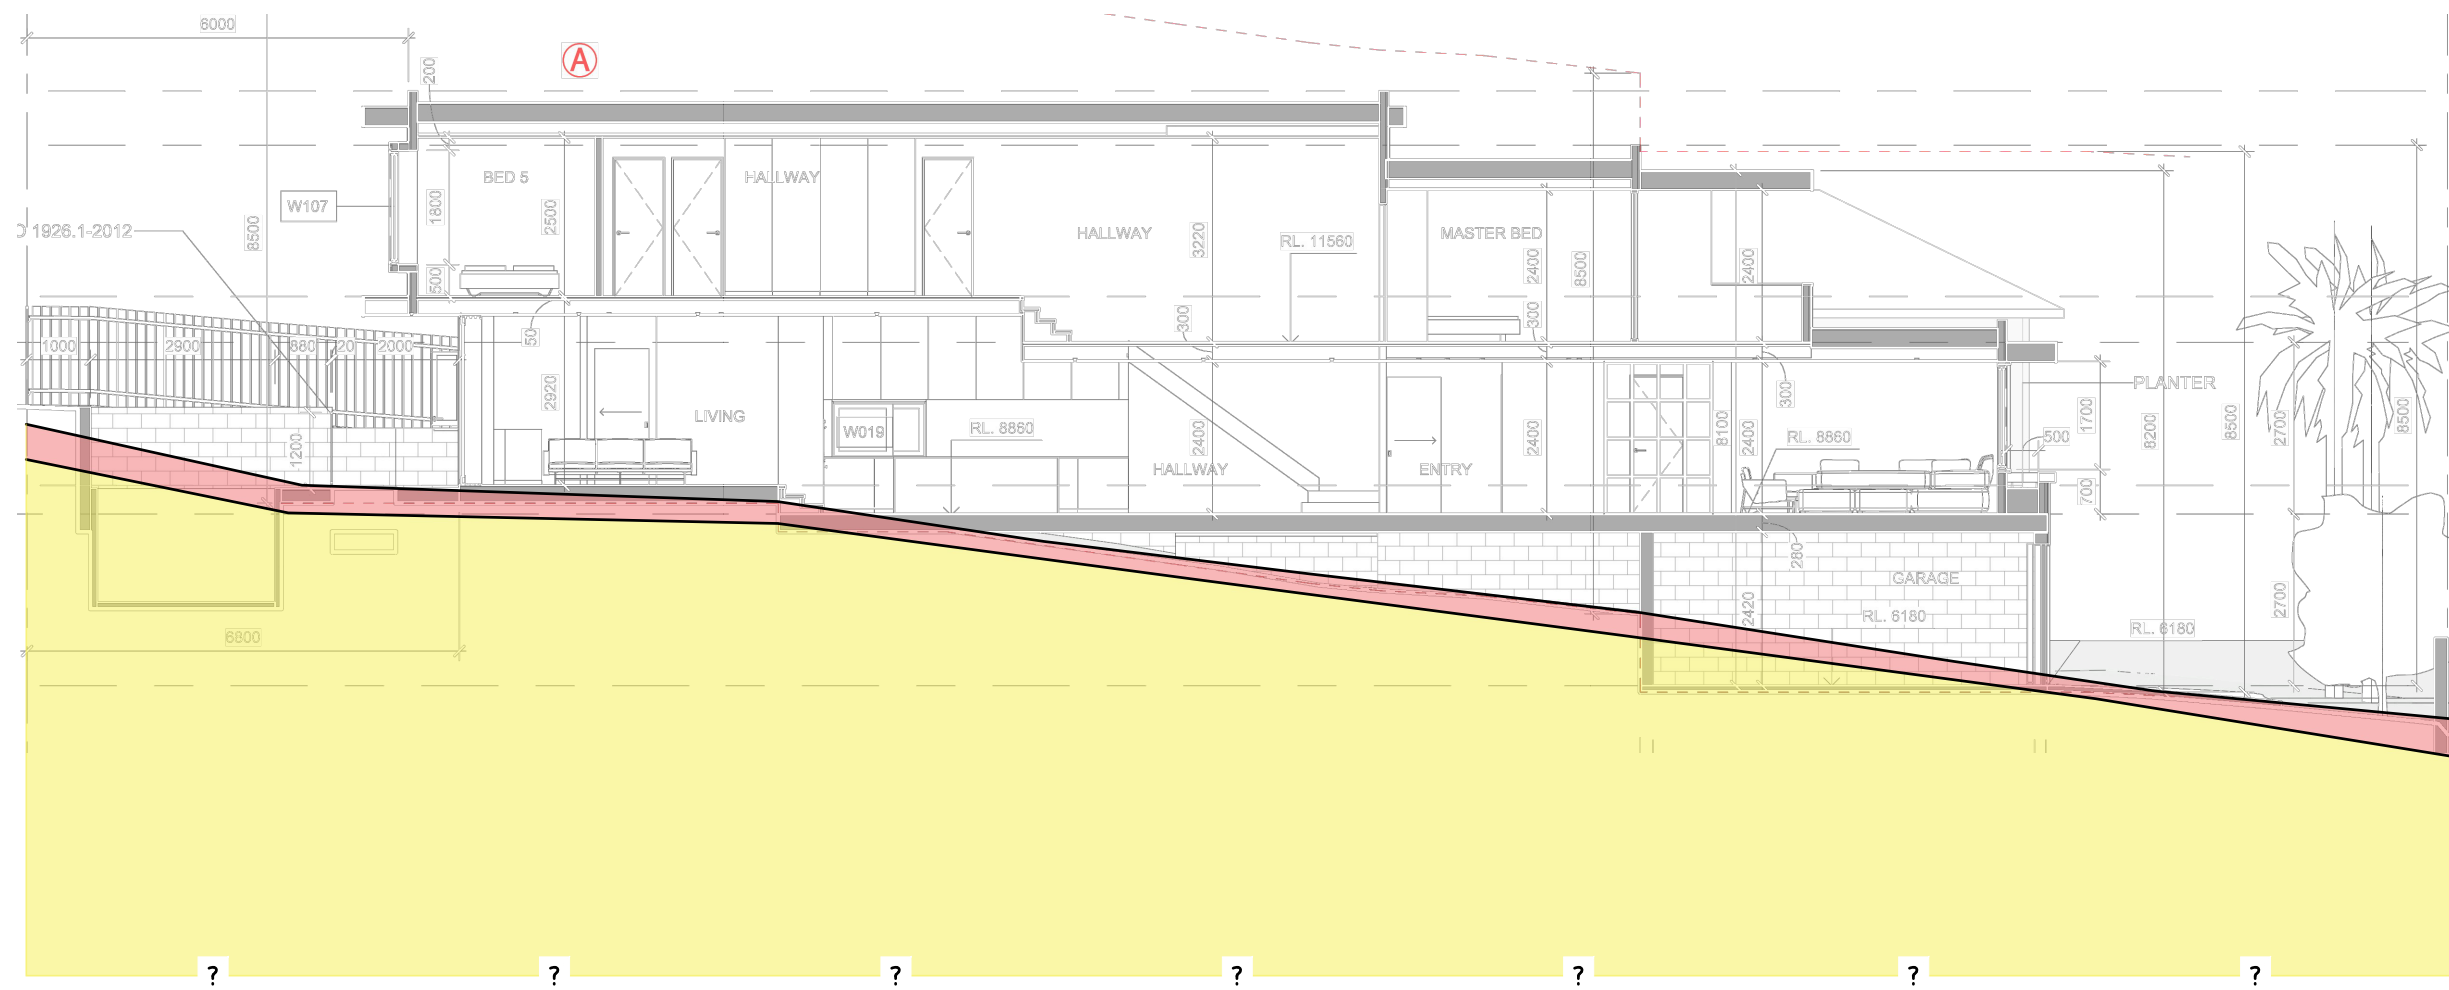
INFERRED GEOLOGICAL SECTION
SCALE NTS

INTERPRETED SUBSURFACE SECTION ONLY.
ACTUAL GROUND CONDITIONS MAY VARY.

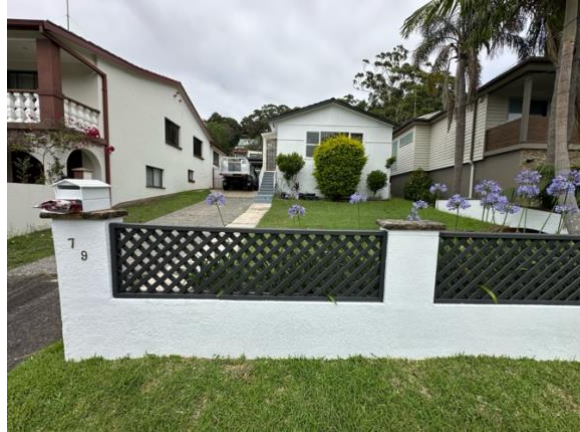
Photo 1: Frontage of the dwelling facing south-west.

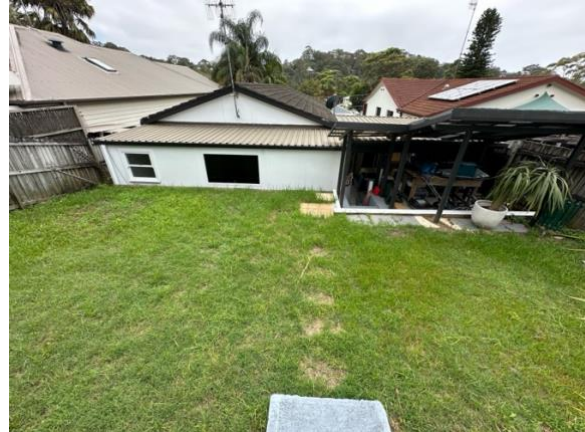
Photo 2: Rear of the dwelling facing north-east.

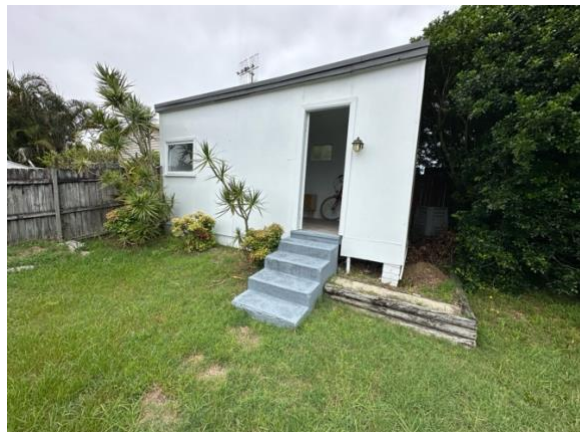
Photo 3: Existing studio at the rear of the site.

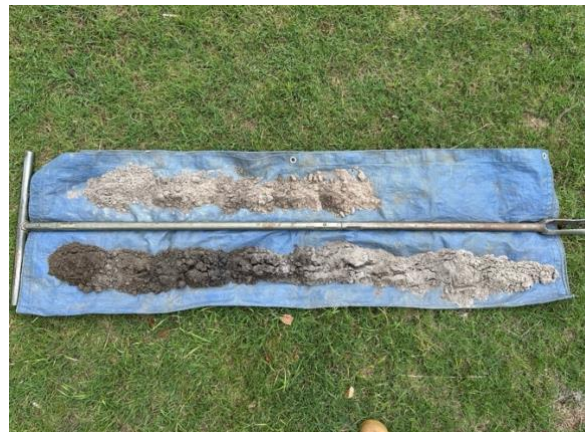
Photo 4: Subsurface soil profile seen in BH1.

Depth (m)	Water	Graphic Log	Drilling Method	Material Description	Consistency	Moisture	Classification Code
1				Fill Silty SAND SM: poorly compacted, black, fine to coarse grained, with fine to coarse sized gravel, dry.	PC	D	SM
				Silty SAND SM: loose, black grey, fine to medium grained, natural moist.	L	M	SM
				Silty SAND SM: loose, grey white, fine to medium grained, natural moist.			
2				BH1 Terminated at 1.8m (End of test. Equipment maximum depth)
