ARBORICULTURAL IMPACT ASSESSMENT

Date: 9th November 2022

Site: 12 Coonanga Road, Avalon Beach 2107 (LOT 194 DP 14534)

Author: Antony Osborn

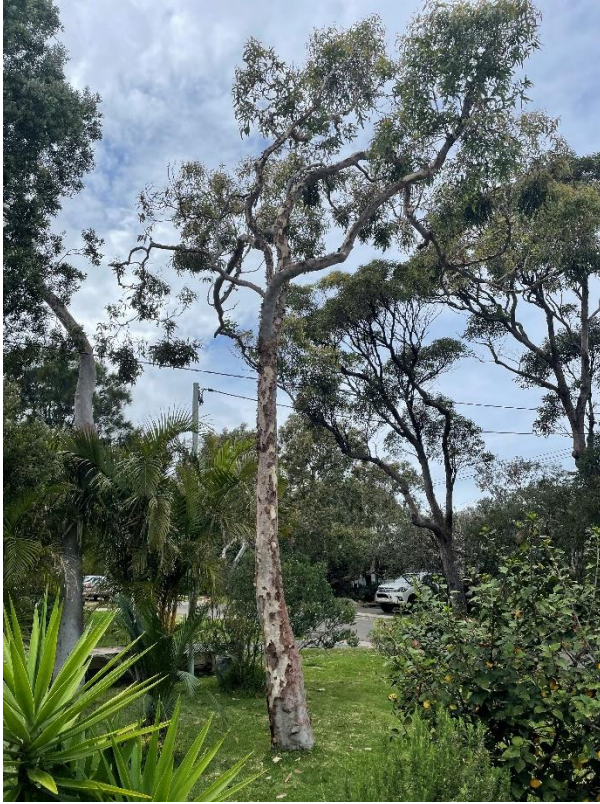
- 5.1 Tree 1 has a major encroachment from the proposed entrance pathway. There is also other activity to take place within the TPZ, these include a sandstone feature wall and bin storage. Tree 1 has poor form, is asymmetrical and is showing signs of poor health and vigour (see appendix 4, figure 1). It has low landscape significance and low retention value.

Figure 1: Tree 1 *Angophora costata* showing poor form, poor health and vigour and asymmetrical crown.

- 6.1 There is a major encroachment to the TPZ of Tree 1. The tree has low retention value and landscape significance. Due to the tree having poor form and showing signs of poor health and vigour it is not a viable option to retain tree during construction works. It is recommended the tree be removed.

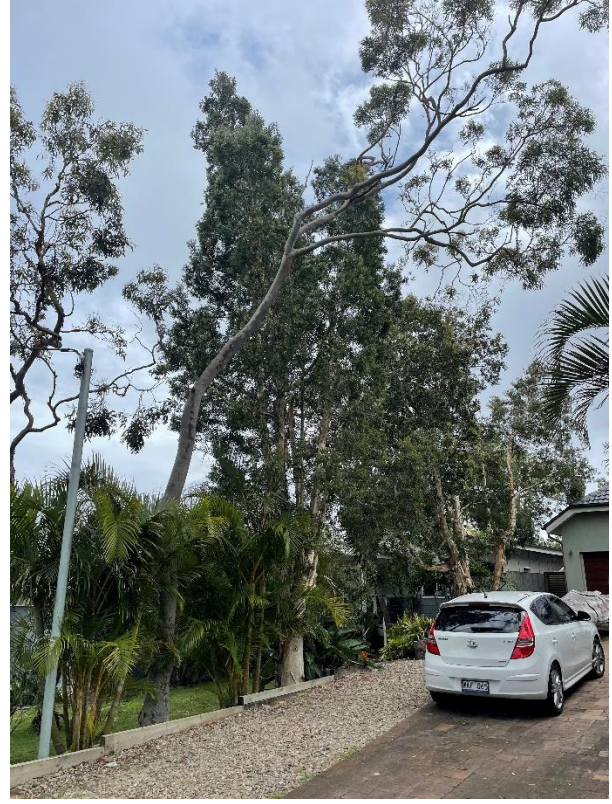
time of inspection. Both trees had poor form and Tree 2 was in decline (see Appendix 4, figures 1 and 2).

- 5.2 There is a proposed sandstone feature wall, planter box and bin storage located in the TPZ of Tree 2. It is hard to ascertain the exact value of the encroachment. This aside the tree has poor form, is showing signs of poor health and vigour and is in decline (see Appendix 4, figure 2). The tree has low landscape significance and low retention value.

Figure 2: Tree 2 *Corymbia citriodora* showing poor form, poor health and vigour, asymmetrical crown and exhibiting signs of decline. Low ULE <5 years.

- 6.2 Tree 2 is impacted by the proposed development. No further calculations are necessary as the tree is in decline and has a ULE of <5 years. No remedial measures would likely save the tree. It is recommended the tree be removed.

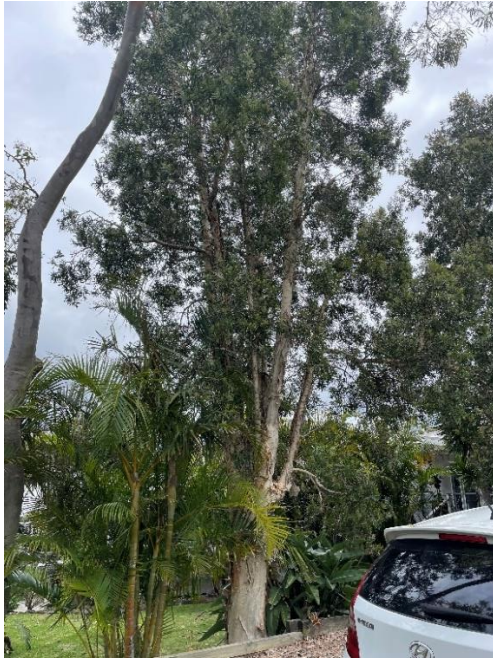
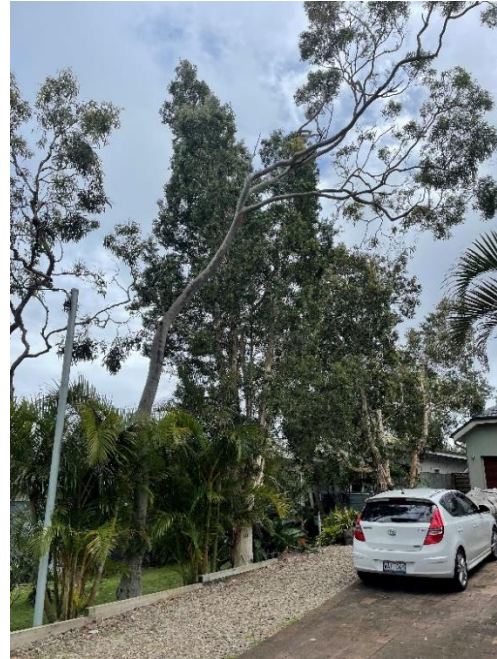
- 5.3 Tree 3 has a major encroachment by the house and is further affected by a protrusion into the TPZ by the roof. There is also a small encroachment by the sandstone feature wall, planter box, bin area and other activity. The tree is showing signs of fair health and vigour, however seems to have been lopped some time ago and as a result has poor form. The stems have poor taper and heavy branch loading (see Appendix 4, figure 3 and 4). The tree has low landscape significance and low retention value.

Figure 3 and 4: Tree 3 *Melaleuca quinquenervia* showing signs of previous lopping and poor form.

- 6.3 Tree 3 is impacted by the proposed development. Consideration was made for retaining the tree and altering building plans. However due to poor form of the tree, low landscape significance and low retention value. It is recommended the tree be removed.

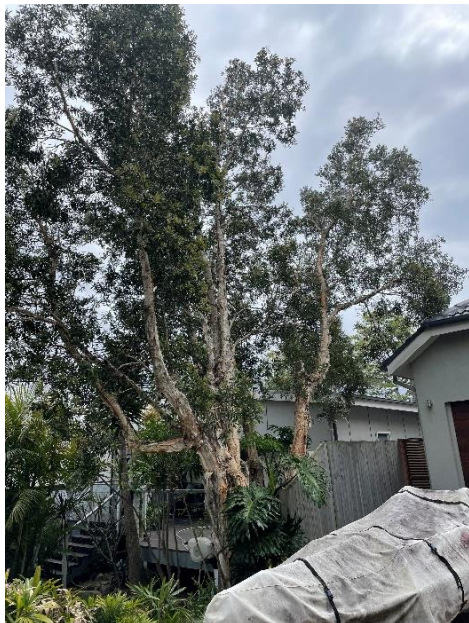
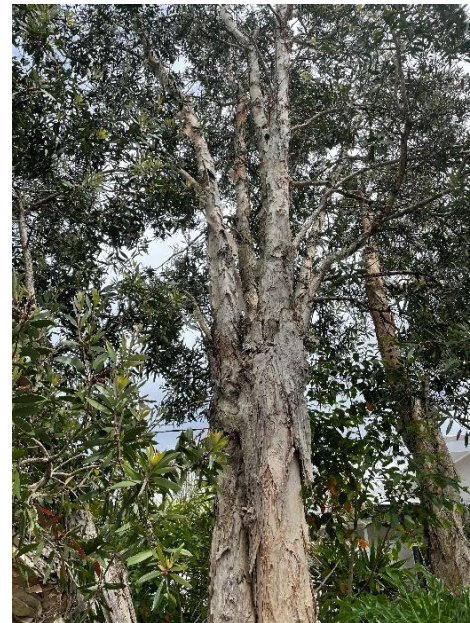
4.8 Tree 3 and Tree 4 are mature *Melaleuca quinquenervia* (Paperbark). Both trees were exhibiting signs of fair health and vigour at the time of inspection. Tree 3 seems to have been lopped some time ago and as a result has poor form. Tree 4 has poor form and has some defects and included branch junctions (see Appendix 4, figures 3, 4, 5 and 6).

- 5.4 Tree 4 has a major encroachment and is partly located in the footprint of the new development. The tree is over mature and is exhibiting signs of poor form (see Appendix 4, figure 5 and 6). The tree has low landscape significance and low retention value.

Figure 5 and 6: Tree 4 *Melaleuca quinquenervia* exhibiting signs of poor form, asymmetrical crown and branch inclusions.

- 6.4 Tree 4 is located in the footprint of the new development. The removal of the tree is required to accommodate the new development. The tree has poor form, low landscape significance and low retention value. It is recommended the tree be removed.

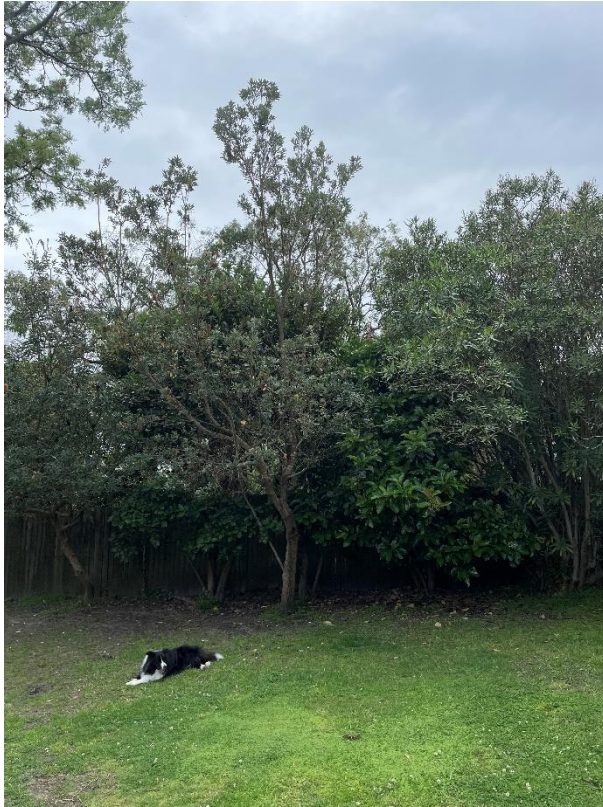
4.9 Tree 5 is a semi mature *Banksia integrifolia* (Coastal banksia). The tree is located at the rear of the property and was exhibiting signs of good health and vigour at the time of inspection (see Appendix 4, figure 7).

- 5.5 Tree 5 is not affected by any of the development and is to be retained (see Appendix 4, figure 7).
- 5.6 Tree 6, Tree 7 and Tree 8 are located in the footprint of the proposed swimming pool. They are exempt species under the council's Tree Protection Ordinance. The client has specified that these trees are to be removed prior to construction. No recommendations or further discussion will be made about these trees.

Figure 7: Tree 5 *Banksia integrifolia* to be retained. Tree protection fencing to be set up to protect the TPZ.

- 6.8 Tree protection fencing should be put in place to protect the TPZ of Tree 5 during the entire development process. This will restrict activities within the TPZ (see Appendix 3 for more information).
