**Sent:** 15/04/2024 8:17:59 AM  
**Subject:** DA2023/832 Objections  
**Attachments:** Leplatrier 15-04-24.pdf;

OBJECTIONS TO DA AMENDMENT 12-04-24

From Robert Story and Susan Duncan Story

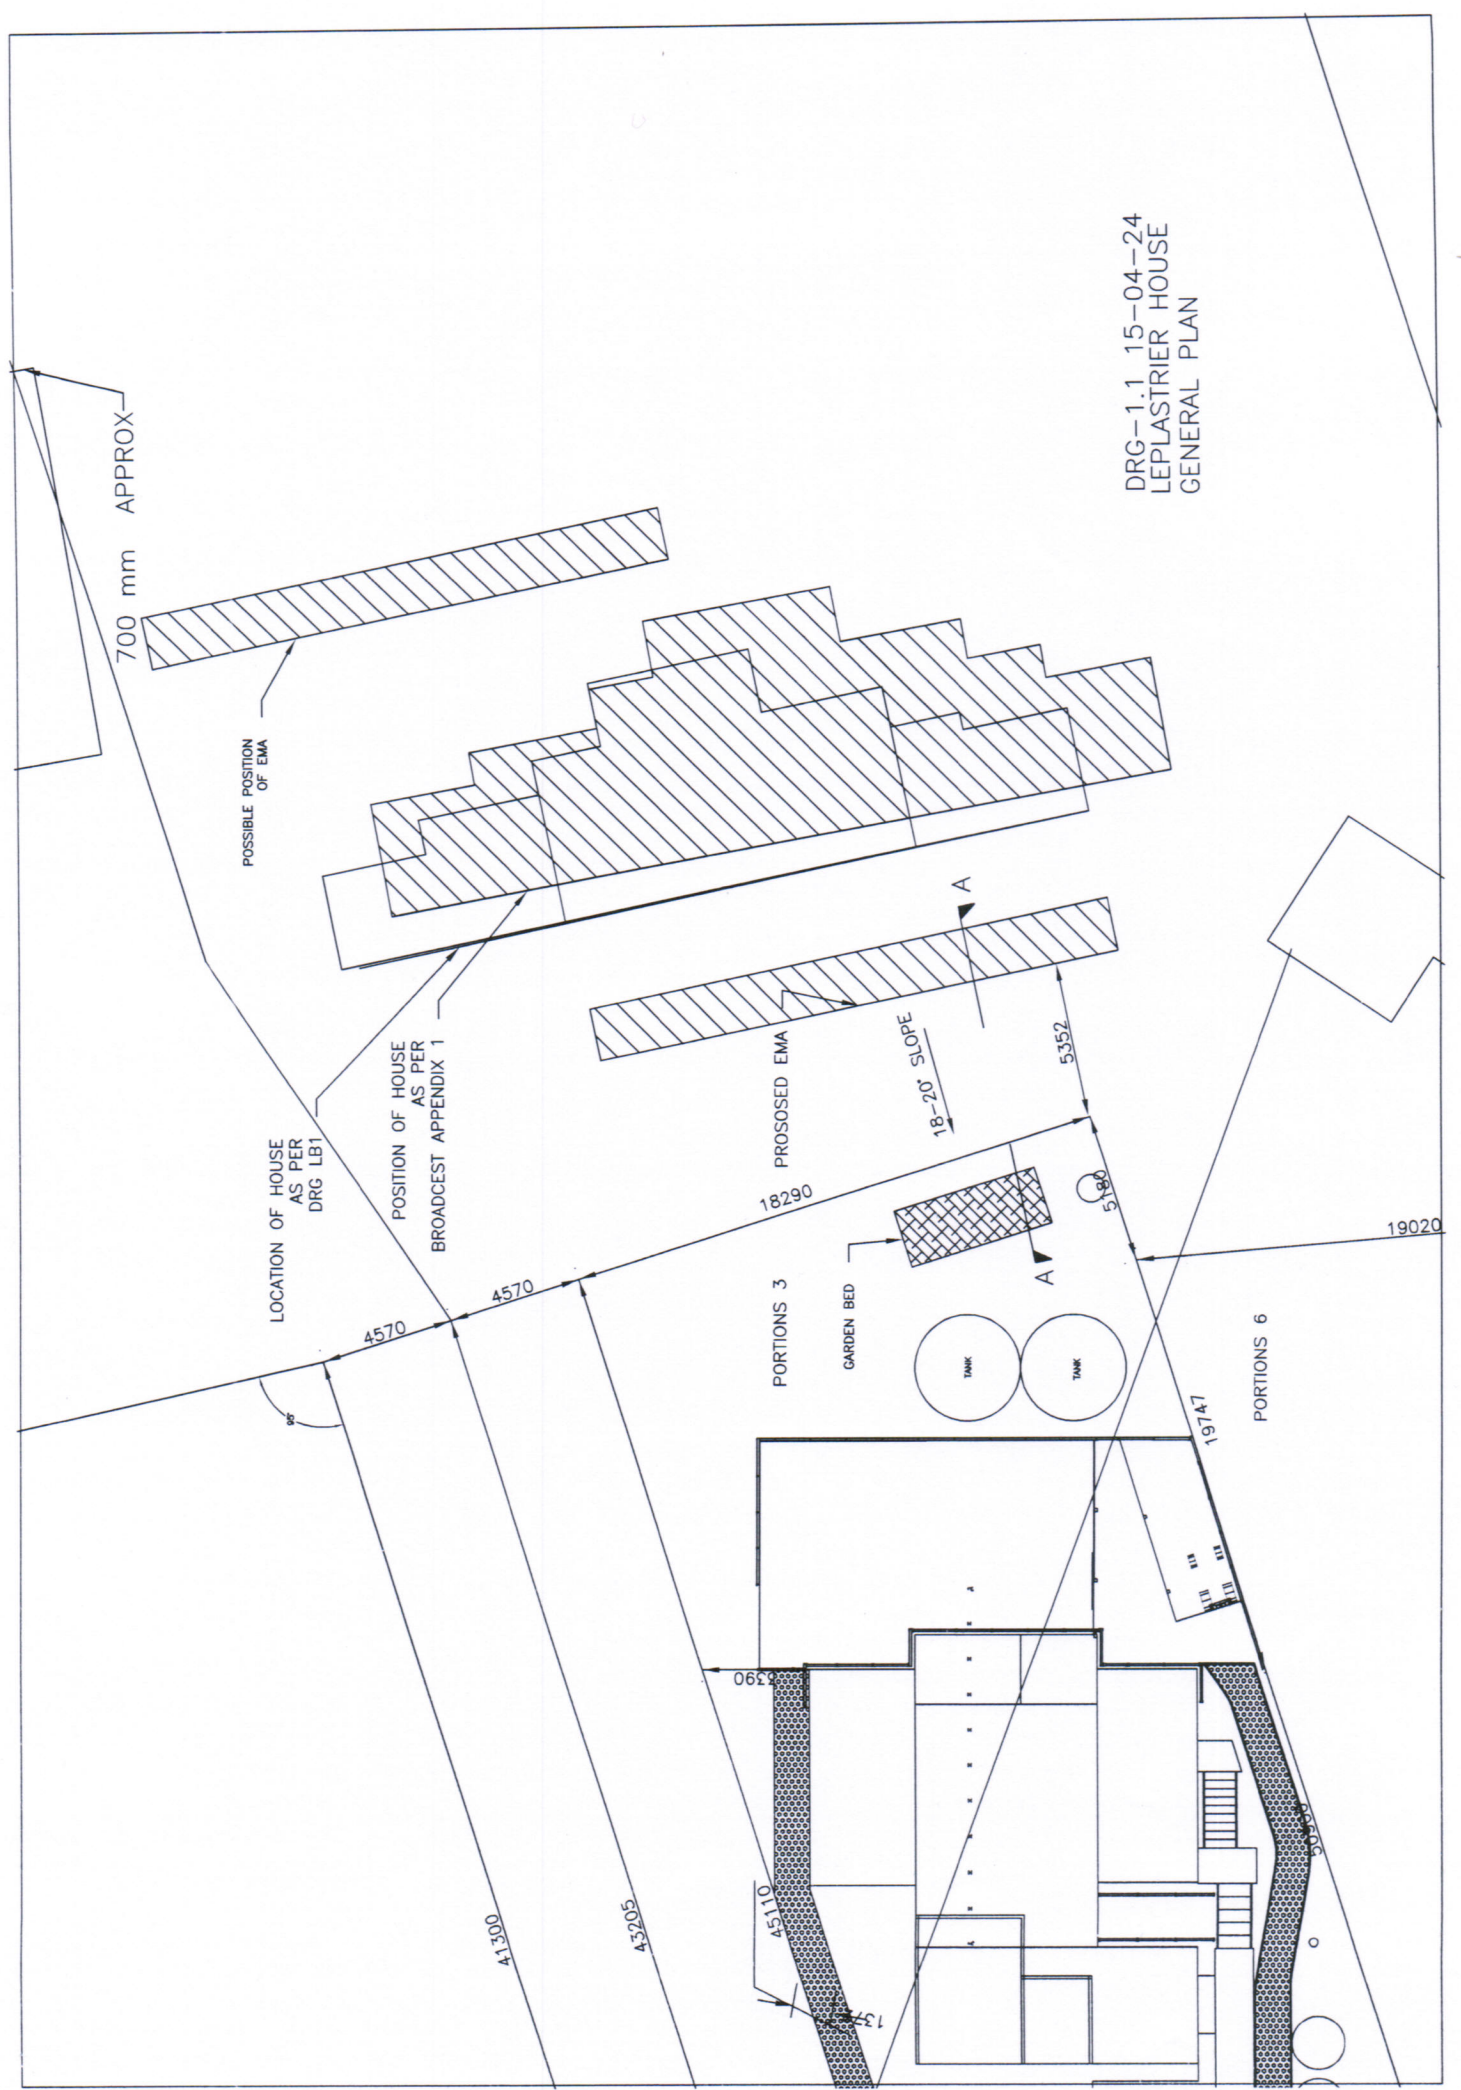
DRG-1.1 15-04-24  
LEPLASTRIER HOUSE  
GENERAL PLAN

From this investigation, the EMA as depicted on Broadcrest's report cannot be located in this position. If it is approved in this position, there will be no choice but to take further action.

POSSIBLE POSITION OF EMA

LOCATION OF HOUSE AS PER DRG LB1

POSITION OF HOUSE AS PER BROADCAST APPENDIX 1

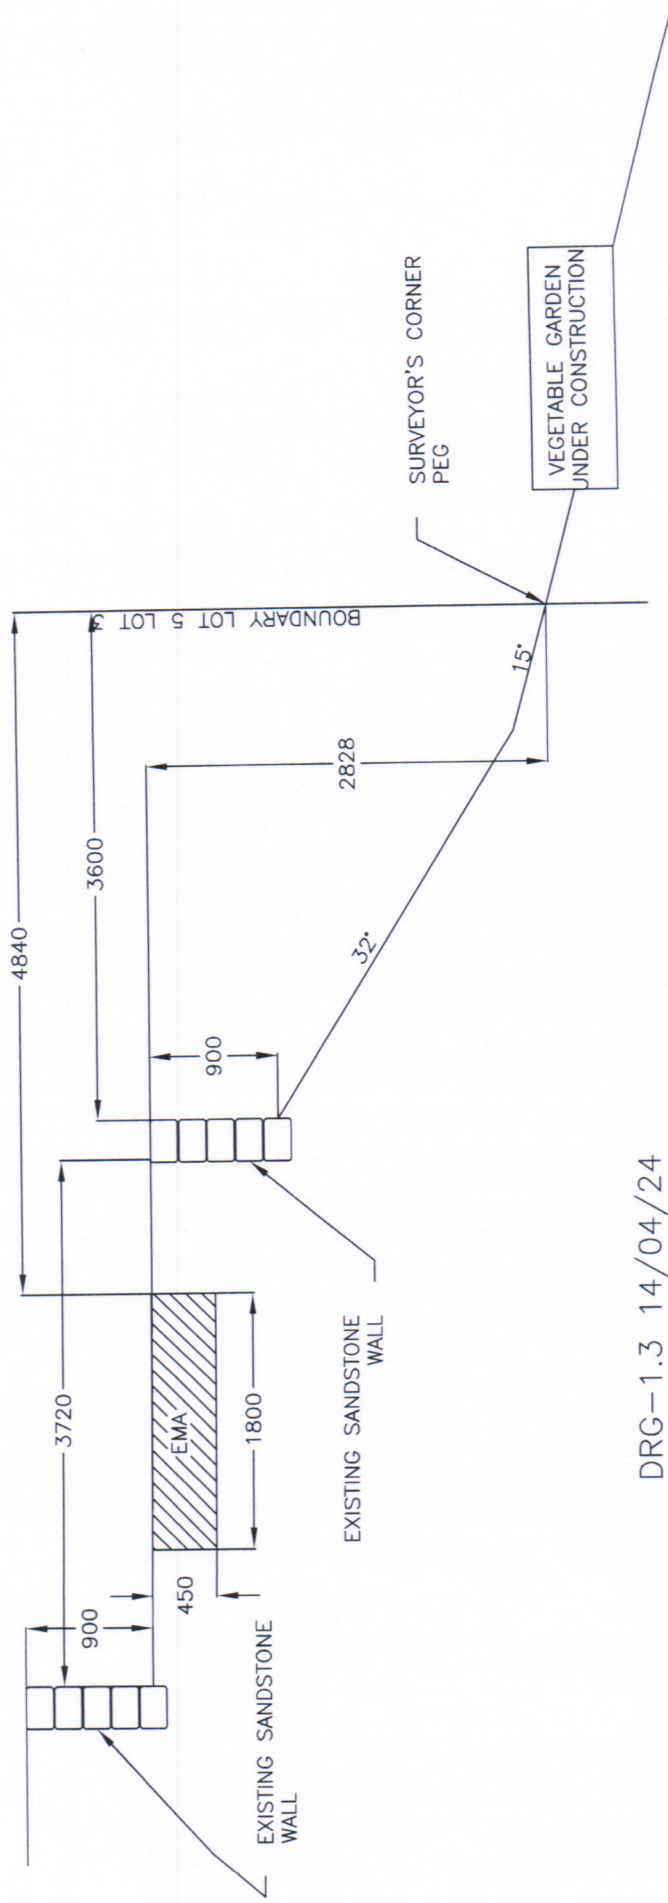
DRG-1.3 14/04/24  
 LEPLASTRIER HOUSE  
 SITE MEASUREMENTS EMA TO BOUNDARY  
 SECTION AA DRG-1.1

- 1) The EMA is located between 2 existing sandstone walls. This fixes position.
- 2) There is an existing surveyor's peg on the property boundary of Lot 3 and Lot 5.
- 3) Site measurements were taken as depicted on DRG 1.3 and location of section on DRG 1.1. See below.
- 4) The setback of the EMA to Lot 3 is 4.84 metres and not the 6.2 metres as indicated by Broadcrest.
- 5) The EMA is a pressurized system so any pipe breakage would result in effluent flowing down to Lot 3.
- 6) There is an underlying clay layer in the area so effluent would reach this layer and permeate to Lot 3.
