LANDSLIP RISK PRELIMINARY ASSESSMENT

To accompany a Development Application to the Northern Beaches Council
for proposed alterations and additions to the existing residence at:

12 Kalianna Crescent
Beacon Hill, NSW 2100

Meher House Trust
October 2020

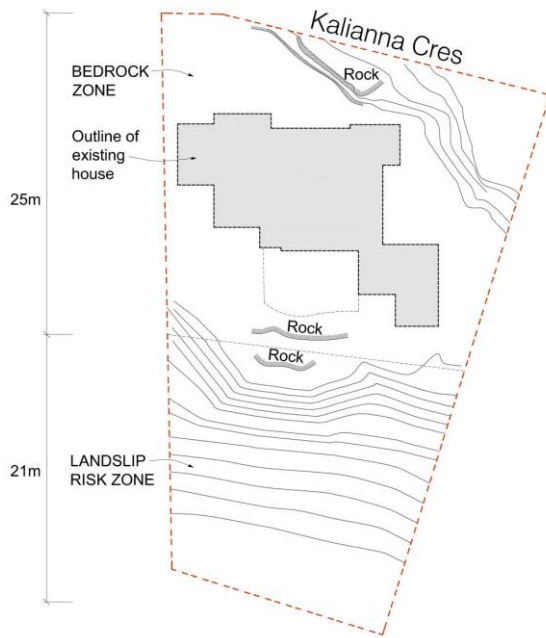
Figure 2: Different parts of the site

The site features two different parts. The first part is next to the street and it is relatively flat and with a rock substrate. The second part is very steep and it is where the landslide risk exist.

As shown on the diagram above, the existing house lies comfortably on the centre of the rock section and away from the landslide risk area and it has proved its structural stability over a number of years.

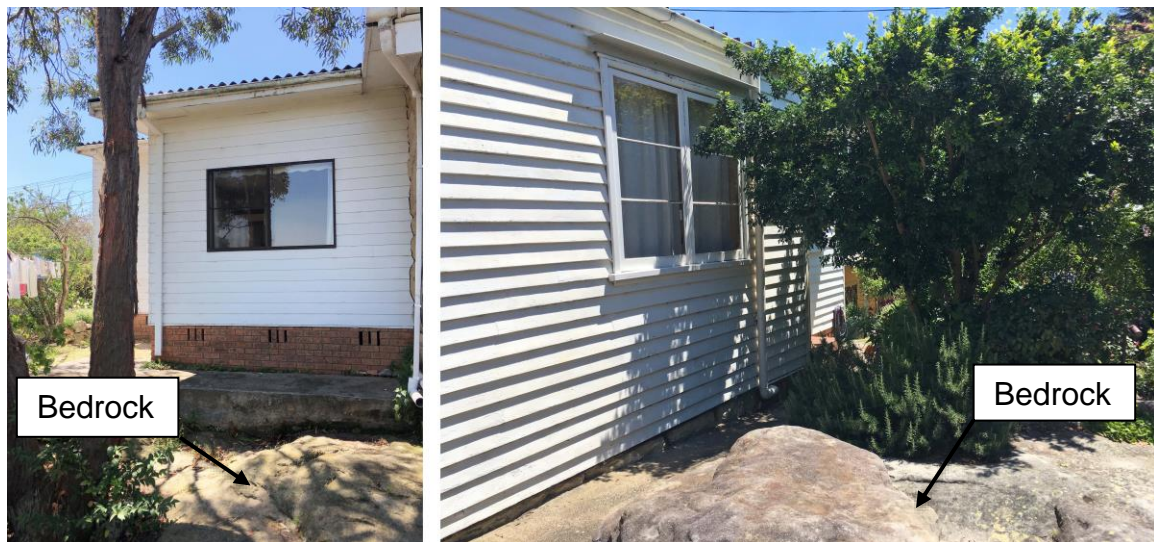
Figure 3: The existing house sits on the bedrock zone

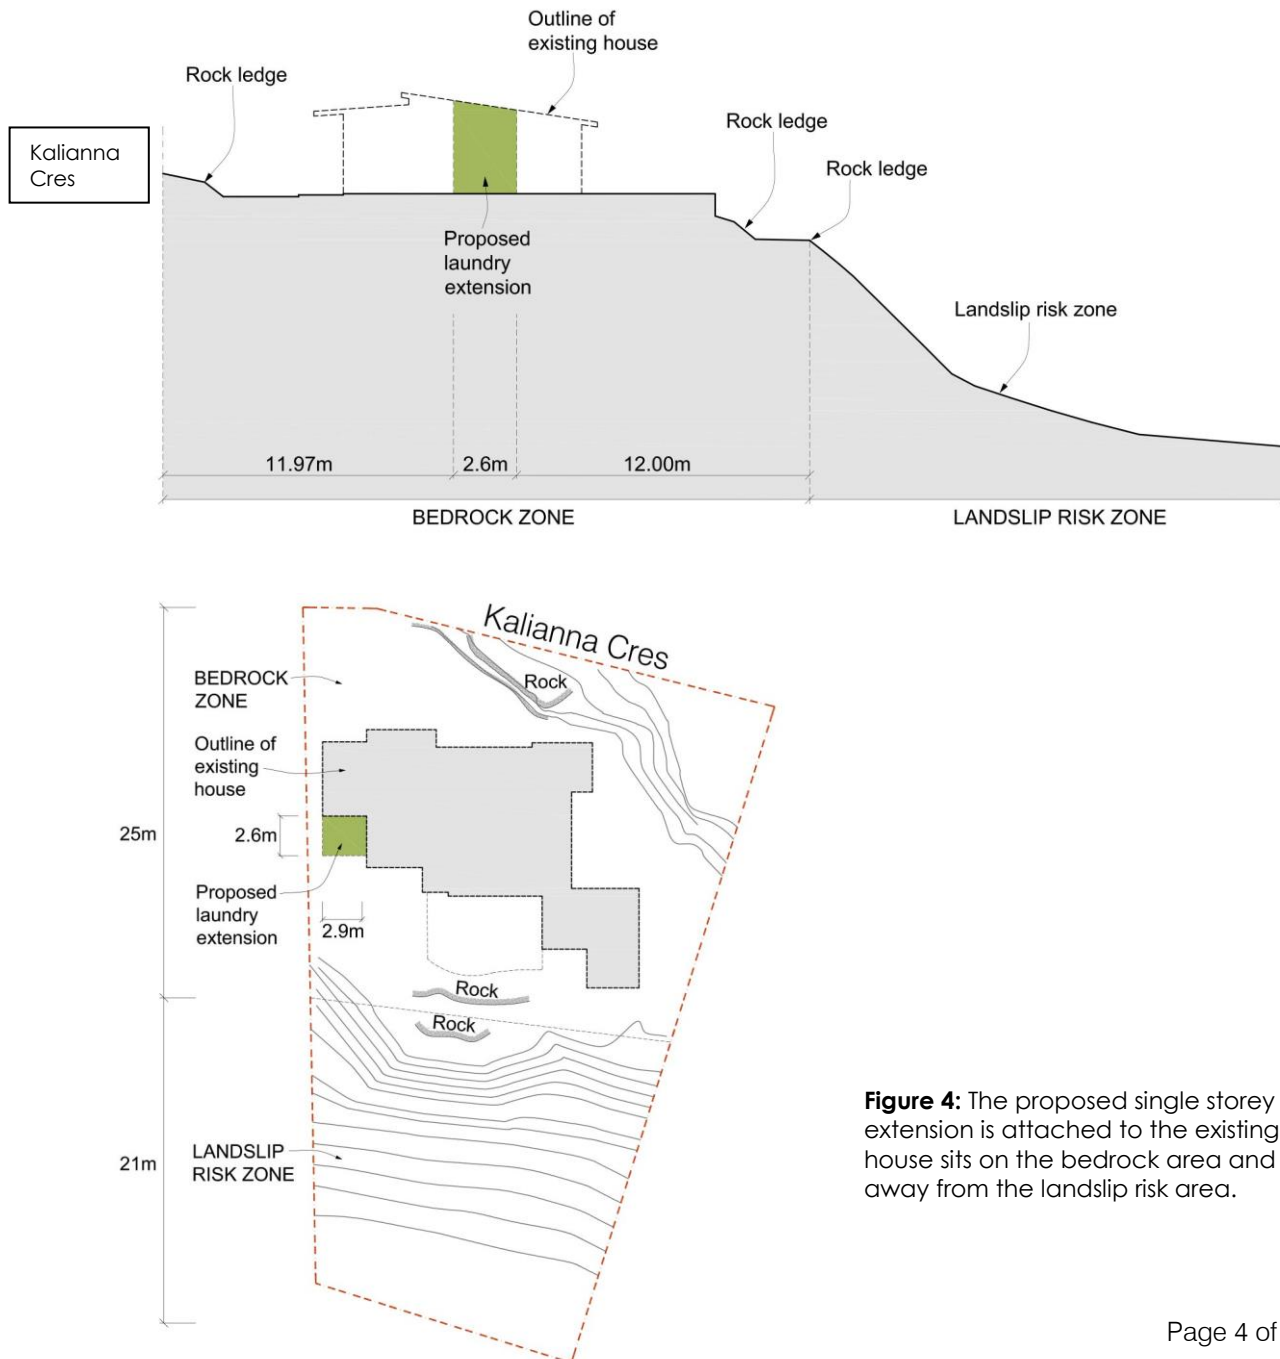
The proposed extension to the existing house is a small 2.49m x 2.8m single storey laundry attached to existing house. The proposal lies within the first section of the site on the bedrock area.

Due to the small nature of the proposal and the fact that it sits directly on the bedrock there is no effect to the existing geological stability of the site and the existing subsurface flow conditions.

Figure 4: The proposed single storey extension is attached to the existing house sits on the bedrock area and away from the landslide risk area.
