Arboricultural Impact Assessment Report

Site Address: Lot 9, 18 Alexander Avenue, Collaroy NSW

Report on trees at: Lot 9, 18 Alexander Avenue, Collaroy NSW

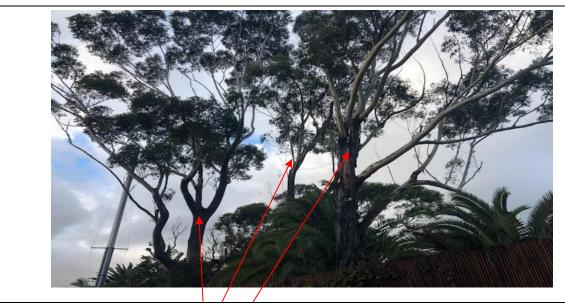
Photo C: Rear of property and trees 4, 5 and 6.

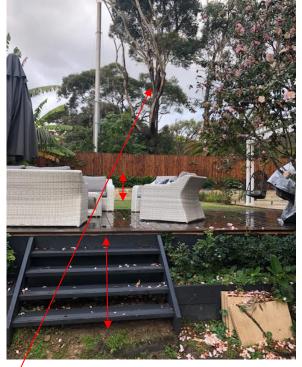
Photo E: Rear of site, existing level changes and tree
