Construction Impact & Management Statement

July 2021 UPDATED January 2022

Site:	Lot 152 in DP 29335 1 Kanimbla Crescent BILGOLA PLATEAU, NSW
Client:	John & Helen Wood 1 Kanimbla Crescent BILGOLA PLATEAU, NSW 2107
Author:	Kyle A Hill Registered (Arb Aus #1884) Practising & Consulting Arborist Post Graduate Certificate in Arboriculture, Uni of Melb Diploma of Horticulture-Arboriculture TAFE, Grow SA Certificate of Horticulture, TAFE Certificate Advanced Tree Care TAFE Founder -Growing My Way Tree Services (1977) Member of International Society of Arboriculture Member of Arboriculture Australia

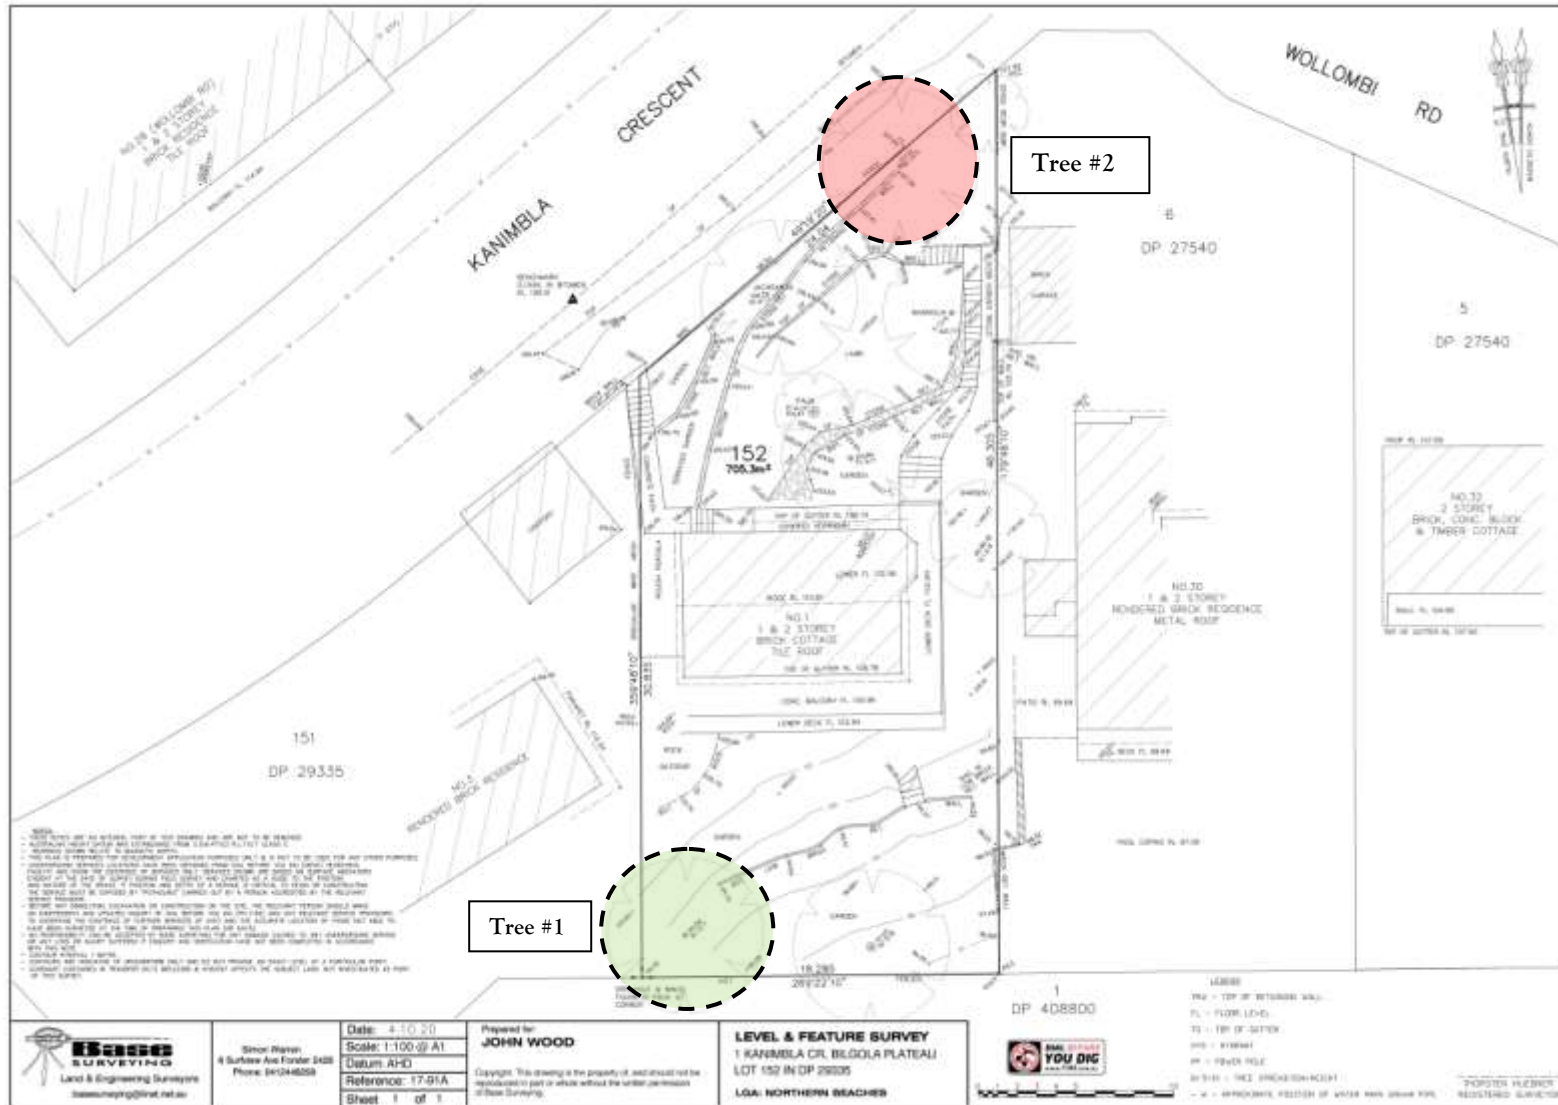
Figure 4: Site Survey with discussed Tree Locations plotted.

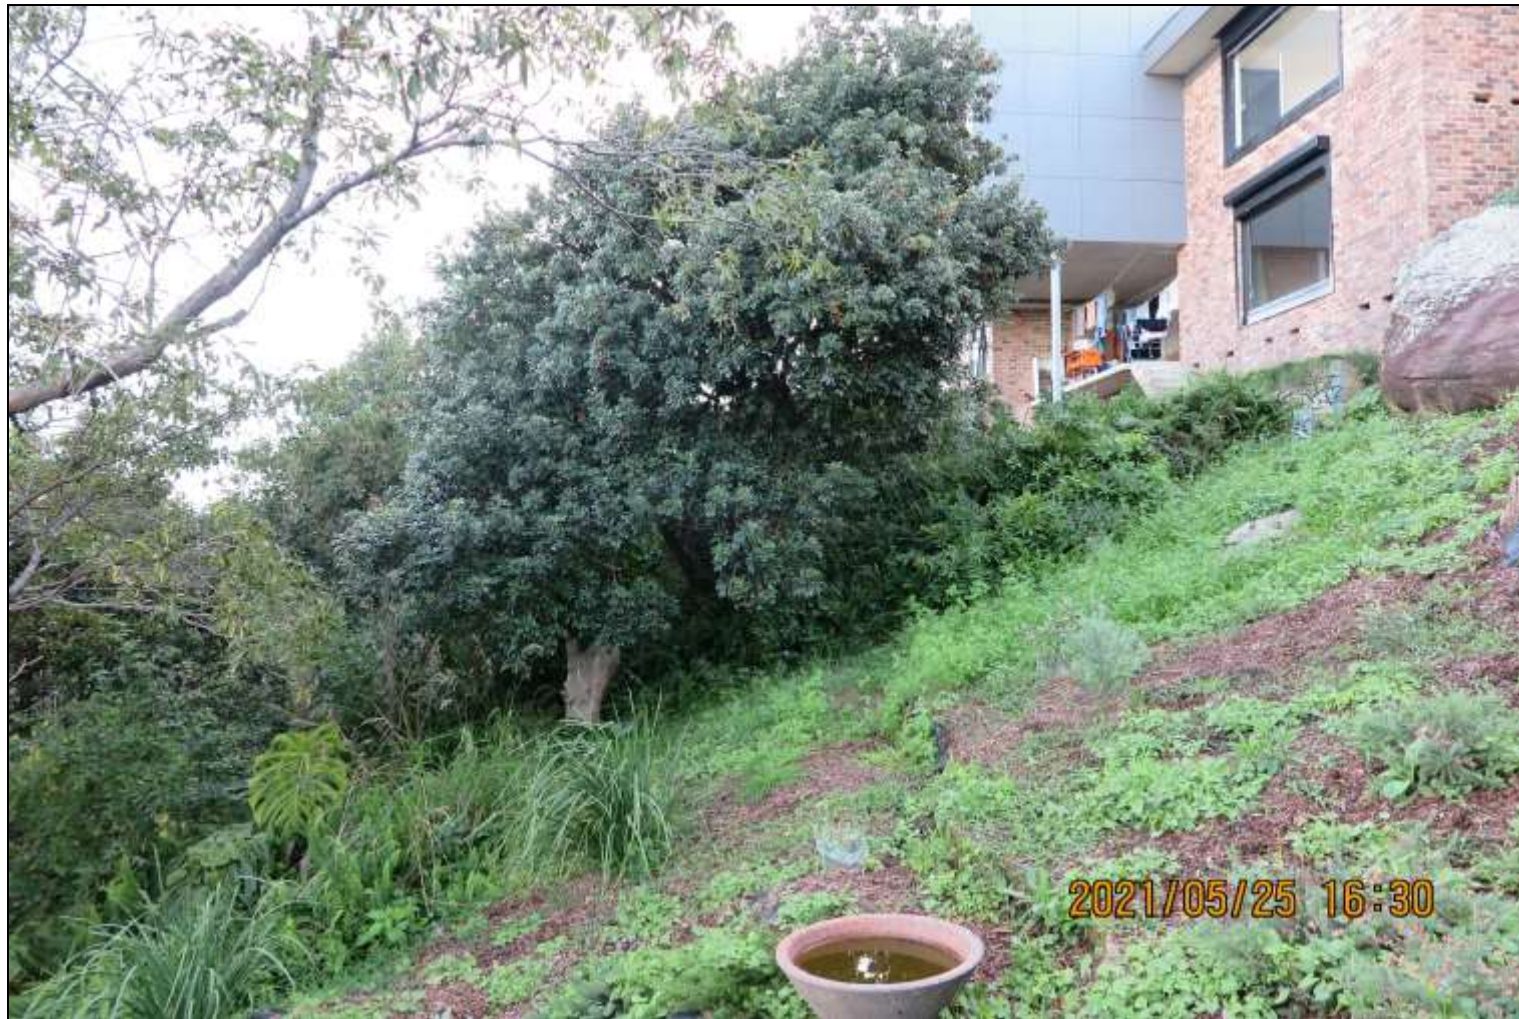
Figure 6: Photograph confirm the location & habit of the discussed Tree #1. Note: Asymmetrical canopy profile.

As can be seen page 13, Figure 6 photograph the tree is long term exposed to the prevailing off the Pacific Ocean East & South wind events. Hence its canopy bias away from the ocean winds.

The proposed southern boundary retaining wall below Tree #1 as briefed & discussed in detail with the property owner/developer is confirmed to be within the trees calculated Tree Protection Zone & Structural Root Zone radial distances. On this basis, the section of retaining wall within 4.80m of its trunk centre will require a structure to be built with “flexibly located, manually excavated footing sites” with the retaining wall portion supported by beams preferably at or above existing natural ground level. See page 10, proposed site plan to confirm the location of the retaining wall. Taking into additional consideration, minor canopy pruning likely to be required for new built form/tree canopy separation Tree #1 is considered as able to be managed without any compromise to its *Useful Life Expectancy*.

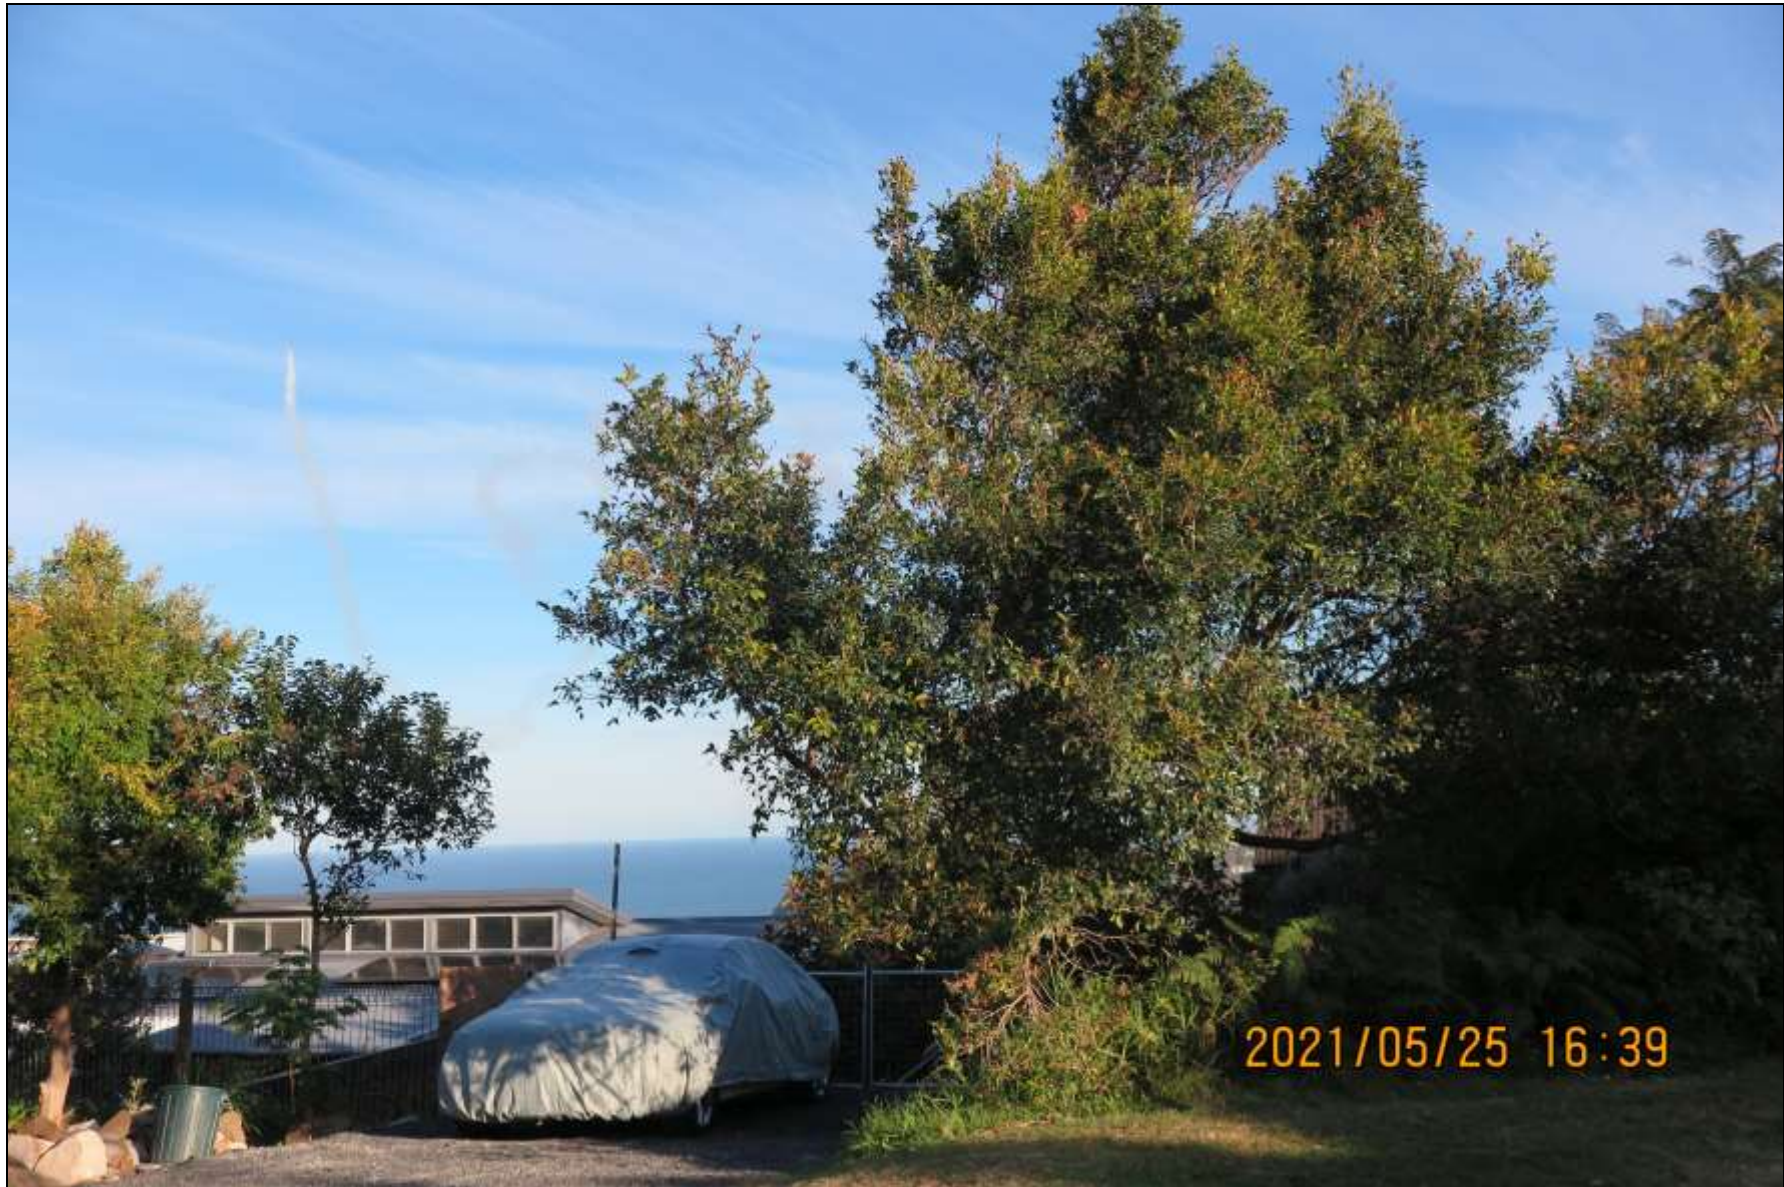
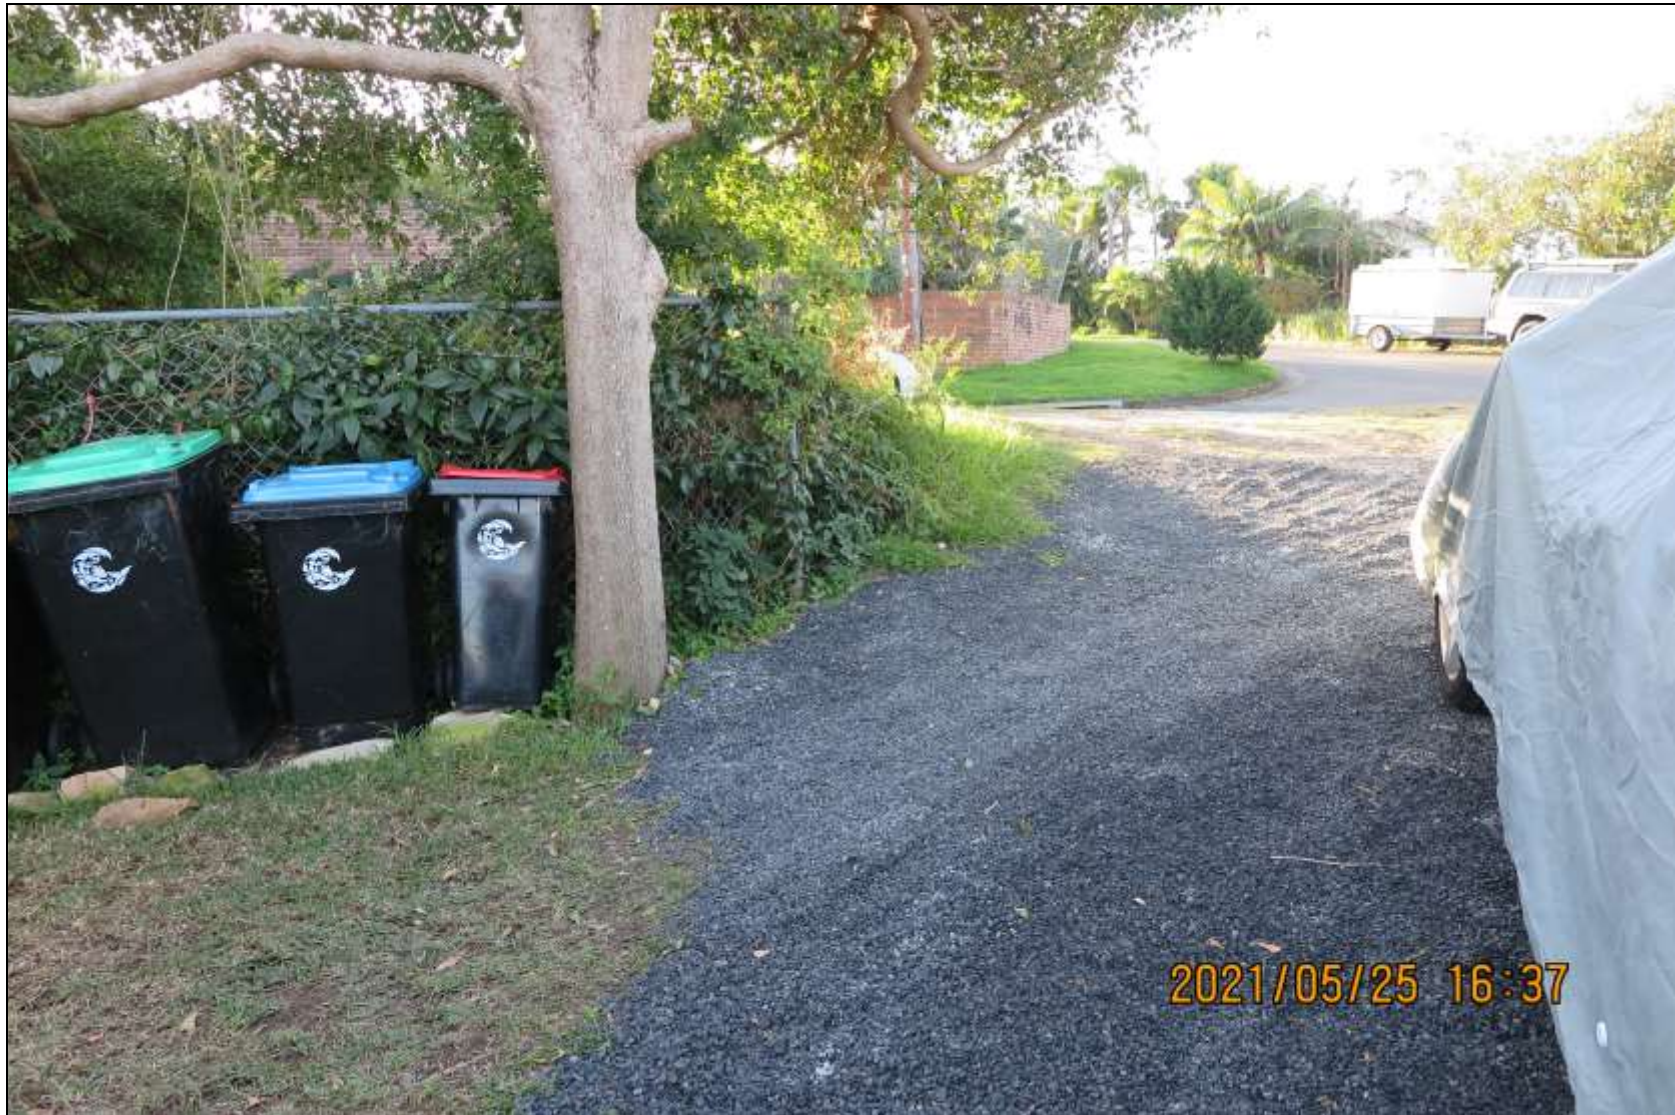
Figure 7: Above & previous page illustrates Tree #2 location & condition. Note; change of soil level at tree trunk base.

Tree #2 is simply incompatible with the location of the as proposed carport & driveway re-configuration. Additionally, it has been subjected to at least one (1) change in natural soil levels within both its calculated SRZ & TPZ radial distances.

These facts combined with the proposed works is considered as being reasonably predicted to have an adverse impact on its Useful Life Expectancy.
