GEOTECHNICAL PEER REVIEW
PROPOSED RESIDENTIAL DEVELOPMENT
3 BERITH STREET, WHEELER HEIGHTS, NSW

GEOTECHNICAL INVESTIGATION:

New Apartment Block and Basement Carpark at 3 Berith Street, Wheeler Heights

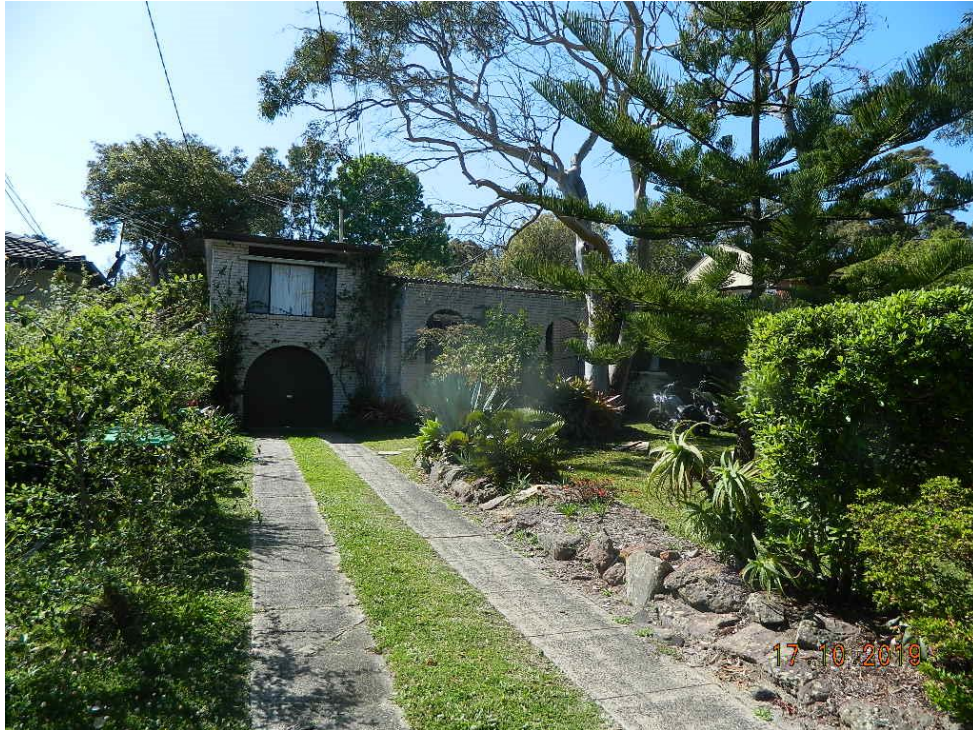
Photo 1

- 2.3** A concrete driveway and lawn run from the road frontage to the foot of the house (Photo 1). The part two storey brick house is supported on brick walls. The walls show no visible signs of movement and are considered stable. This house is to be demolished as part of the proposed works and a new two storey apartment block constructed. A concrete path runs along the N common boundary providing access to the rear of the house. A partially in ground pool is located upslope of the house with the fill used to level the area supported by a 0.8m high brick retaining wall in good condition (Photo 2). A gently sloping lawn extends upslope of the pool to the rear common boundary (Photo 3). A timber shed is located along this boundary (Photo 4).

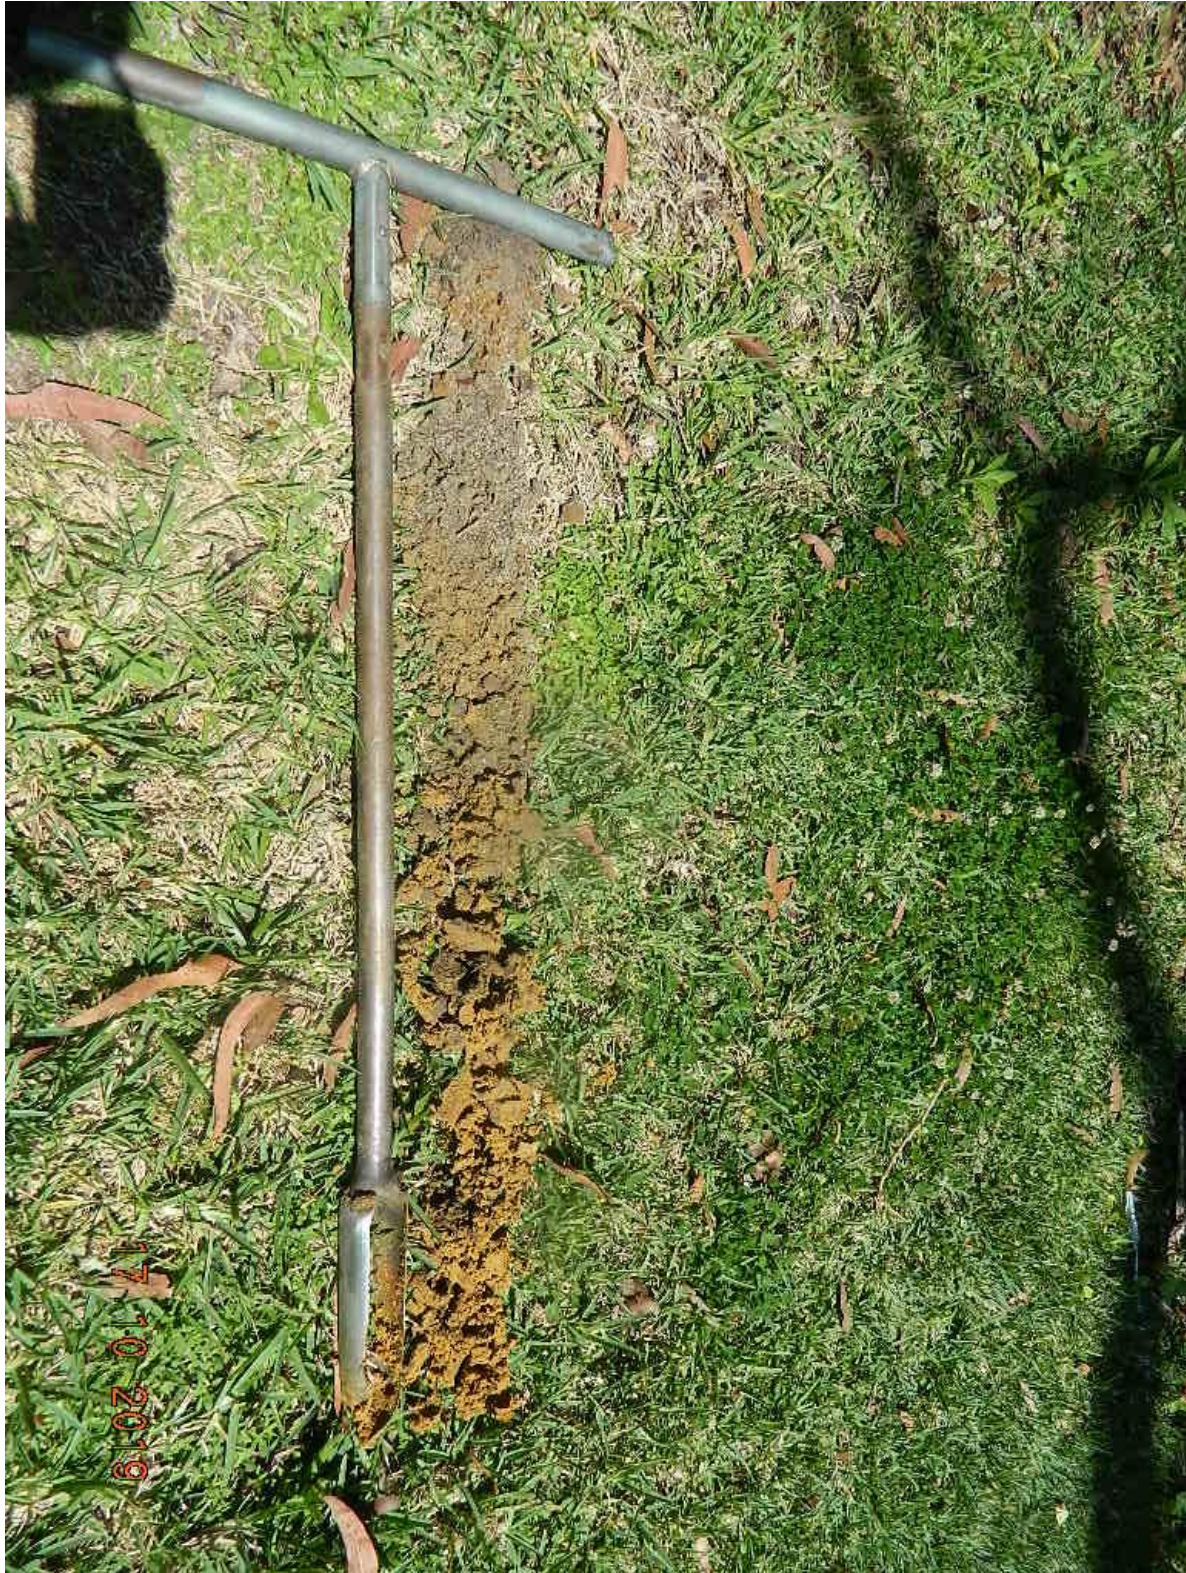
Photo 5 – AH1

1. We consider the upper soil layer logged as 'Top Soil' encountered at 0m to 0.5m depth should be logged as 'Fill' given it has been placed by anthropogenic process (by man) as defined by the Australian Standard 1726:2017, '*Geotechnical Site Investigations*'.
2. The soils appear to have not been logged in accordance with the AS1726:2017 given the omission of the plasticity, moisture condition and strength of the Sandy Clay soil which was encountered at 0.5m to 1.0m depth.
3. We note that no borehole log was provided with the geotechnical report, only a summary within the report text.

AUGER HOLE 1 (~RL76.0) – AH1 (Photo 5)

Depth (m)	Material Encountered
0.0 to 0.5	TOP SOIL , sandy soil, dark brown medium grained with trace organic matter.
0.5 to 1.0	SANDY CLAY , brown, medium to coarse grained with rock fragments.

Refusal @ 1.0m in rock fragments. No watertable encountered.
