# Geotechnical Assessment

**Project:** Alterations & Additions  
125 Rickard Road, North Narrabeen NSW

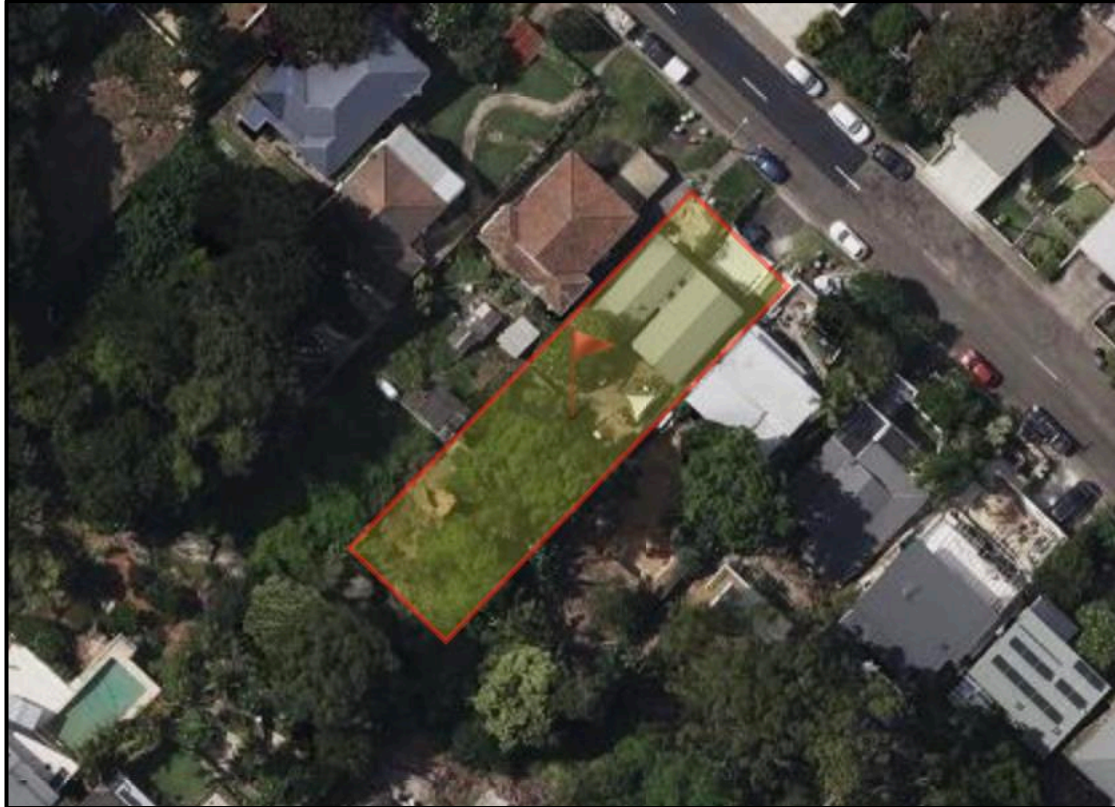
**Figure 1.** Site location – 125 Rickard Road, North Narrabeen NSW (© SIX Maps NSW Gov)

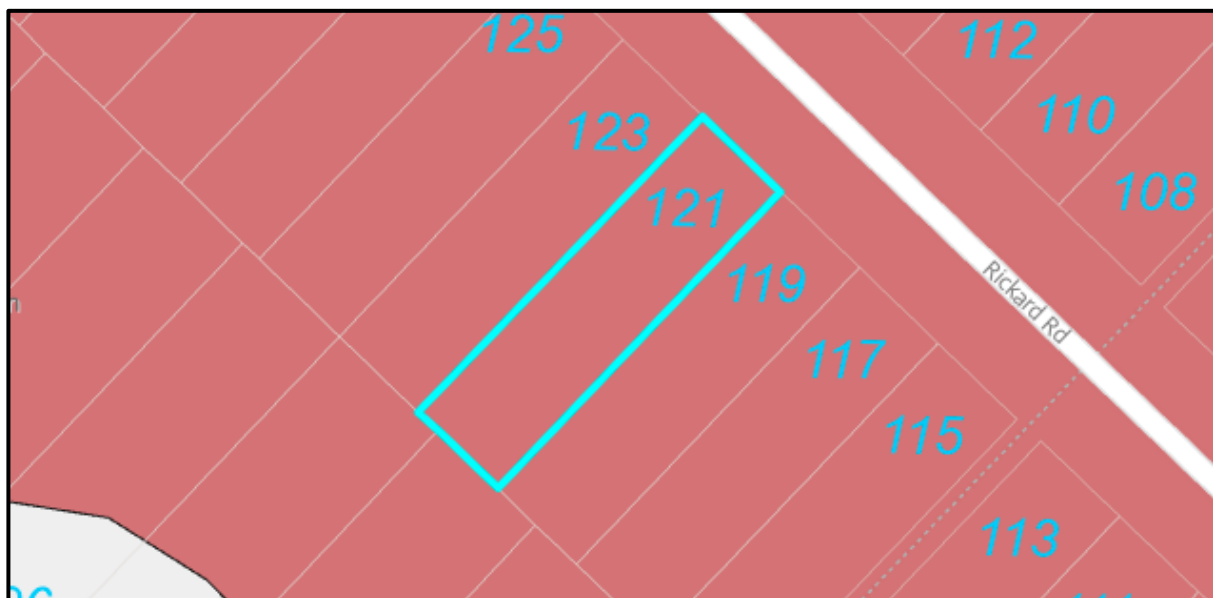
**Image 2.** PLEP Geotechnical Hazard Map  
– 121 Rickard Road, North Narrabeen NSW © NBC Maps

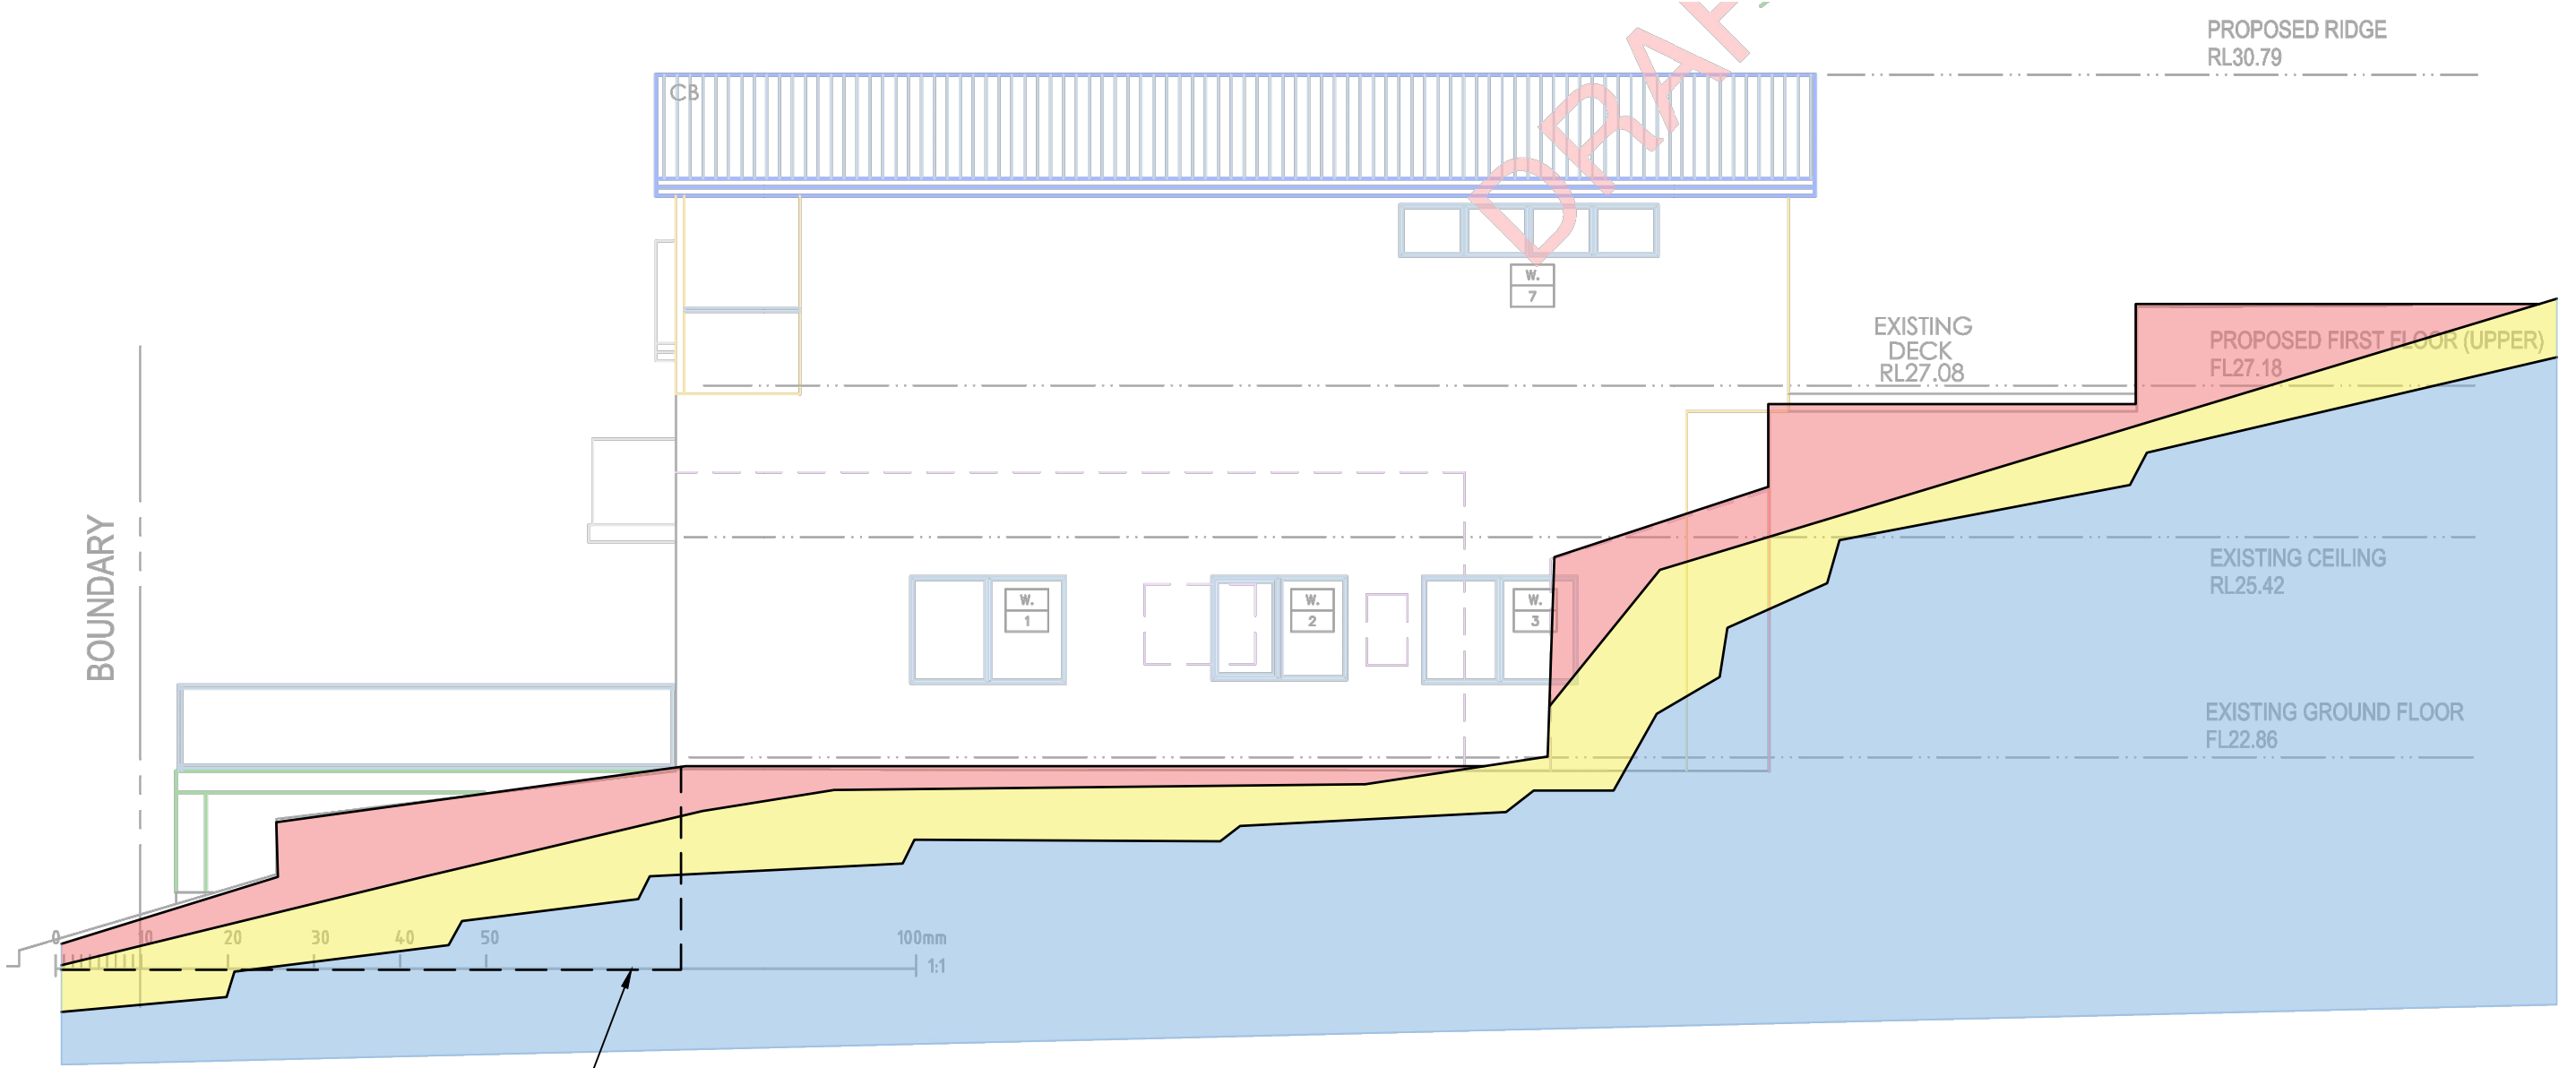
INTERPRETED SUBSURFACE SECTION ONLY.  
ACTUAL GROUND CONDITIONS MAY VARY.

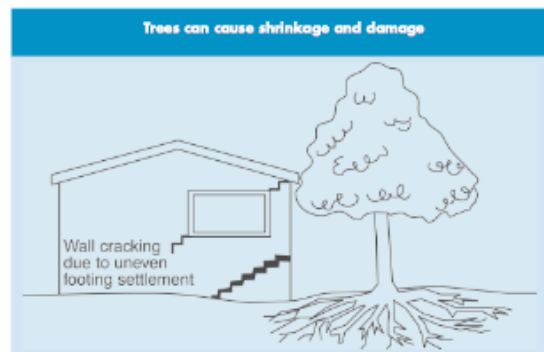
As the weather pattern changes and the soil begins to dry out, the external footings will be first affected, beginning with the locations where the sun's effect is strongest. This has the effect of lowering the external footings. The doming is accentuated and cracking reduces or disappears where it occurred because of dishing, but other cracks open up. The roof lines may become convex.

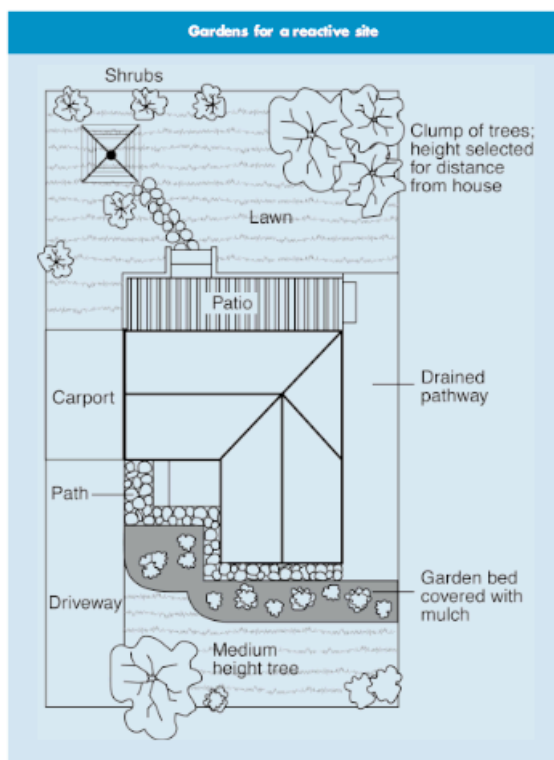
- Water that is transmitted into masonry, metal or timber building elements causes damage and/or decay to those elements.
- High subfloor humidity and moisture content create an ideal environment for various pests, including termites and spiders.
- Where high moisture levels are transmitted to the flooring and walls, an increase in the dust mite count can ensue within the living areas. Dust mites, as well as dampness in general, can be a health hazard to inhabitants, particularly those who are abnormally susceptible to respiratory ailments.
