**Re: Objection to Development Application No. DA2020/1567**  
**Property: 9 Bate Avenue, Allambie Heights NSW 2100**

Geotechnical assessment of conditions related to stormwater/groundwater flow into  
No. 11 Bate Avenue, Allambie Heights.

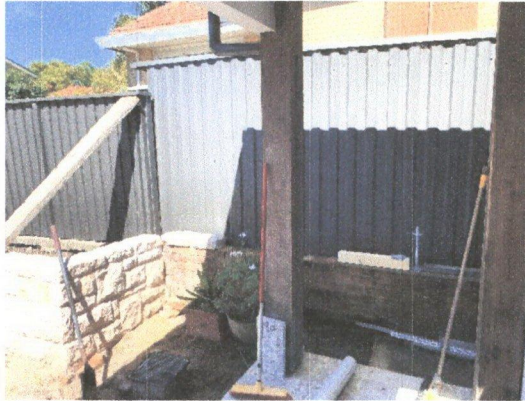
It is understood that as of at least early March 2020 that significant volumes of stormwater inflow to your property have occurred. This stormwater is flowing into your property below the low brick retaining wall on the boundary, adjacent to the rear south-west corner of your house, and has created a scour/erosion zone due to its flow with significant volumes of soils deposited in your property and your drainage system, see Photographs 1, 2 and 3.

Photo: 1 – Brick boundary retaining wall at rear of house

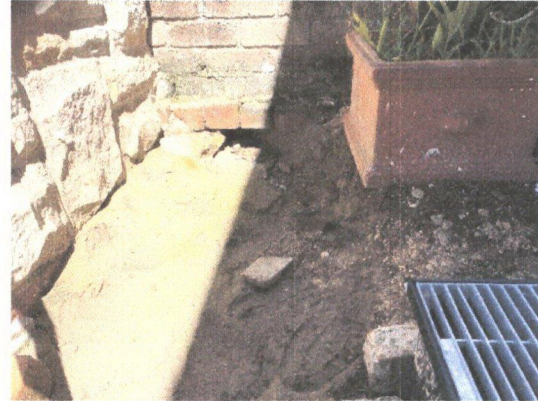
Photo: 2 – Eroded channel below wall

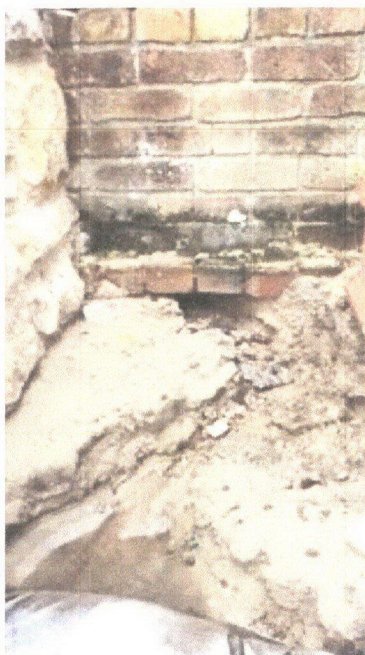
Inspection through the eroded zone into the sub-ground area of the neighbouring property revealed a significant zone of erosion below what appears to be the neighbouring carport slab along with the exposure of a PVC pipe, which is understood to be related to a stormwater easement formed along the eastern side of No. 9, see Photographs 3 and 4.

Photo: 3 – showing eroded channel below wall and sandy soil deposited into site after 4<sup>th</sup> January 2021

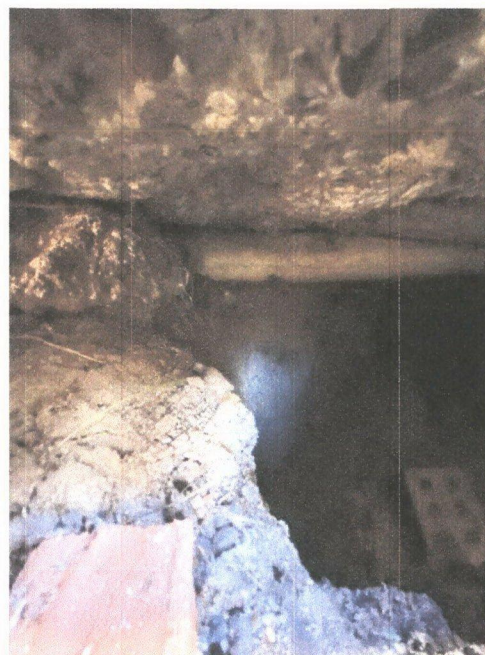
Photo: 4 - View of void eroded below neighbouring carport showing undermined PVC pipe near surface

The photos from the void created below the neighbouring property show a PVC pipe which is anticipated to be the drainage pipe which was installed within the easement. The pipe is now significantly eroded and undermined and will be expected to have complete failure in the near future with likely further increases of stormwater flow and subsequent detrimental impacts to your property. As such, the issues related to the inflow need to be resolved in the immediate future.
