**RE: CONSERVATION MANAGEMENT STRATEGY & STATEMENT OF HERITAGE IMPACTS
FOR 3 BILGOLA AVENUE - BILGOLA BEACH 2072**

**Conservation Management Strategy &
Statement of Heritage Impacts
3 Bilgola Avenue, Bilgola Beach
NSW 2072**

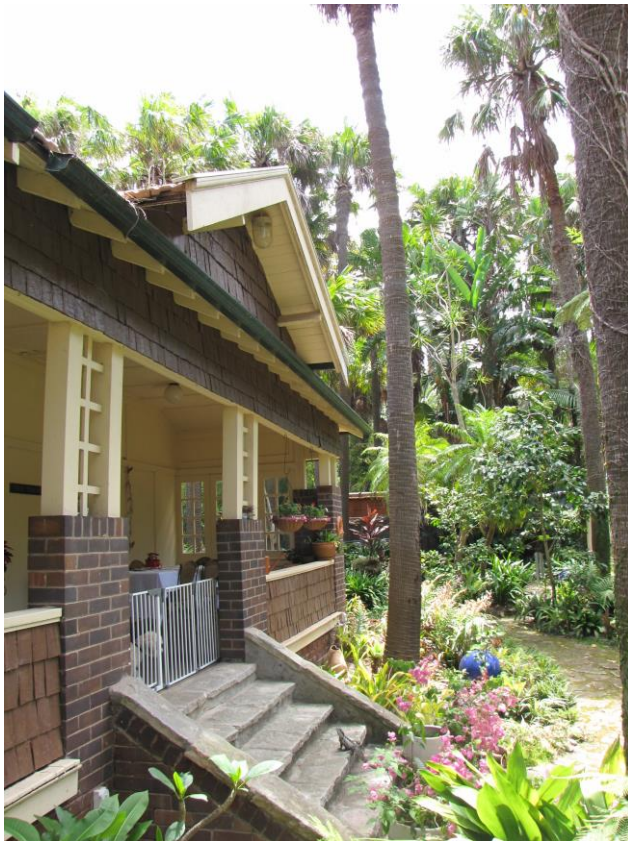
The front of “*The Palms*” is in generally sound condition but brickwork around the base courses to the front of the verandah requires repointing. This indicates that additional drainage may be warranted to ensure the underfloor area remains dry. Removal of the later path along the western side would also assist in ventilation of the underfloor areas.

Figure 11: North Eastern Elevation (front) with dark face brick piers, timber twin posts and gablet over brick & stone stairs. Traditional shingle cladding used as balustrade infill, frieze and gable cladding. Sub-tropical garden setting featuring cabbag tree palms.

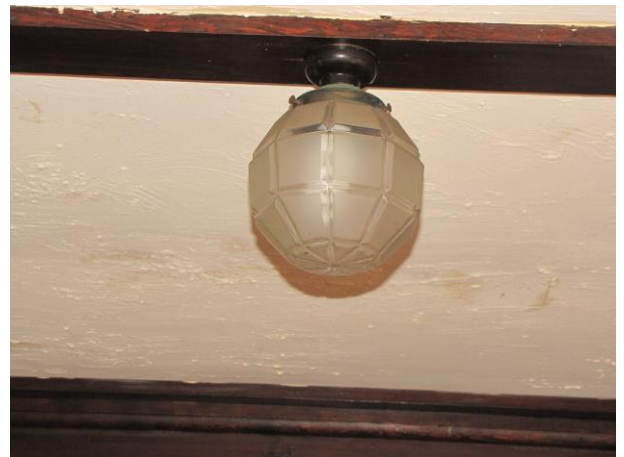
Figure 23: Original light fitting – one of pair in inglenook.
Trowelled repairs to plaster of battened ceiling.

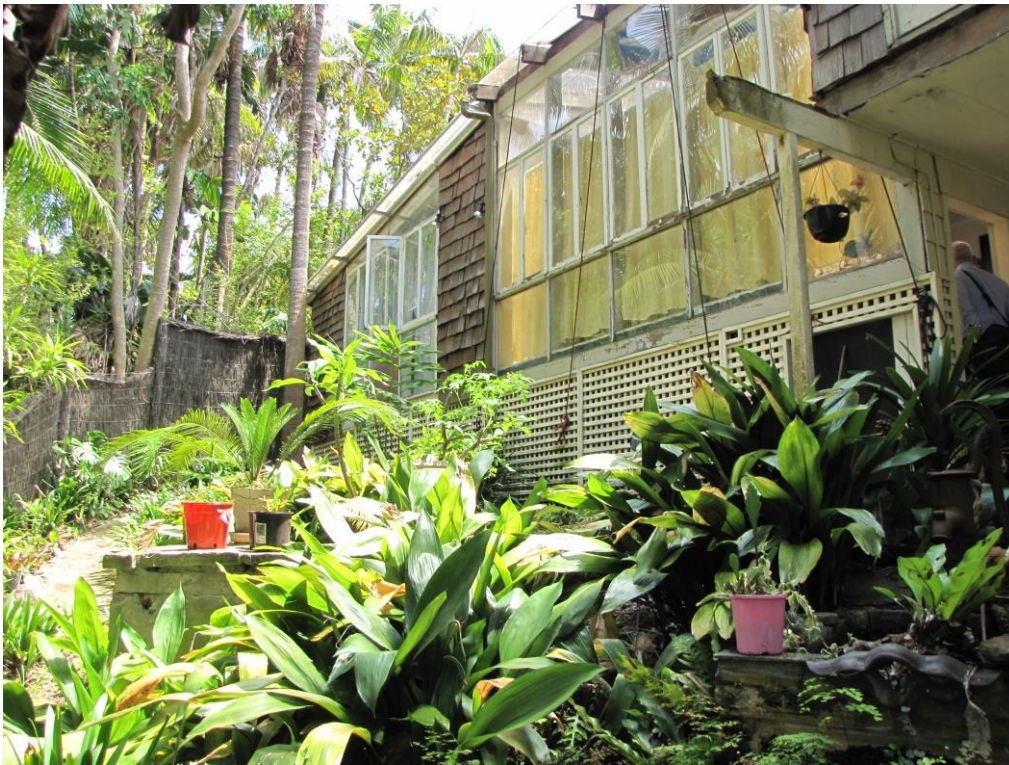
The 1970’s addition has been clad partly in shingles and has an exposed timber structure internally with an extensive area of glass roof. Timber framed windows generally facing south, have also deteriorated in the environment of the palm grove with its exposure to the offshore

winds. While moderately sympathetic in terms of materials, this structure has not stood the test of time and has several design flaws including leaking glass roof and localised termite damage.

Figure 29: South Western 1970's additions – shingled timber framed split level addition with lattice infill to underfloor areas.

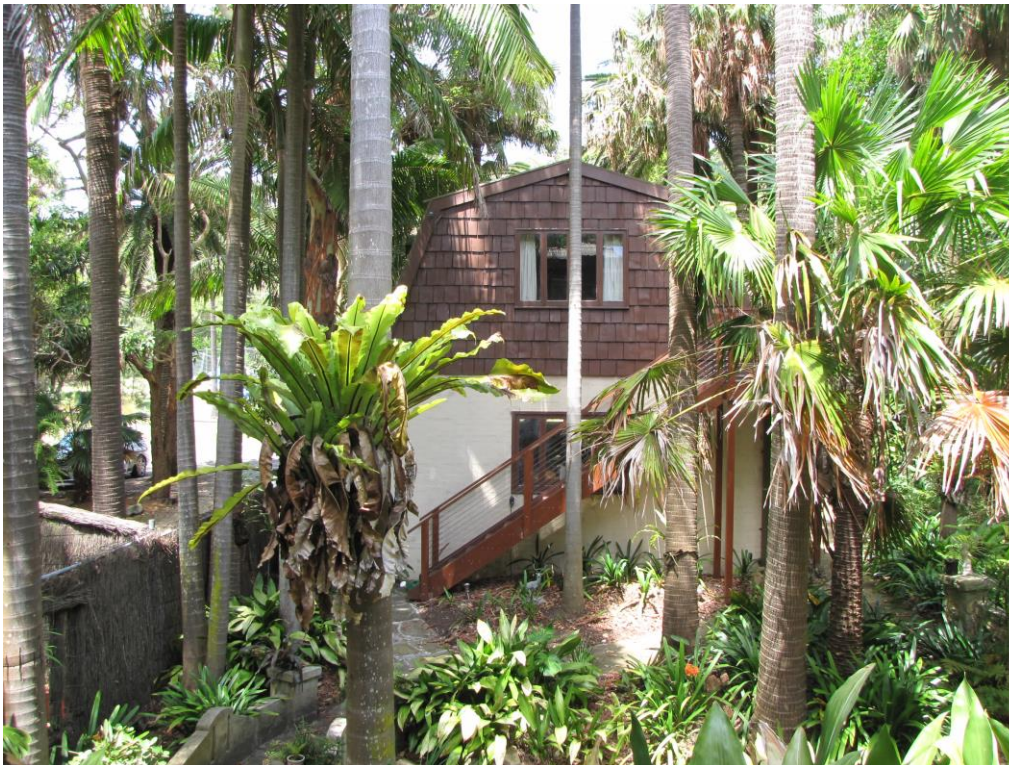
This rear free standing Garage / Loft at the rear to the south west is of indeterminate late 20th Century construction, built in several stages. It is idiosyncratic, having a mansard roof with shingled gables. It is poorly matched to the original house in terms of form and character but has sufficient separation to ensure it does not intrude on the immediate garden setting of “*The Palms*”.

Figure 30: Garage / Loft Annexe – shingled gables to mansard roof addition over earlier brick garage. This building is separated from the main house by the Bilgola Creek channel requiring two stone footbridges for access.

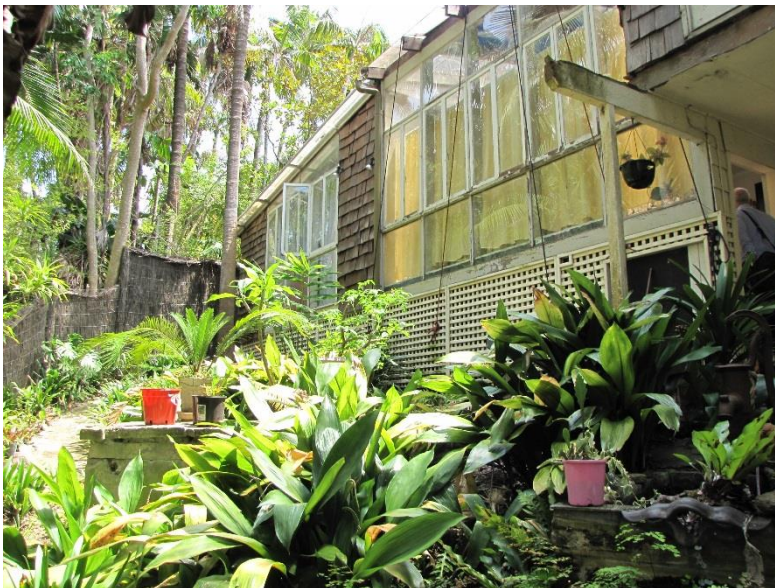
Figure 34: View of the 1970's additions from the vicinity of the Creek.
Source: Colin Israel – Heritage Advice 2014.

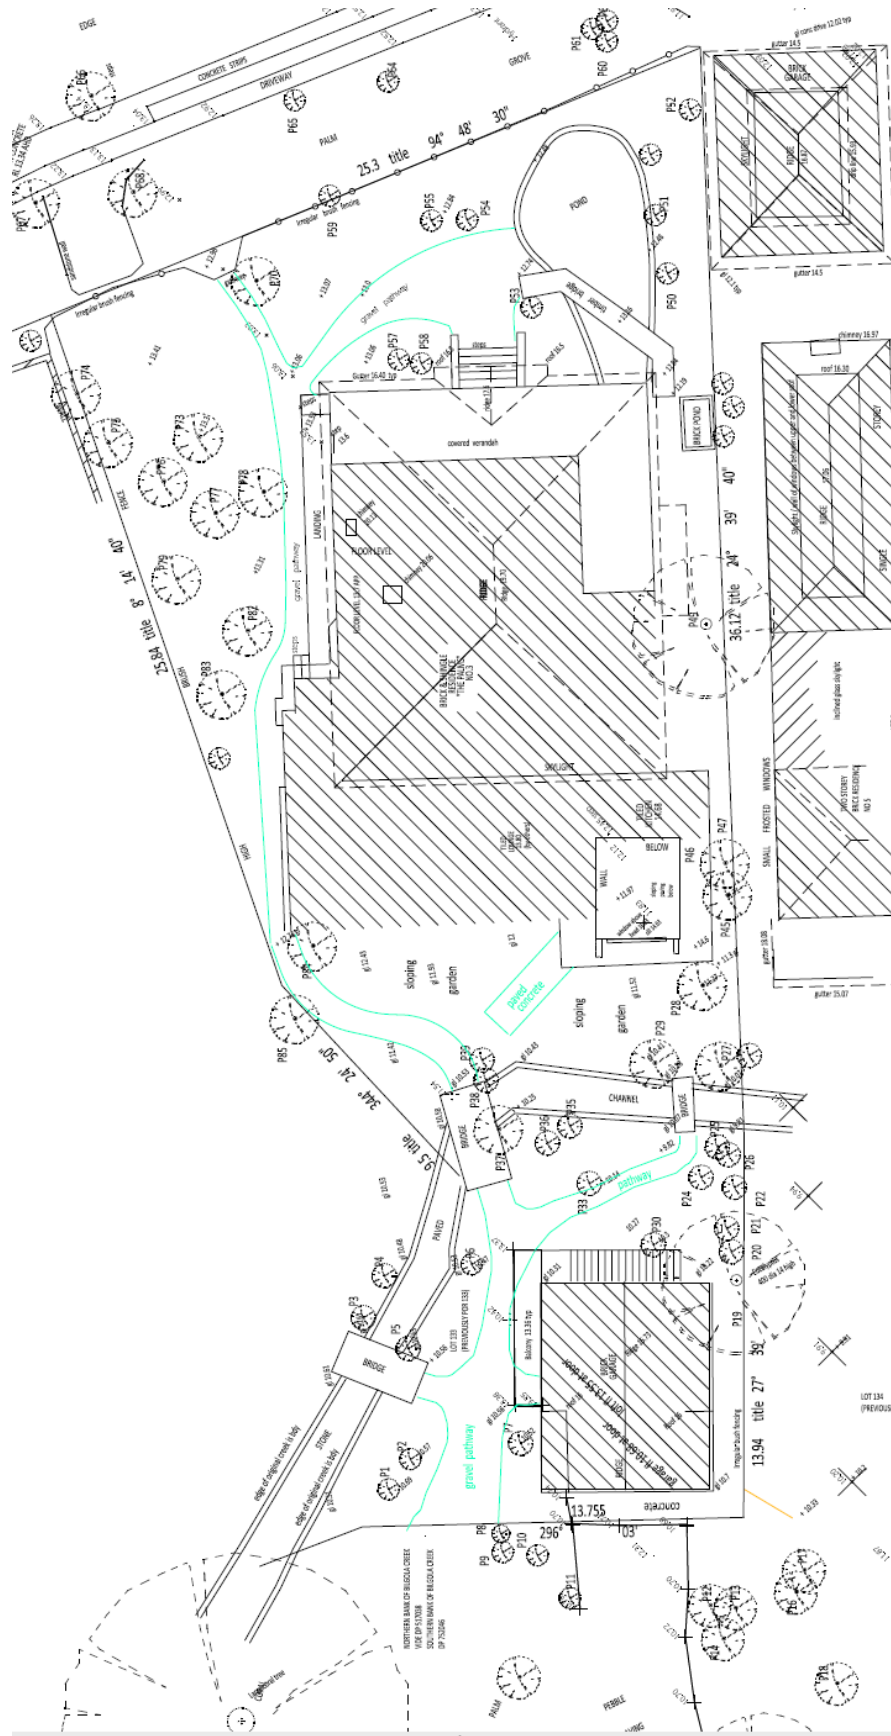
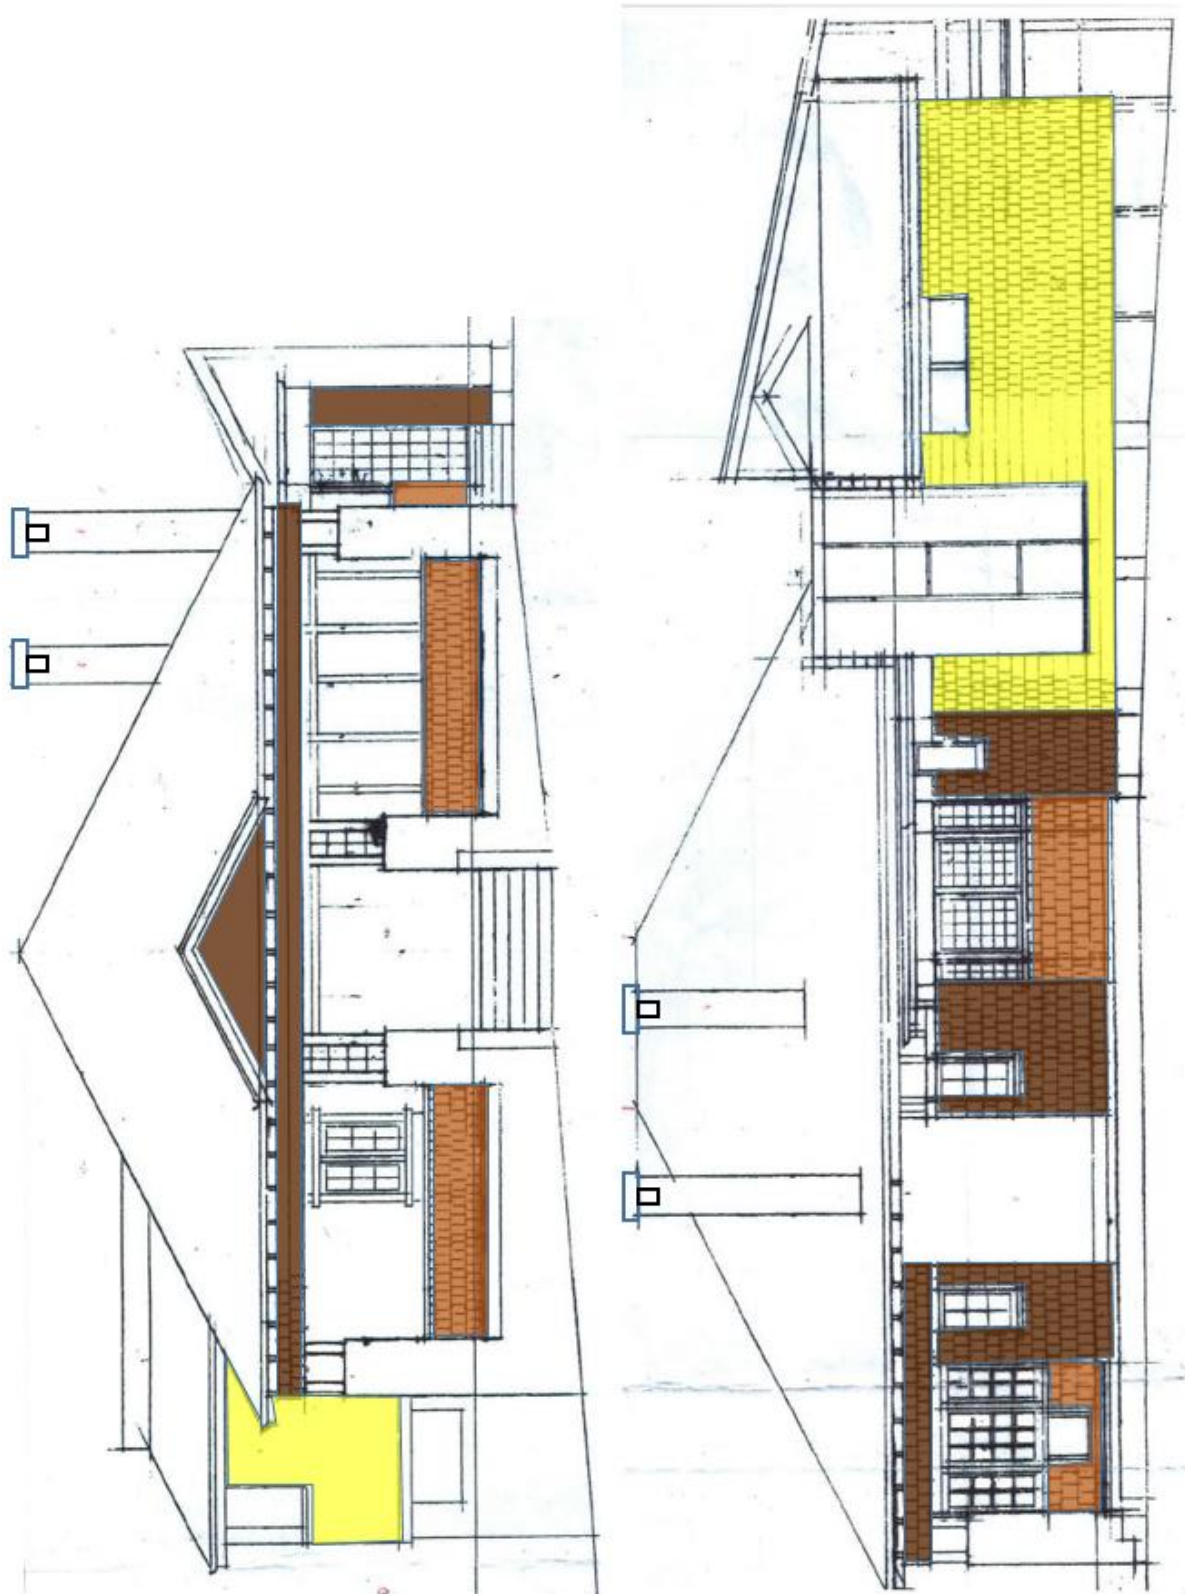
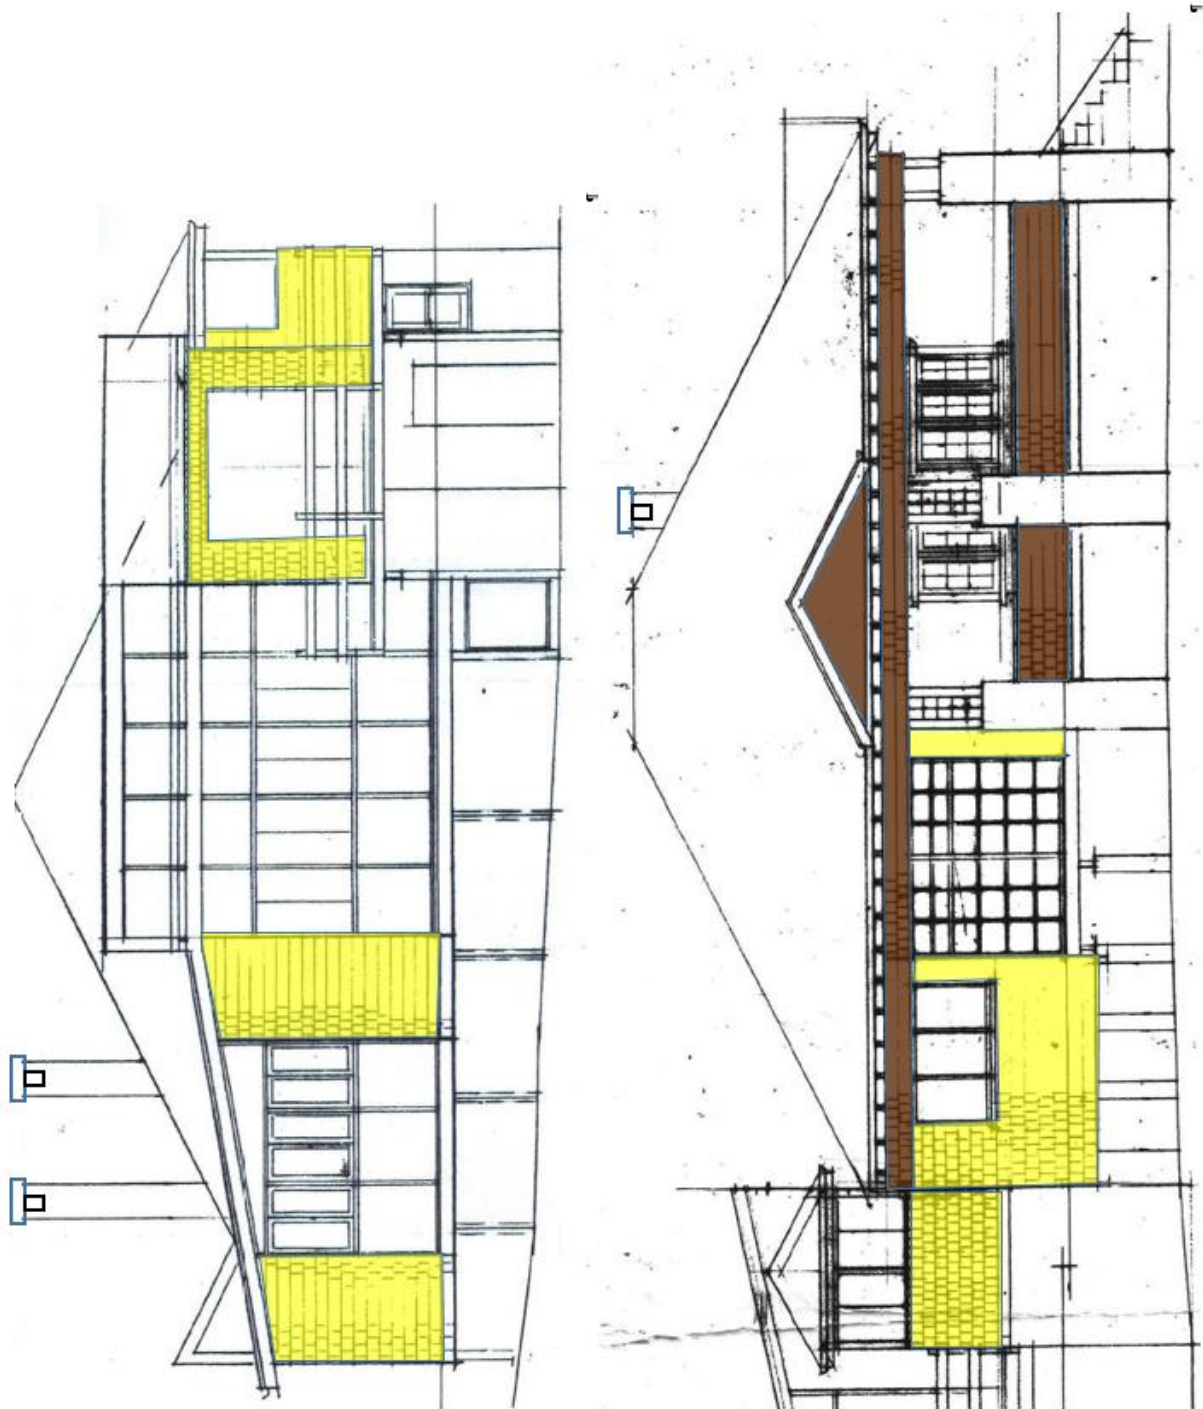
ATTACHMENT 2: ANALYSIS OF EXISTING SHINGLE CLADDING

BROWN / TAN – Original / Sympathetic 1940's – Retain & Repair
