## ARBORICULTURAL IMPACT ASSESSMENT REPORT

Prepared For:	Scott Shepherd
Site Address:	67 Woolgoolga Street, North Balgowlah, NSW, 2093
Inspection Dates:	17 <sup>th</sup> January 2023
Report Date:	19 <sup>th</sup> January 2023
Revised Date:	9 <sup>th</sup> March 2023

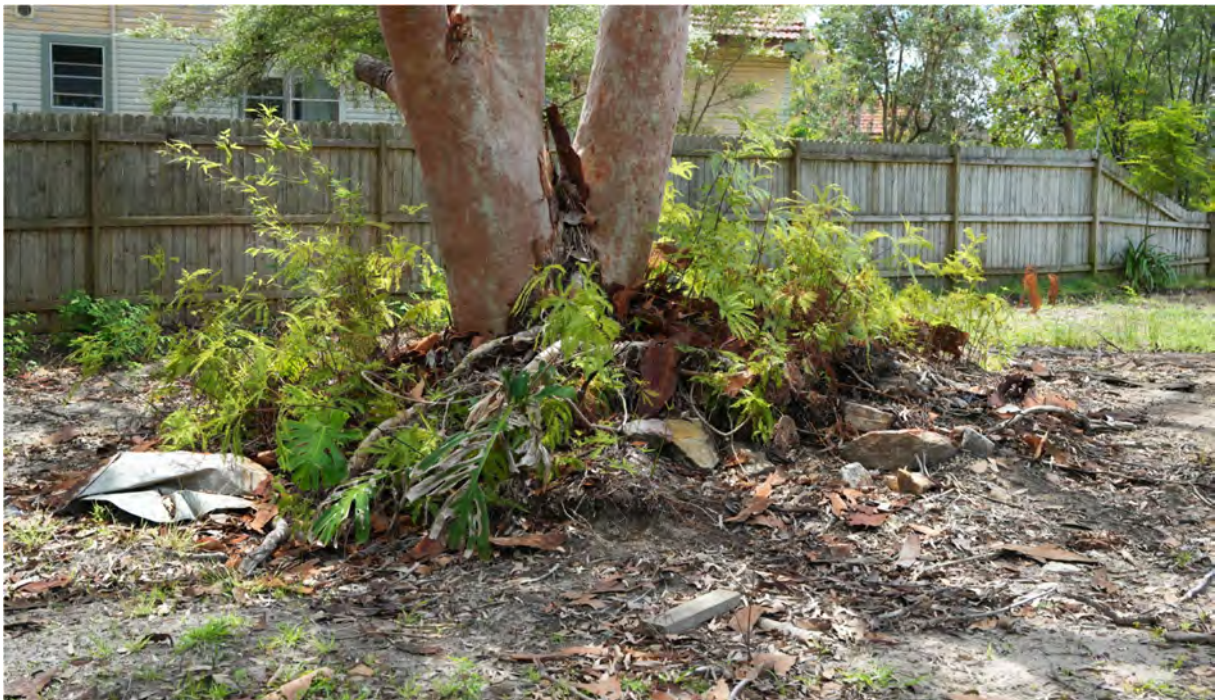
Photographic comparison with the previously commissioned AIA report by the Author indicates soil levelling has occurred within the SRZ area of this tree, possibly associated with the removal of monstera vine.

*Image 2: Soil levelling was noted at the base of Tree 10.*

- 5.4.1 Due to observed damage following demolition, it is recommended that routine tree health assessments are scheduled annually for the 5 years following completion of the development to monitor long-term impacts from damage.

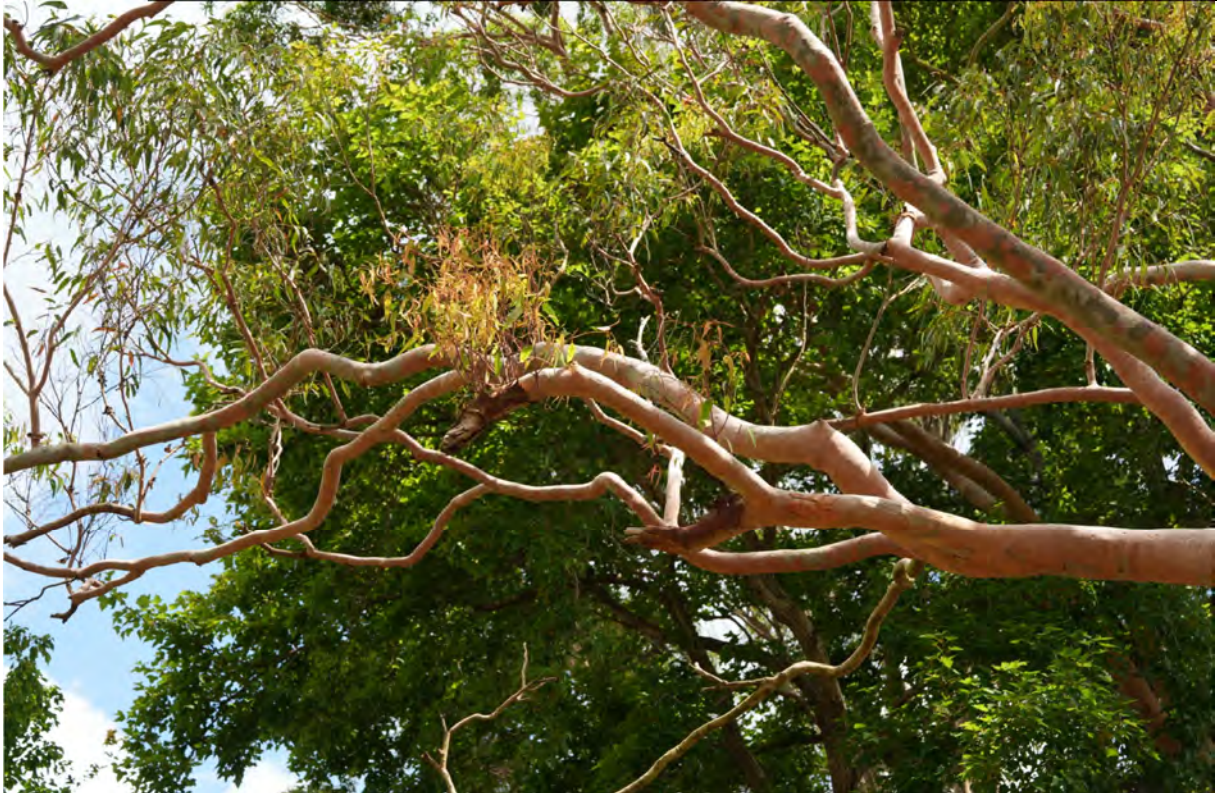
- 3.4.9 Tree 10 was mature and in good health. This tree was of the highest landscape significance on the site. Recent minor branch and canopy damage was noted in the tree's canopy. Recent epicormic shoots were noted within the vicinity of this damage.

*Image 3: Recent epicormic shooting on Tree 10 is a common side-effect of injuries or stress.*

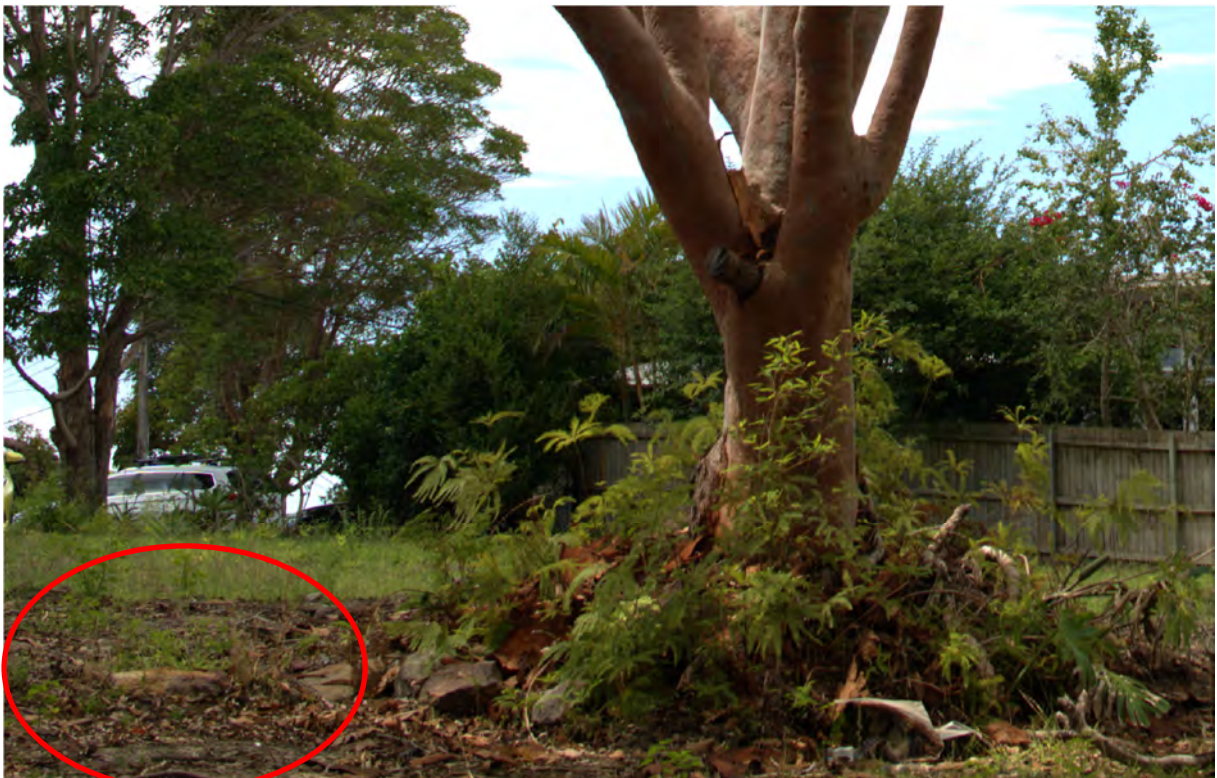
*Of concern* was the observation of structural root damage to the North-East of the tree with a 1.5m offset. Based on this observation, the stability of the tree *may* have been compromised due to negligence of demolition contractors *et al*.

*Figure 4: Root damage for Tree 10 as seen.*
