Tree Assessment

Alterations & Additions

**10 Wirringulla Ave
Elvina Bay**

Report Prepared by Julia Stanton
Syncarpia Vegetation Management
24 Windsor Street Tarbuck Bay 2428
juliastanton@ozemail.com.au
Mob:0417398050
October 2020

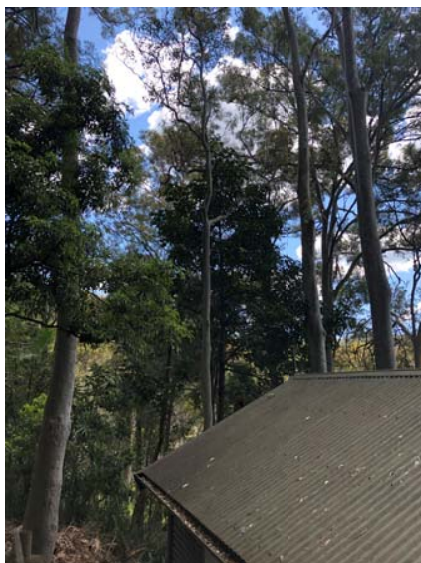
Photo 1 Trees 1, 2, 3 & 4

Tree 2 is a semi-mature specimen of *Corymbia maculata* (Spotted Gum) in Fair health & condition, & of poor - fair form, with moderate epicormics growth & suppressed development of crown. This tree is in direct conflict with the addition and is proposed for removal.

Tree 3 is a semi-mature specimen of *Corymbia maculata* (Spotted Gum) in fair health & poor condition & form. The trunk & canopy contains epicormics growth and canopy has a significantly reduced crown. This tree is in direct conflict with the addition and is proposed for removal.

Tree 1 is a mature specimen of *Corymbia maculata* (Spotted Gum) in good health & condition. This tree is located adjacent to the existing concrete stairs & 2.75m from the addition footprint 6m from excavation to accommodate the corner post pier footings. The excavation for the proposed development is located outside the calculated SRZ (Structural Root Zone) & TPZ (Tree Protection Zone). This tree is to be protected & retained and TPZ /Exclusion fencing & trunk protection is to be establish prior to the commencement of site works. Excavation within 5m is to be undertaken by hand.

Tree 4 is a mature specimen of *Corymbia maculata* (Spotted Gum) in fair – good health & condition & of good form, located on the adjacent to the existing stairs. This tree is located 0.5m from the edge of the proposed deck & 2m & 3m from excavation to accommodate pier footings. Excavation for one pier footing is within the calculated SRZ and within the calculated TPZ for the other footing.

- Tree & soil protective zones & trunk protection are to be established prior to commencement of site works (Specifically for Trees 1, 4). Fencing is to be maintained for the duration of construction works. Refer to Figure 1 for recommended tree protective / exclusion fencing.

- **Specifically trunk protection is required for Trees 1 & 4.** Suitable trunk protection would include geotextile or similar as padding covered with timber battens or sheet metal strapped together. Trunk protection **must not** be nailed to the trunk of trees.

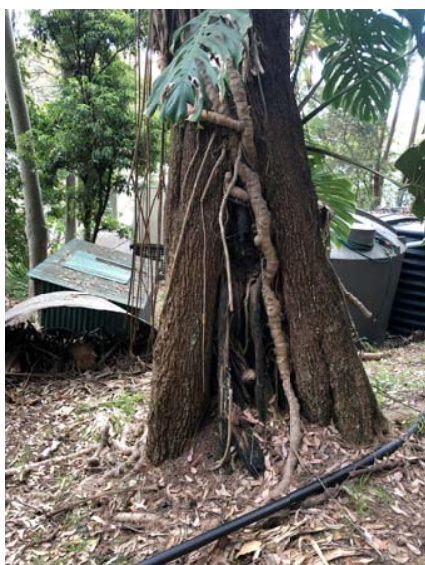
Photo 5 Tree 5

- Tree 5 is an over mature specimen of *Allocasuarina torulosa* (Forest Oak) in poor health & condition, with significant lower trunk decay. This tree is in decline & recommended for removal.
