# ARBORICULTURAL IMPACT ASSESSMENT

27 Alan Avenue, Seaforth.

Prepared for: Nick Bell Architects

Date: October 18, 2019.

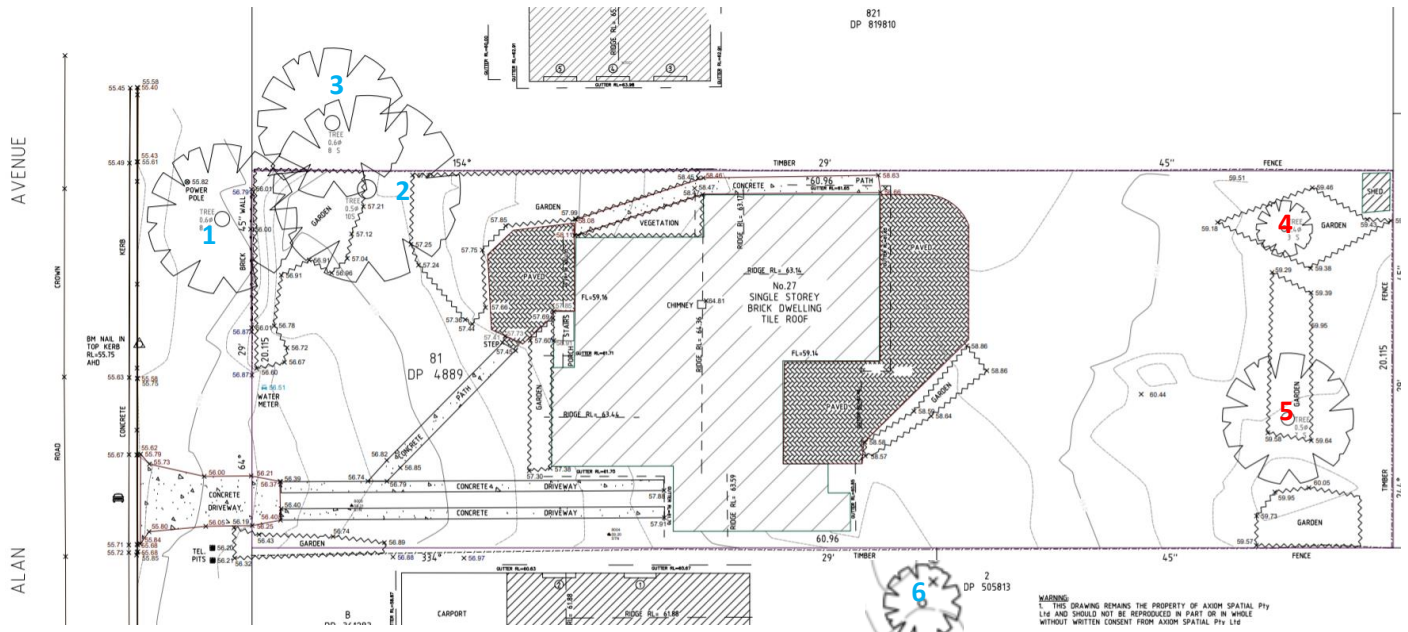
Figure 9-Site survey showing existing dwelling and trees to be retained (blue) and removed (red).

The proposed development at 27 Alan Avenue will require the removal of two (2) trees of low and very low retention value (trees 4 & 5).

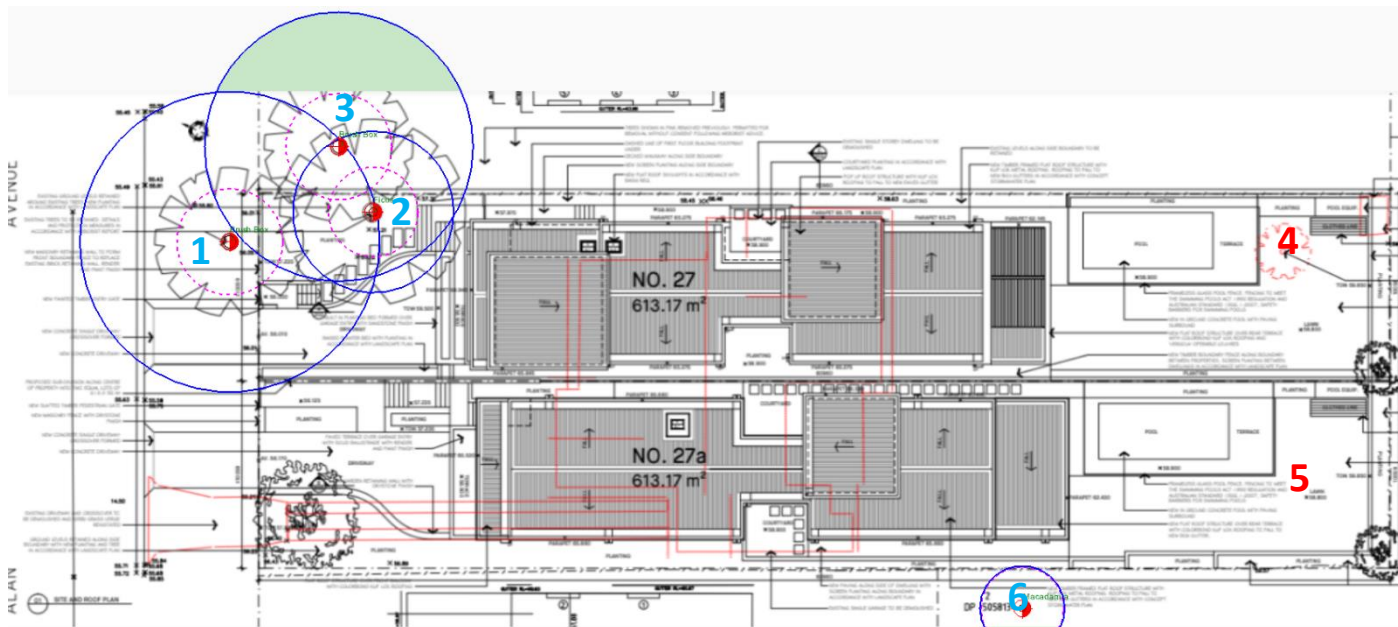
Figure 13- Drawing showing the encroachments upon retained trees (blue numbering) and trees proposed for removal (red numbering).

Tree one (1) is a council street tree specimen of *Lophostemon confertus*- Brush Box which will be encroached upon by the proposed driveway crossing and retaining wall into lot A and the removal and replacement of the existing front brick fence/retaining wall. The driveway bisects the tree protection zone (TPZ) of tree #1 at 3.6m from the centre of the tree, resulting in a calculated encroachment of around 22%. The front boundary fence is already an established structure so there will be no new encroachment to this area, however tree protection measures to mitigate any potential impacts will be required. The pedestrian entry and driveway retaining wall provide further minor encroachments, however these are relatively minor and given the raised soil levels inside the property boundary, significant tree roots from tree one are unlikely to be impacted. This species of tree is considered as being very tolerant of root disturbance, but non-destructive excavation will be required to assess the roots that will be impacted by the driveway crossing. The front wall will need to be carefully demolished by hand and reinstated using pier and beam or other sensitive construction methods to bridge over and retain any significant roots which are discovered. The demolition of the existing wall and reinstatement of a new wall will require Arborist supervision. Minor pruning of the tree canopy may be required to provide clearance over driveway crossing.

Tree five (5) is a poorly structured *Eucalyptus nicholii*- Narrow-leaved Black Peppermint which will suffer a major encroachment for the swimming pool terrace and also for the levelling of the rear yard. This tree is an exempt species and also has hazardous structure. This tree will require removal.

1. Trees 4 & 5 should be removed to enable the development to proceed.
2. Trees 1, 2, 3, 6 are currently proposed for retention and protection.
3. Tree protection fencing and signage must be installed in accordance with AS4970-2009 and located as depicted in appendix 3- Tree protection plan.
4. Ground protection and trunk and branch protection will be required for trees 1 & 2, as shown in appendix 3- Tree protection plan
5. The removal of tree four (4) will result in the need for at least one replacement planting.
6. Three replacement plantings are proposed and at least one should be one of the replacement species shown in appendix 4- Native tree selection.
7. All tree protection measures must be completed in accordance with AS4970-2009, appendix 2 of this report and appendix 3- Tree protection plan.
