77A Myola Road, Newport

GEOTECHNICAL INVESTIGATION:

Alterations & Additions at 77A Myola Road, Newport

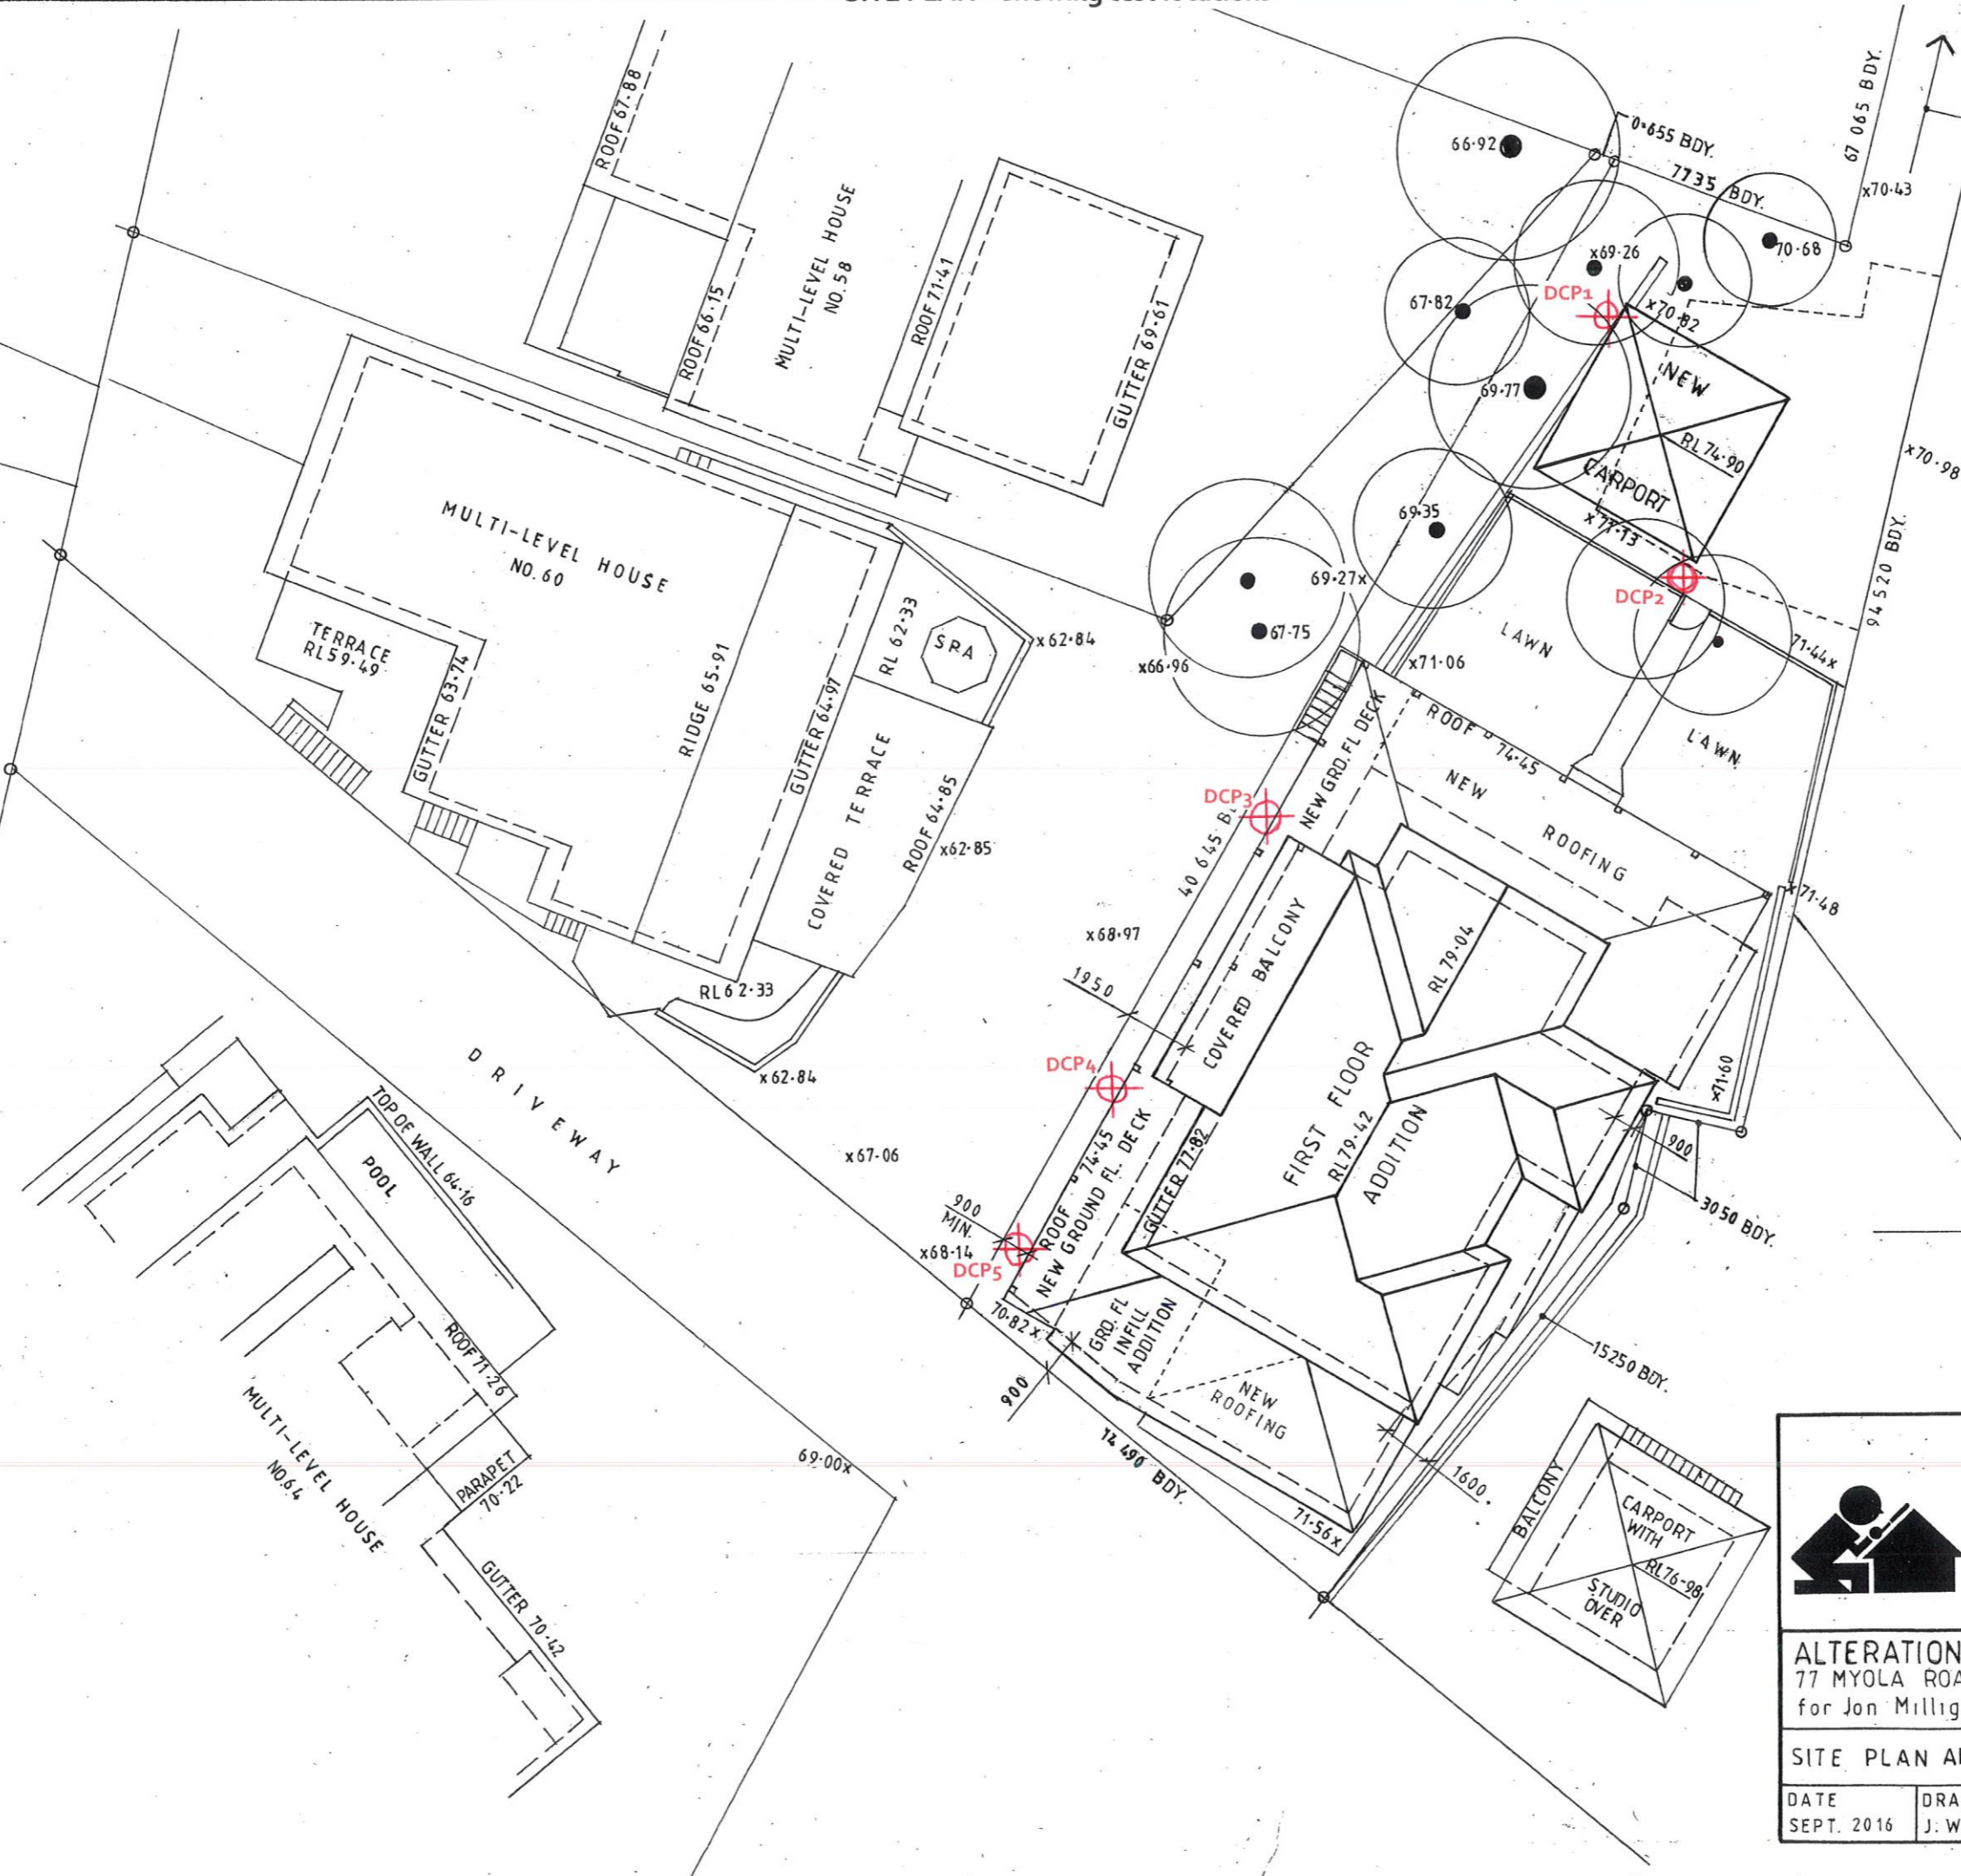
SITE PLAN - showing test locations

Five Dynamic Cone Penetrometer (DCP) tests were put down to determine the relative density of the overlying soil and the depth to bedrock. The locations of the tests are shown on the site plan. It should be noted that a level of caution should be applied when interpreting DCP test results. The test will not pass through hard buried objects so in some instances it can be difficult to determine whether refusal has occurred on an obstruction in the profile or on the natural rock surface. The results are as follows:

DCP1 – Refusal on rock @ 0.1m, DCP bouncing off rock surface, white to light brown sandstone fragments on dry tip. Sandstone exposed immediately below.

DCP2 – Refusal on rock @ 0.7m, DCP bouncing off rock surface, white and brown sandstone fragments on dry tip.

DCP3 – Refusal on rock @ 0.3m, DCP bouncing off rock surface, white sandstone fragments on dry tip. Sandstone exposed ~2.0m to the E.

DCP4 – Refusal on rock @ 1.5m, DCP bouncing off rock surface, light brown sandstone fragments on dry tip. Sandstone exposed to the E and W.

DCP5 – End of test @ 2.6m, DCP still very slowly going down, yellow clayey sand on damp tip.

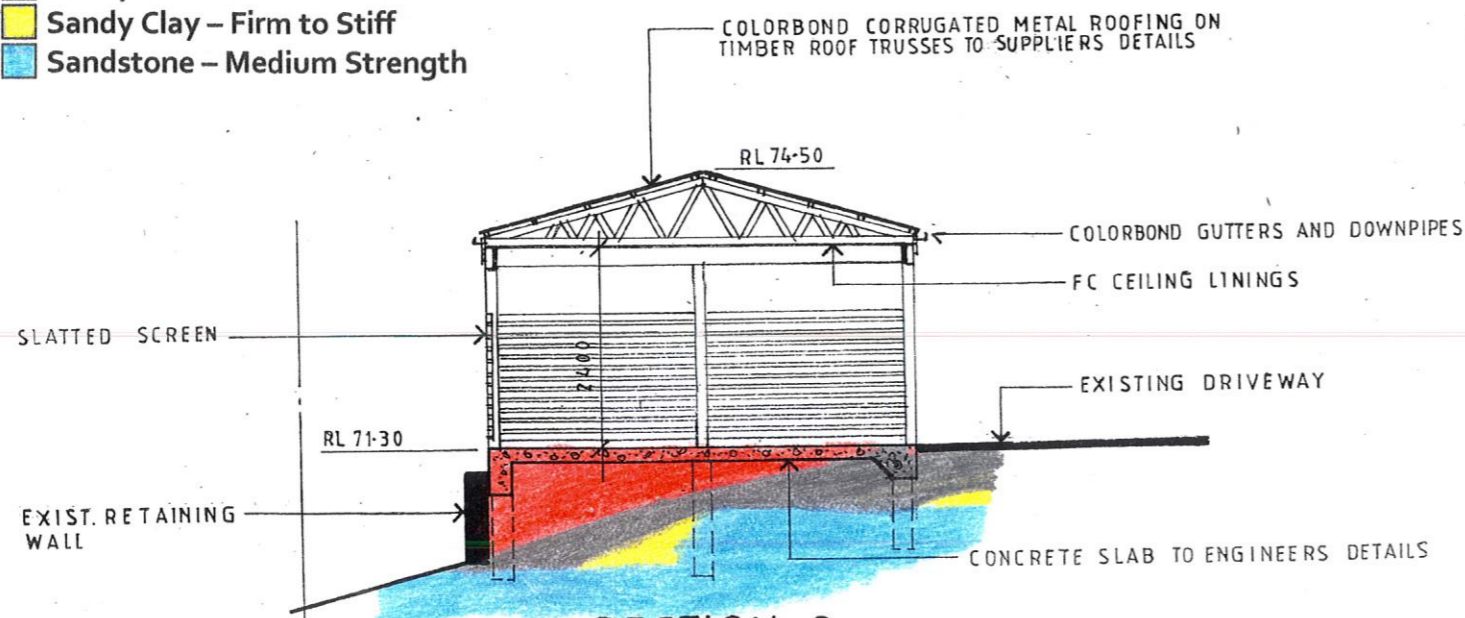
TYPE SECTION – Diagrammatical Interpretation of expected Ground Materials

Sandstone bedrock was observed to be outcropping across and below the site. This is an unusually thick sandstone bed within the Narrabeen Group of rocks. The surface features of the block are controlled by the outcropping and underlying sandstone bedrock that steps up the property forming sub-horizontal benches between the steps. Where the grade is steeper the steps are larger and the benches narrower. Where the slope eases the opposite is true. Where the rock is not exposed it is overlain by filling, sandy soils, and firm to stiff sandy clays that fill the bench step formation. In the test locations, the depth to rock ranged between 0.1 to 2.6m below the current surface, being deeper where filling has been placed for the house and due to the stepped nature of the rock. It is possible DCP 4 was over a joint (crack) in the rock as sandstone was observed to be outcropping on both sides of the test. It is interpreted from ground tests and observations of the retaining wall that DCP 5 passes through ~1.2m of fill before encountering a more typical shale profile. The outcropping sandstone on the property and immediately below is estimated to be medium strength sandstone or better and similar strength rock is expected to underlie most of the site. See Type Section attached for a diagrammatical representation of the expected ground materials.
