# Arboricultural Impact Assessment

Prepared for Wimbledon Pty Ltd  
Site Address: 2A Allen Avenue Bilgola Beach  
22<sup>nd</sup> November 2024

Date	Revision	Change	Stage
12/6/2023	1	Plans	DA
22/11/2024	2	Plans	DA

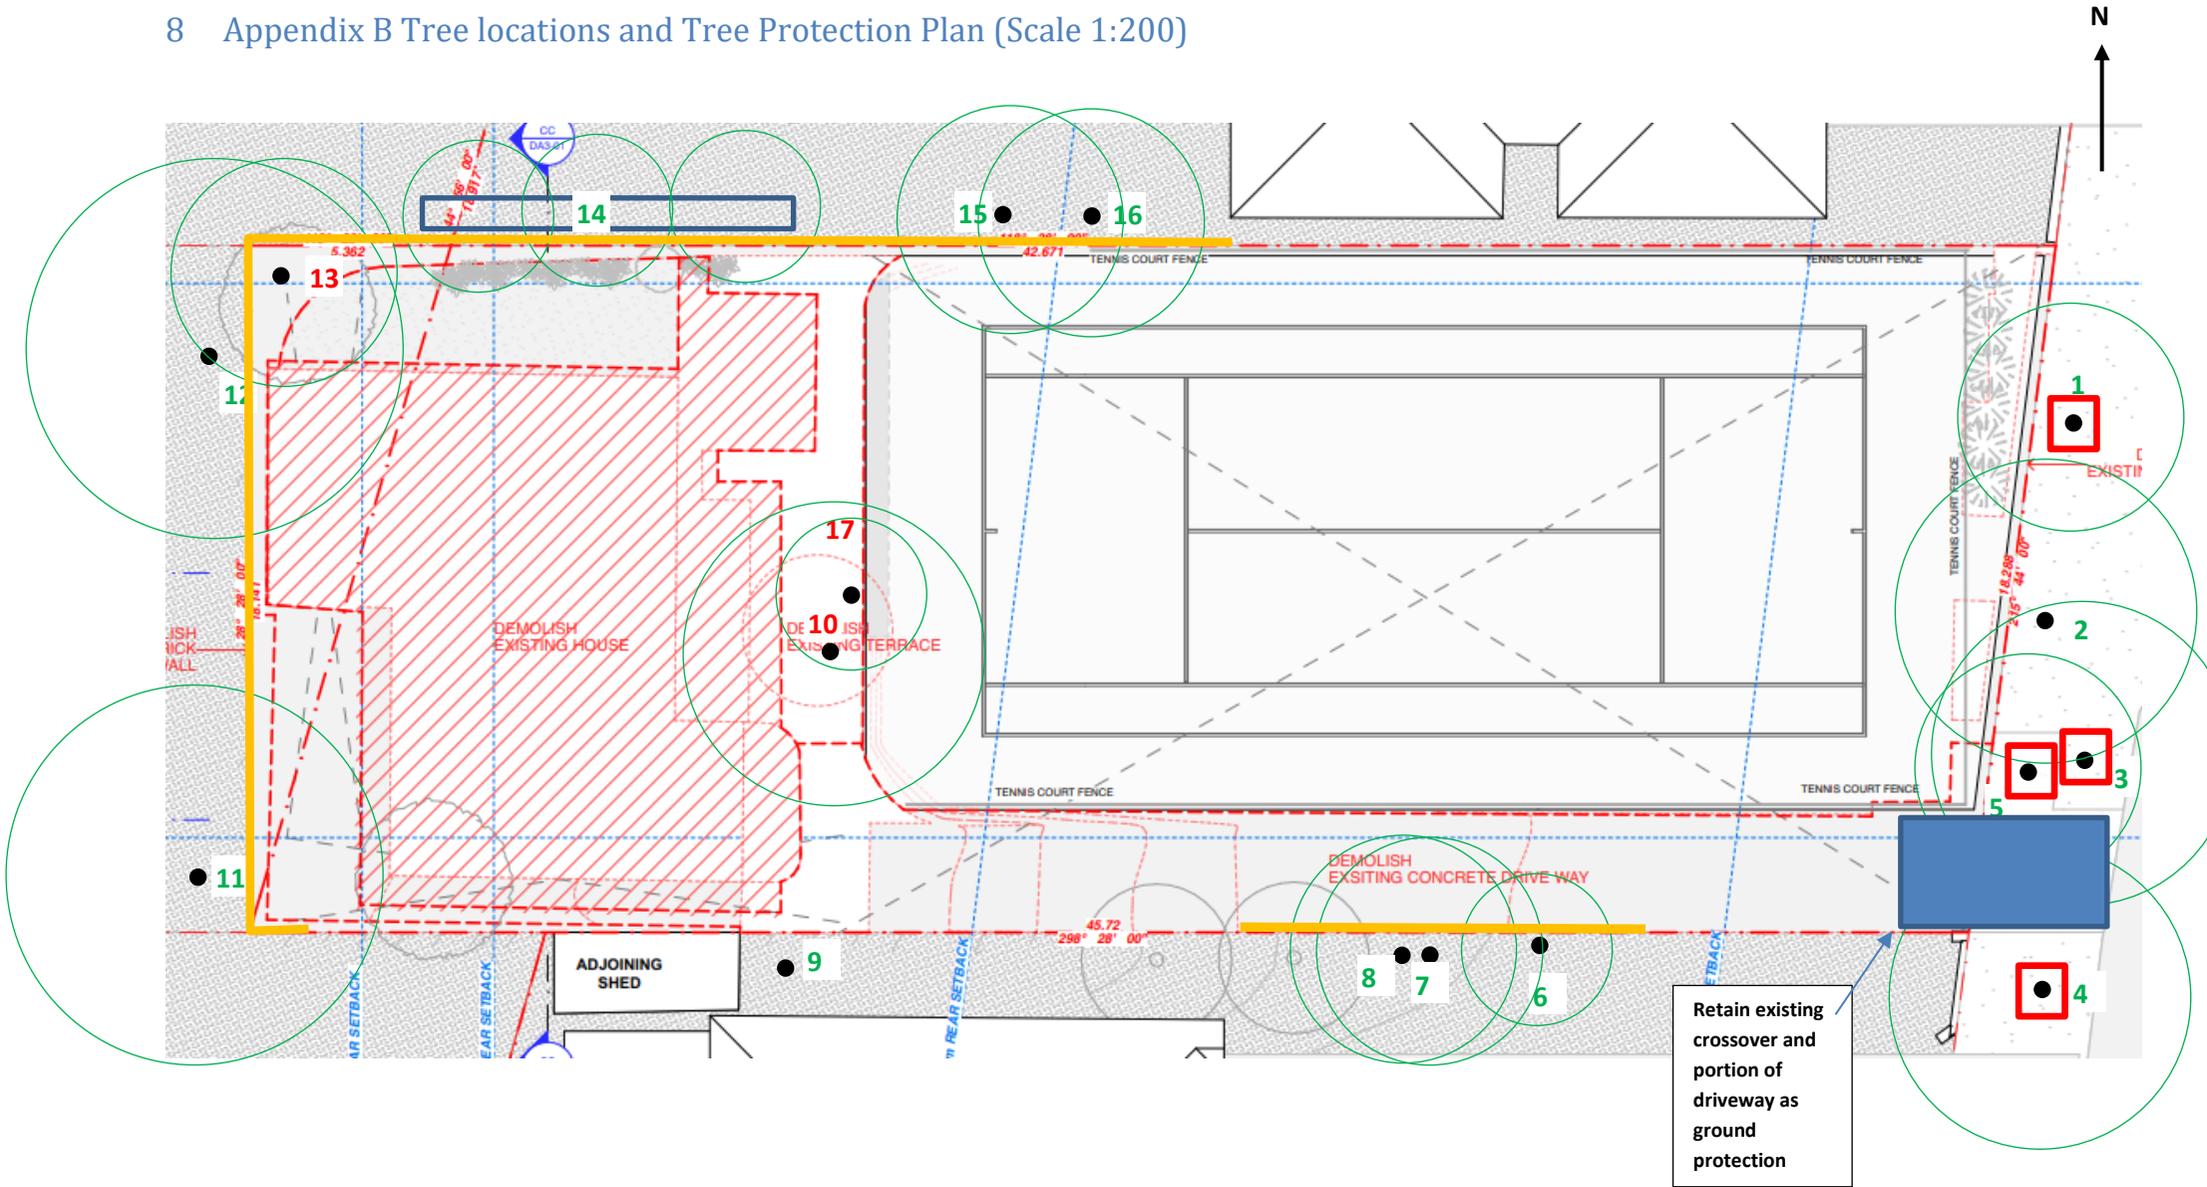
## 8 Appendix B Tree locations and Tree Protection Plan (Scale 1:200)

Table 1 Plan Legend

Requirement	Total	Tree Number	Legend
Trees Removed	3	10, 13, 17	Red
Trees Retained	14	1-9, 11, 12, 14, 15, 16	Green
Tree Protection Zone (TPZ)	17	1-17

Tree protection fencing	8	6, 7, 8, 11, 12, 14, 15, 16

Trunk Protection	4	1, 3, 4, 5

Ground Protection	3	3, 4, 5

1. Removal of trees 10, 13 and 17.
2. Retain trees 1-9, 11, 12, 14, 15 and 16.
3. Hedge/Tree 14 must be pruned back to fence line/boundary and Tree 12 prior to piling.

8. All trees must be retained and protected in accordance with Australian Standard 4970-2009. A tree protection plan has been provided as a guide in section 8. Tree protection fencing and trunk protection is required. See Section 10 Appendix G for generic specifications for these tree protection measures.
