Arboricultural Impact Assessment

6 Mitchell Road, Palm Beach, NSW 2108 **Prepared for:**

02/09/2020 Date:

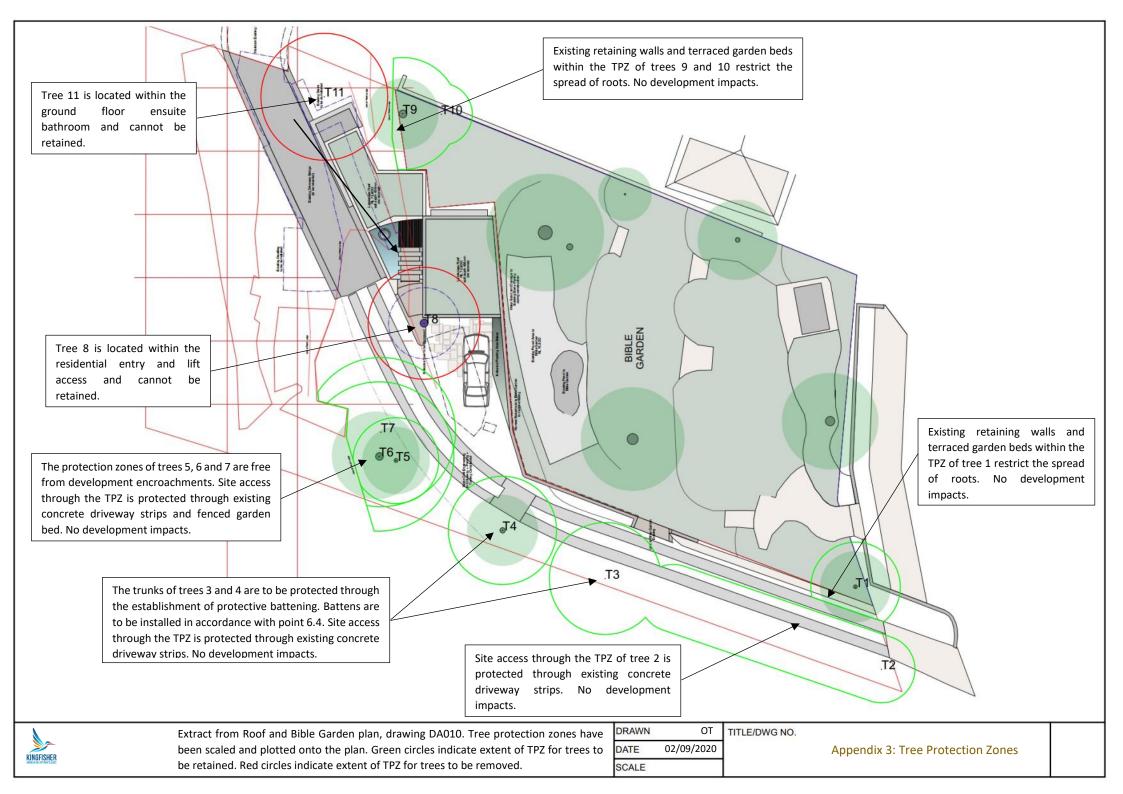
- 3.1.11 Demolition works are not expected to have any impact upon trees retained within the site.
- 3.1.12 **Appendix 3** shows the proposed development with respect to the protection zones of the site's trees.
