ARBORICULTURAL IMPACT ASSESSMENT REPORT

**51 GRANDVIEW DRIVE
NEWPORT NSW 2106**

Prepared for Ms. Maxworthy
c/o Jeremy Adams
Lifestyle Home Designs

13 June 2019
Revision A

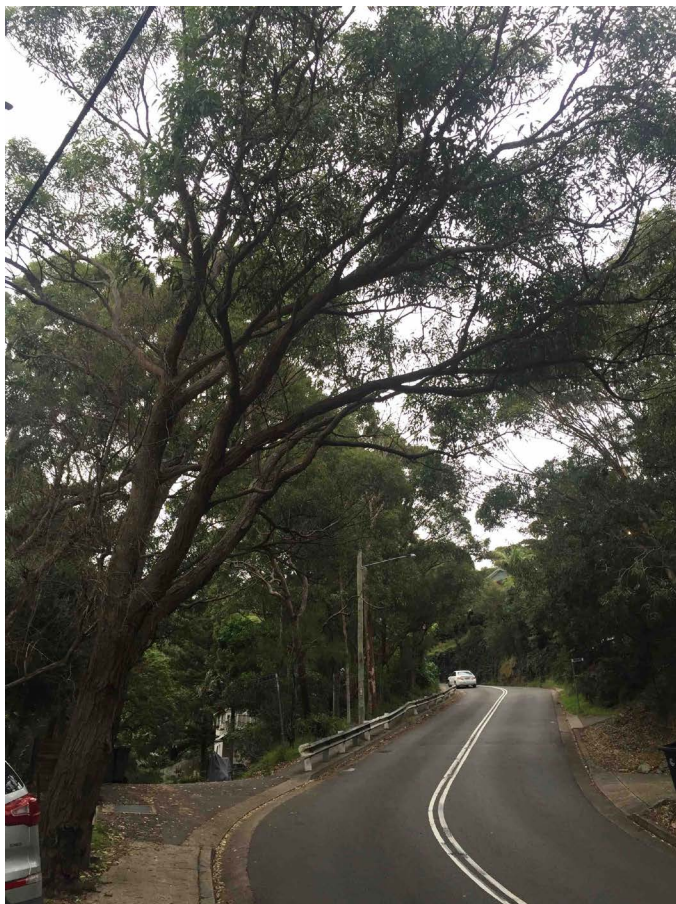
Figure 3: Viewing west up Grandview Drive with Tree No. 1 visible to the left hand side.

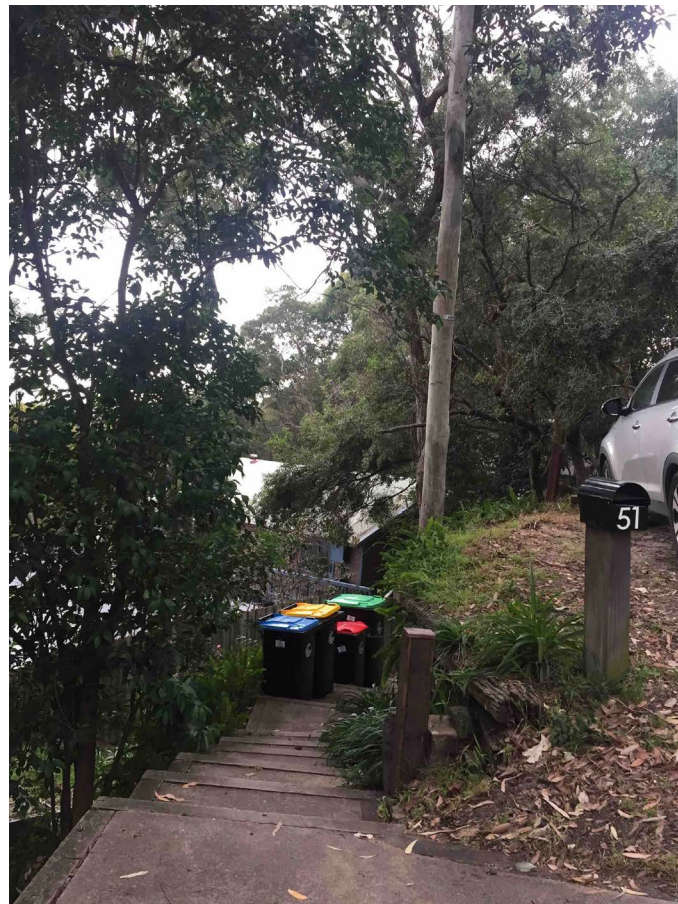
Figure 4: Viewing southwest at the existing steps located on the council verge which provide pedestrian access onto the site.

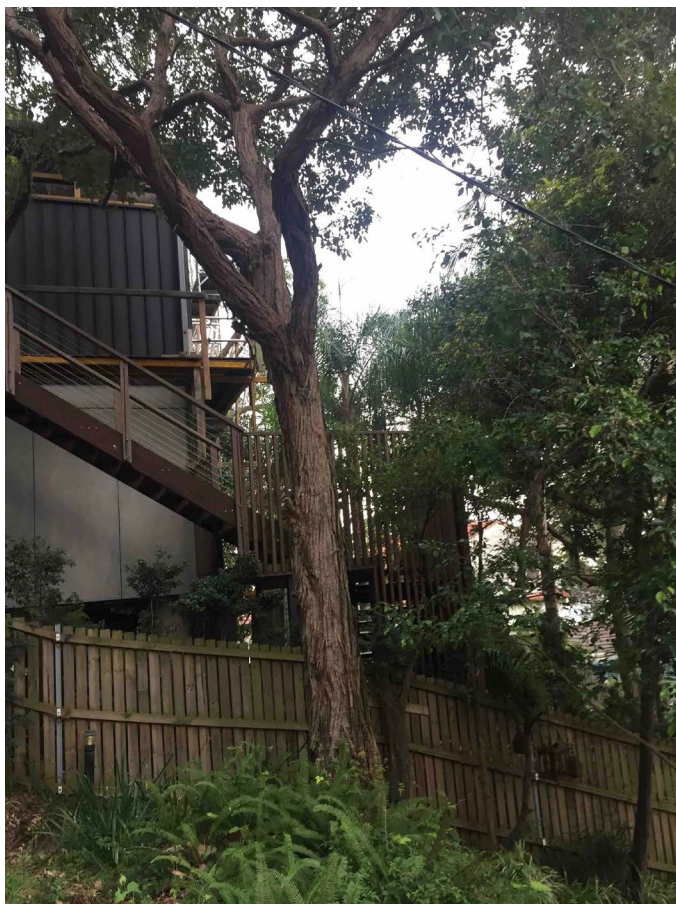
Figure 5: Viewing east at the lower section of trunk of Tree No. 4 (Turpentine)

- Assessment of the likely impact of the works on the existing trees.
- 4.2 The proposed car stand area with studio beneath will necessitate the removal of Tree No. 4 (Turpentine). The tree is a locally occurring species and is a mature specimen with a dominant crown class. The tree exhibits normal vigour and good condition and overall is considered to hold a high retention value on the basis of ecological significance and estimated long life expectancy. Based on discussions with the applicant, alternative designs have been explored in an attempt to retain the tree and accommodate adequate space for a car stand area. However, due to various constraints on the site it is understood the positioning of the car stand area cannot be shifted in a way that will ensure the safe retention of the tree.

- 5.2 The proposed development will result in the removal of one (1) native tree, identified as Tree No. 4 (Turpentine). The tree is considered to have a high retention value on the basis of ecological significance and estimated long life expectancy. Following discussions with the applicant, the author acknowledges there are constraints relating to the site that restrict the positioning of a car stand area. Whilst it may be possible to shift the structure away from the tree and amend the decking so as to retain Tree No. 4, it is the author's opinion the new structure will inevitably result in an adverse impact upon the above and below ground components of the tree. In this particular instance it is recommended Council consider granting permission to remove the tree on the basis that compensatory planting is carried out on the site. The replacement tree should be the same locally occurring species that is being removed ie. *Syncarpia glomulifera* (Turpentine).

- Other physical damage to the trunk or root system; and
 - Any other activity likely to cause damage to the tree.
- 5.4 Written approval from Council will be required to undertake tree removal of Tree No. 4. Tree removal works are only to be undertaken by a qualified arborist (ISAAC member under the supervision of a person with AQF Level 3 or above).

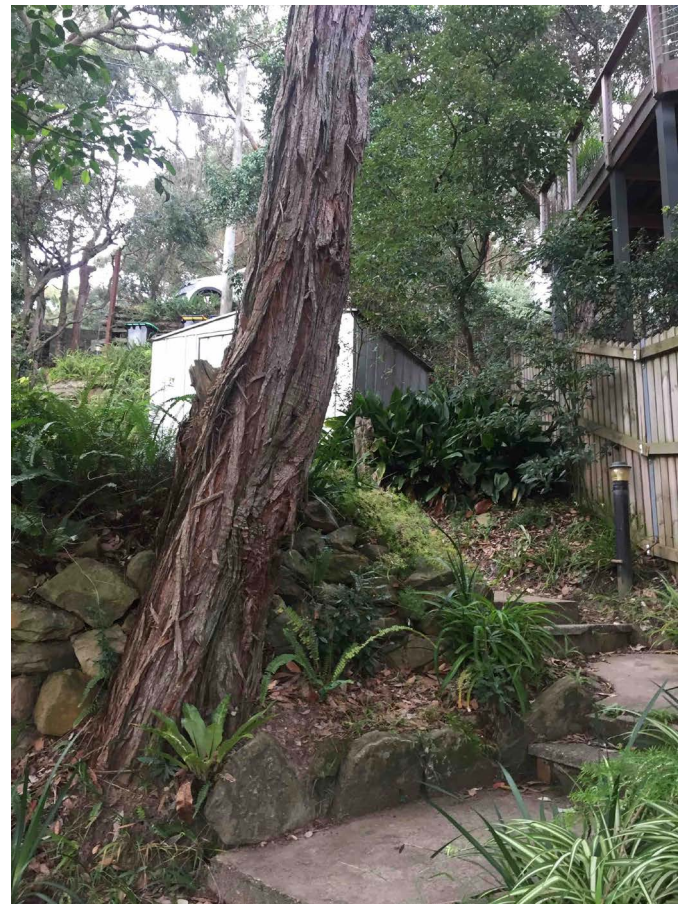
Figure 6: Viewing north at the lower section of trunk of Tree No. 4 (Turpentine)

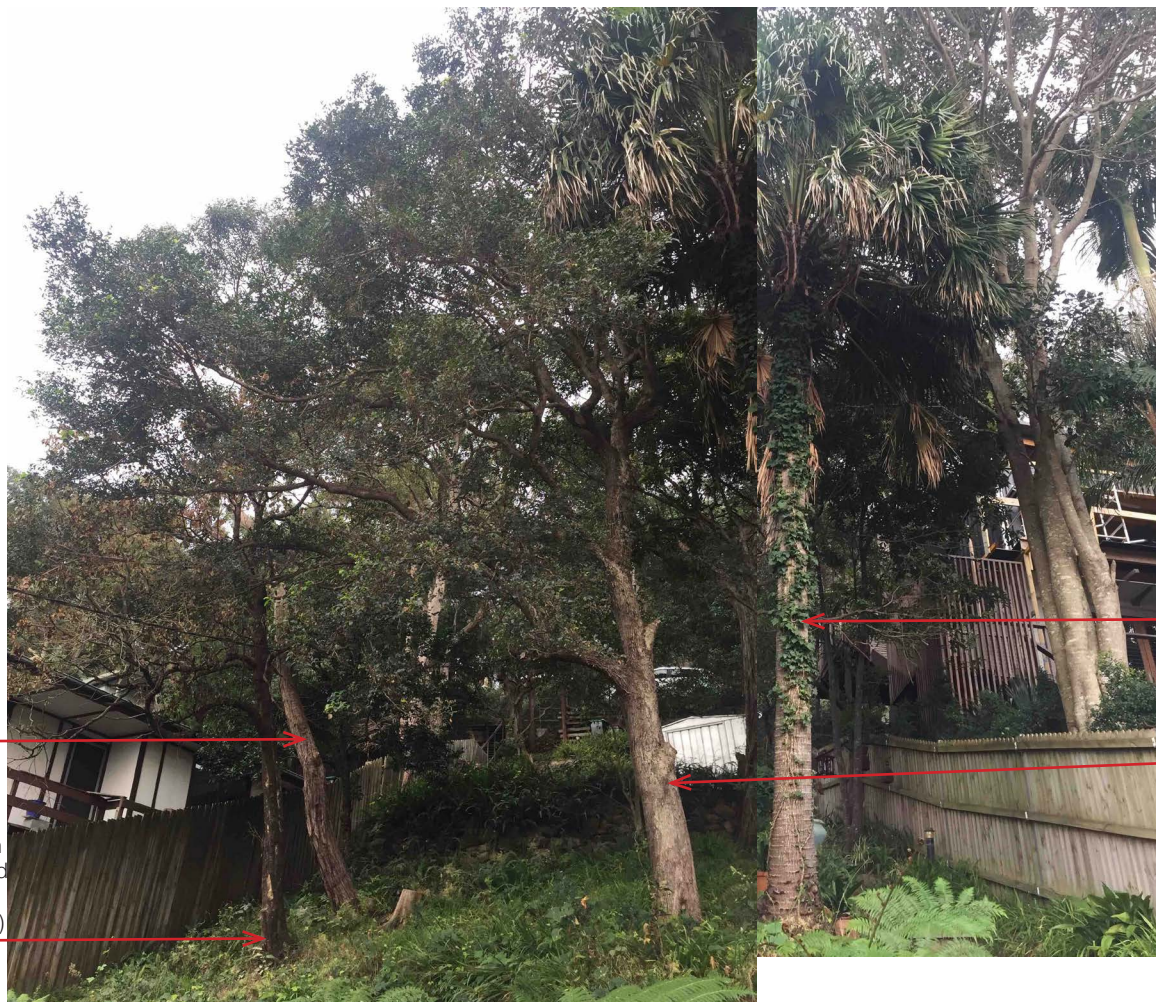
Tree No. 7
(Eucalypt)

Dead
Pittosporum
(not included
in this
assessment)

Tree No. 9
(Cabbage
Tree Palm)

Tree No. 8
(Lilly Pilly)

Figure 7: Viewing north from the front of the existing dwelling at the trees located within the front building setback. Note, two photos joined together above.

- 4.4 The proposed studio timber deck and steps are located in the TPZ of Tree No. 5 (Sandpaper Fig), No. 6 (Crow's Ash) and No. 7 (Eucalypt), representing a numerical encroachment between 10-14%. On the basis that the timber deck and steps shall be a light weight structure supported on post footings, and existing levels in the TPZ remain unchanged, the proposed works should not result in any long term impact upon the trees.
