Arboricultural Impact Assessment Revision A

Client Name: SRM Builders

Site Address: 27 Gulliver Street, Brookvale NSW

Date prepared: 31st March 2022 Revision A: 15th August 2022

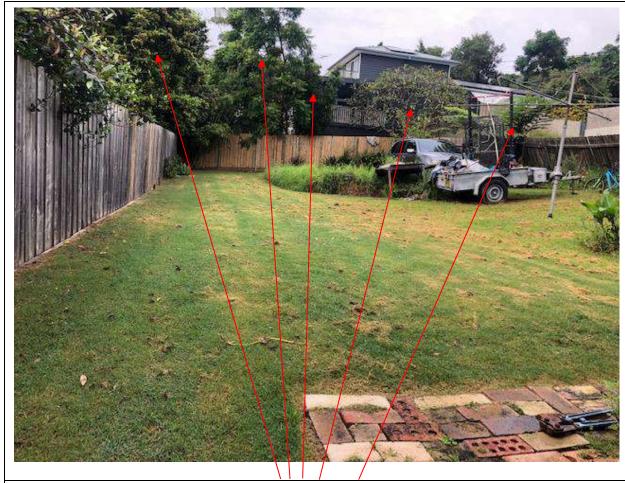
Photo B: Looking to the rear of the site and trees 7,8,10,11 and 12.
