# **Arboricultural Impact Assessment Report**

Site Address: Lot 8, 18 Alexander Avenue, Collaroy NSW

**Phone:** 0426 836 701 **Date Prepared:** 9<sup>th</sup> March 2020

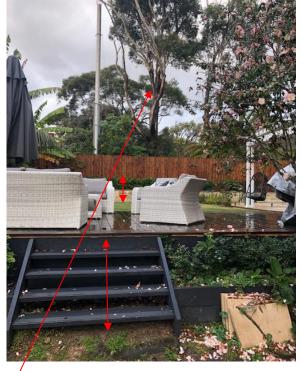
Photo E: Rear of site, existing level changes and tree
