ARBORICULTURAL IMPACT ASSESSMENT
&
TREE PROTECTION SPECIFICATION

REF: L&Co22032 | 07 April 2023 | v3
SITE ADDRESS | 113 Orchard Street, Warriewood
PREPARED FOR | Tony McLain
PREPARED BY |

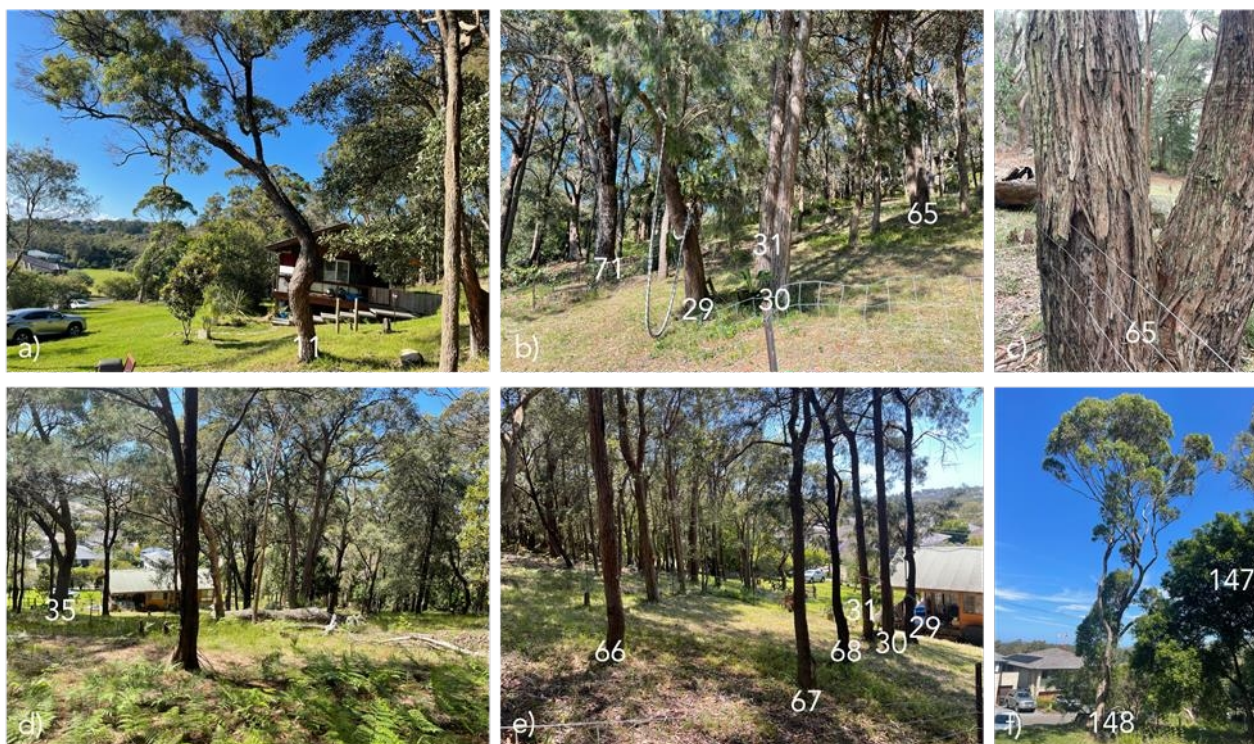
14.0 APPENDIX 9 | PLATES

a) Showing Tree 11. b) Showing Trees 29, 30, 31, 65 & 71. c) Showing Tree 65 in conflict with fencing. d) Showing Tree 35. e) Showing Trees 29, 30, 31, 66, 67 & 68. f) Showing Trees 147 & 148.
