**Proposed Mixed-use Development
4 Delmar Parade & 812 Pittwater Road, Dee Why
NSW**

Geotechnical Investigation

Our ref: 6561-G1
25 November 2021

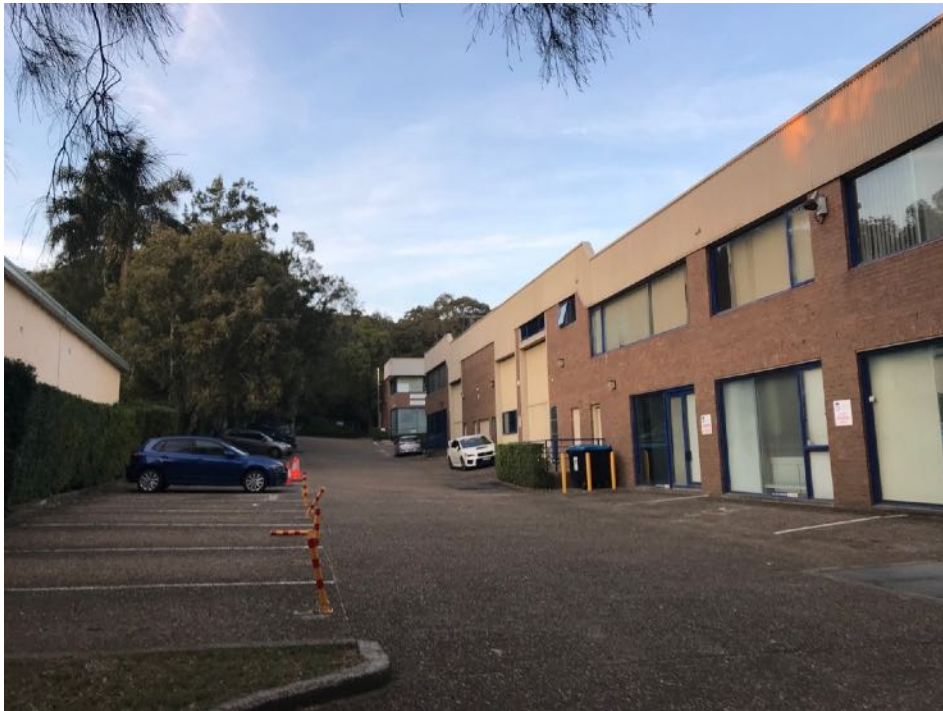
Photo 1
View of eastern part
of site looking south.

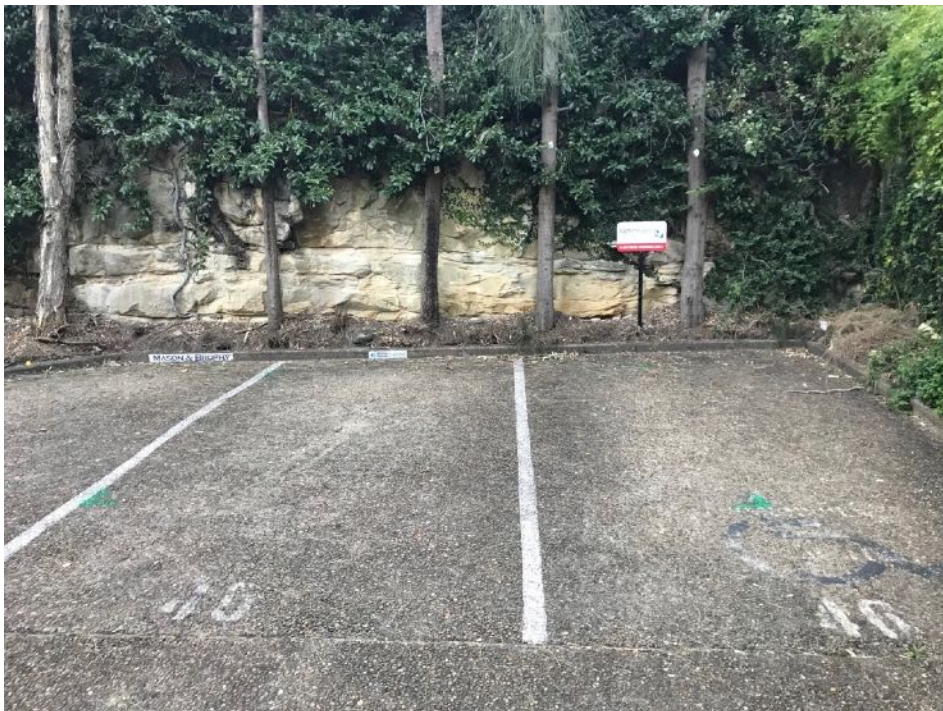
Vegetation is limited to isolated garden beds within the commercial development. Sandstone rock outcrop was observed in the south-eastern part of the site.

Photo 2
View of rock outcrop
in south-eastern part
of site, looking east.

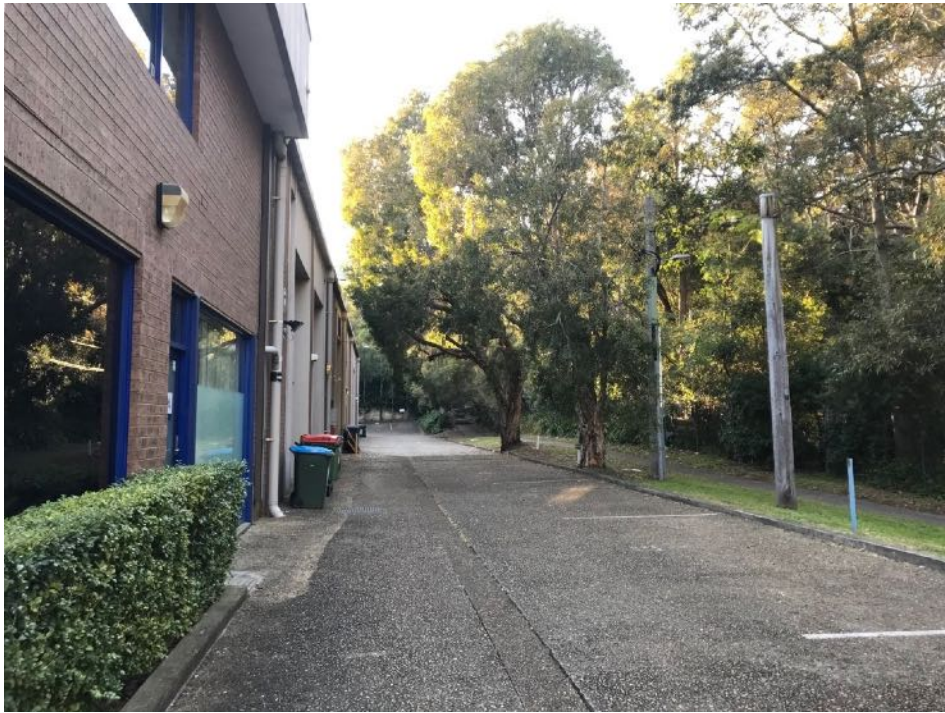
Photo 3
View of southern part
of site looking east.

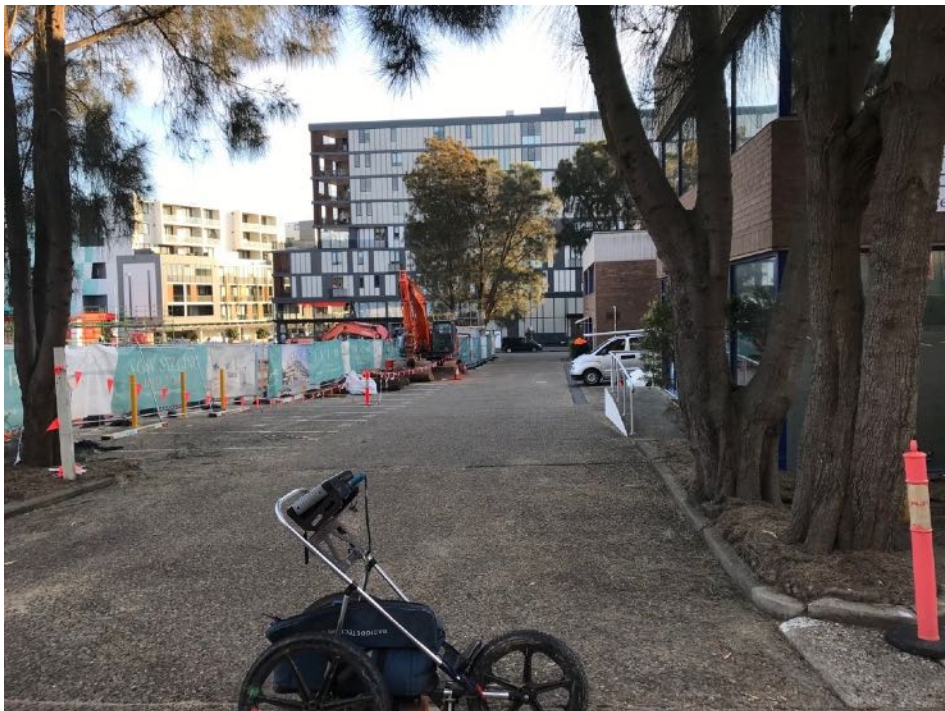
Photo 4
View of western part
of site adjacent to
development at 2
Delmar Parade
looking north

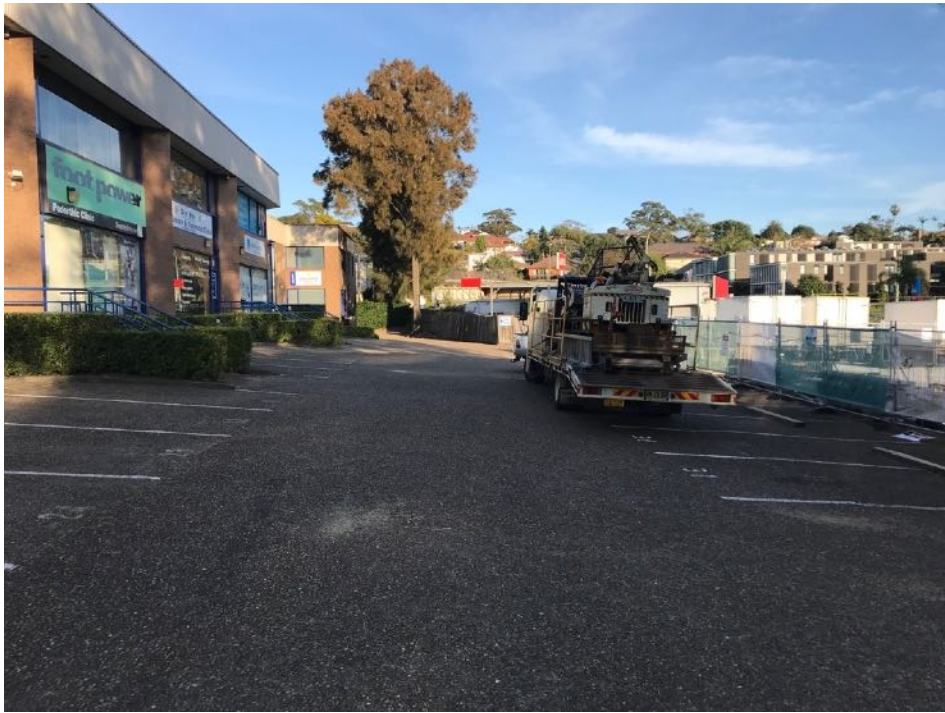
Photo 5

View of western part
of site south of
adjacent
development at 2
Delmar Parade
looking west
