J5980. 8th April, 2025. Page 1.

GEOTECHNICAL INVESTIGATION:

New houses and pool at 2 Bardoo Avenue, North Balgowlah

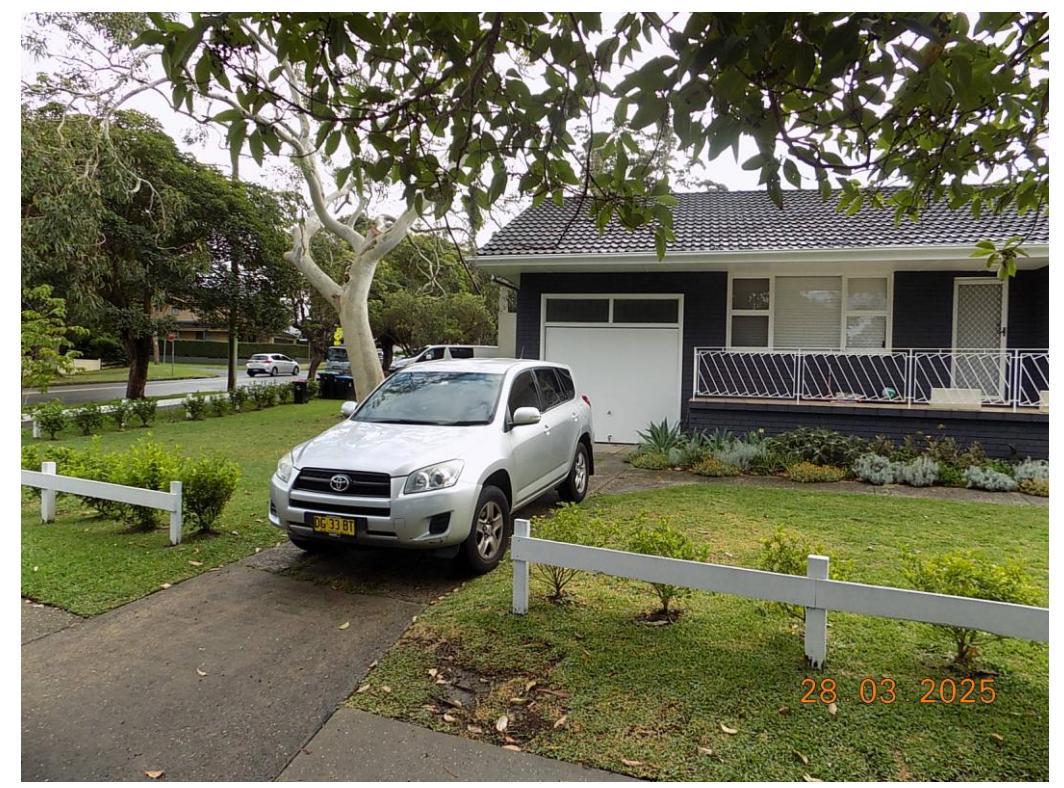
Photo 1

2.3 At the Woodbine Street frontage, a concrete driveway runs to a garage on the ground floor of the house (Photo 1). The single-story house is supported on brick walls. Stepped cracking of up to 3mm width was observed in the E, S and W supporting walls

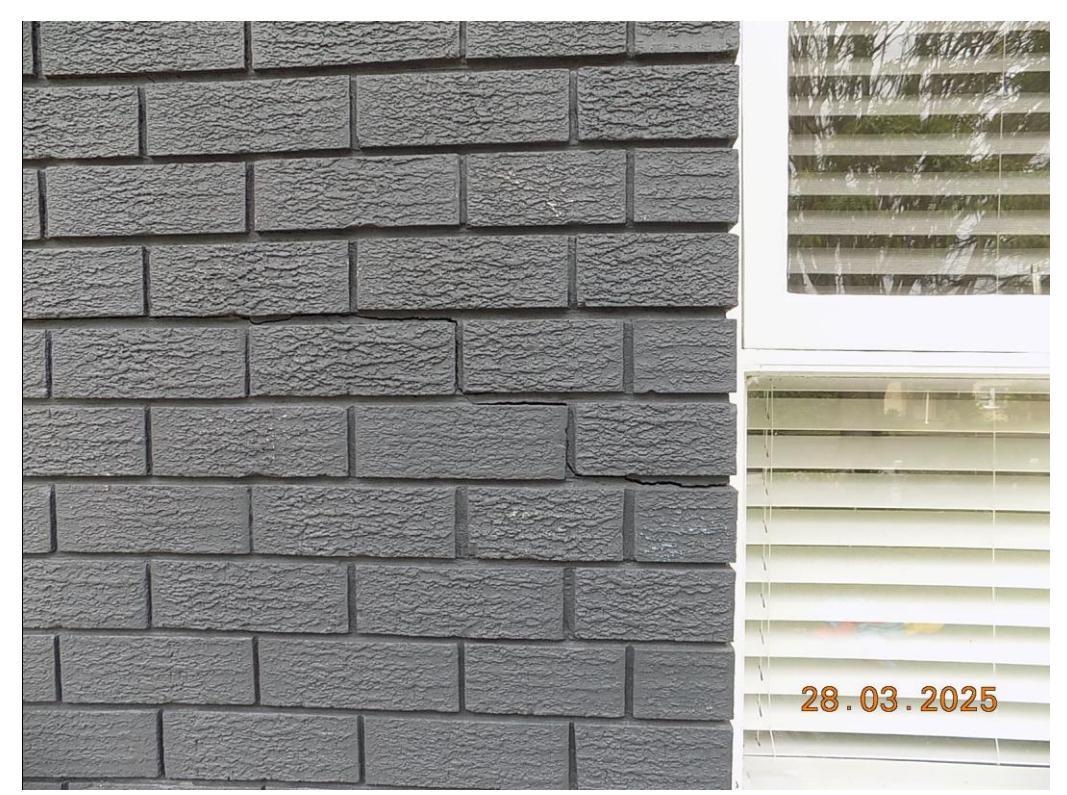
Photo 2

of the house (Photo 2). This cracking appears related to minor movement due to differential settlement and possibly rusting lintels across the window openings. The house will be demolished as part of the proposed works. The land surface surrounding the house is lawn covered. A stable shed in the NE corner of the property is supported on a concrete slab which shows no signs of movement (Photo 3). The shed will be demolished for the proposed pool.

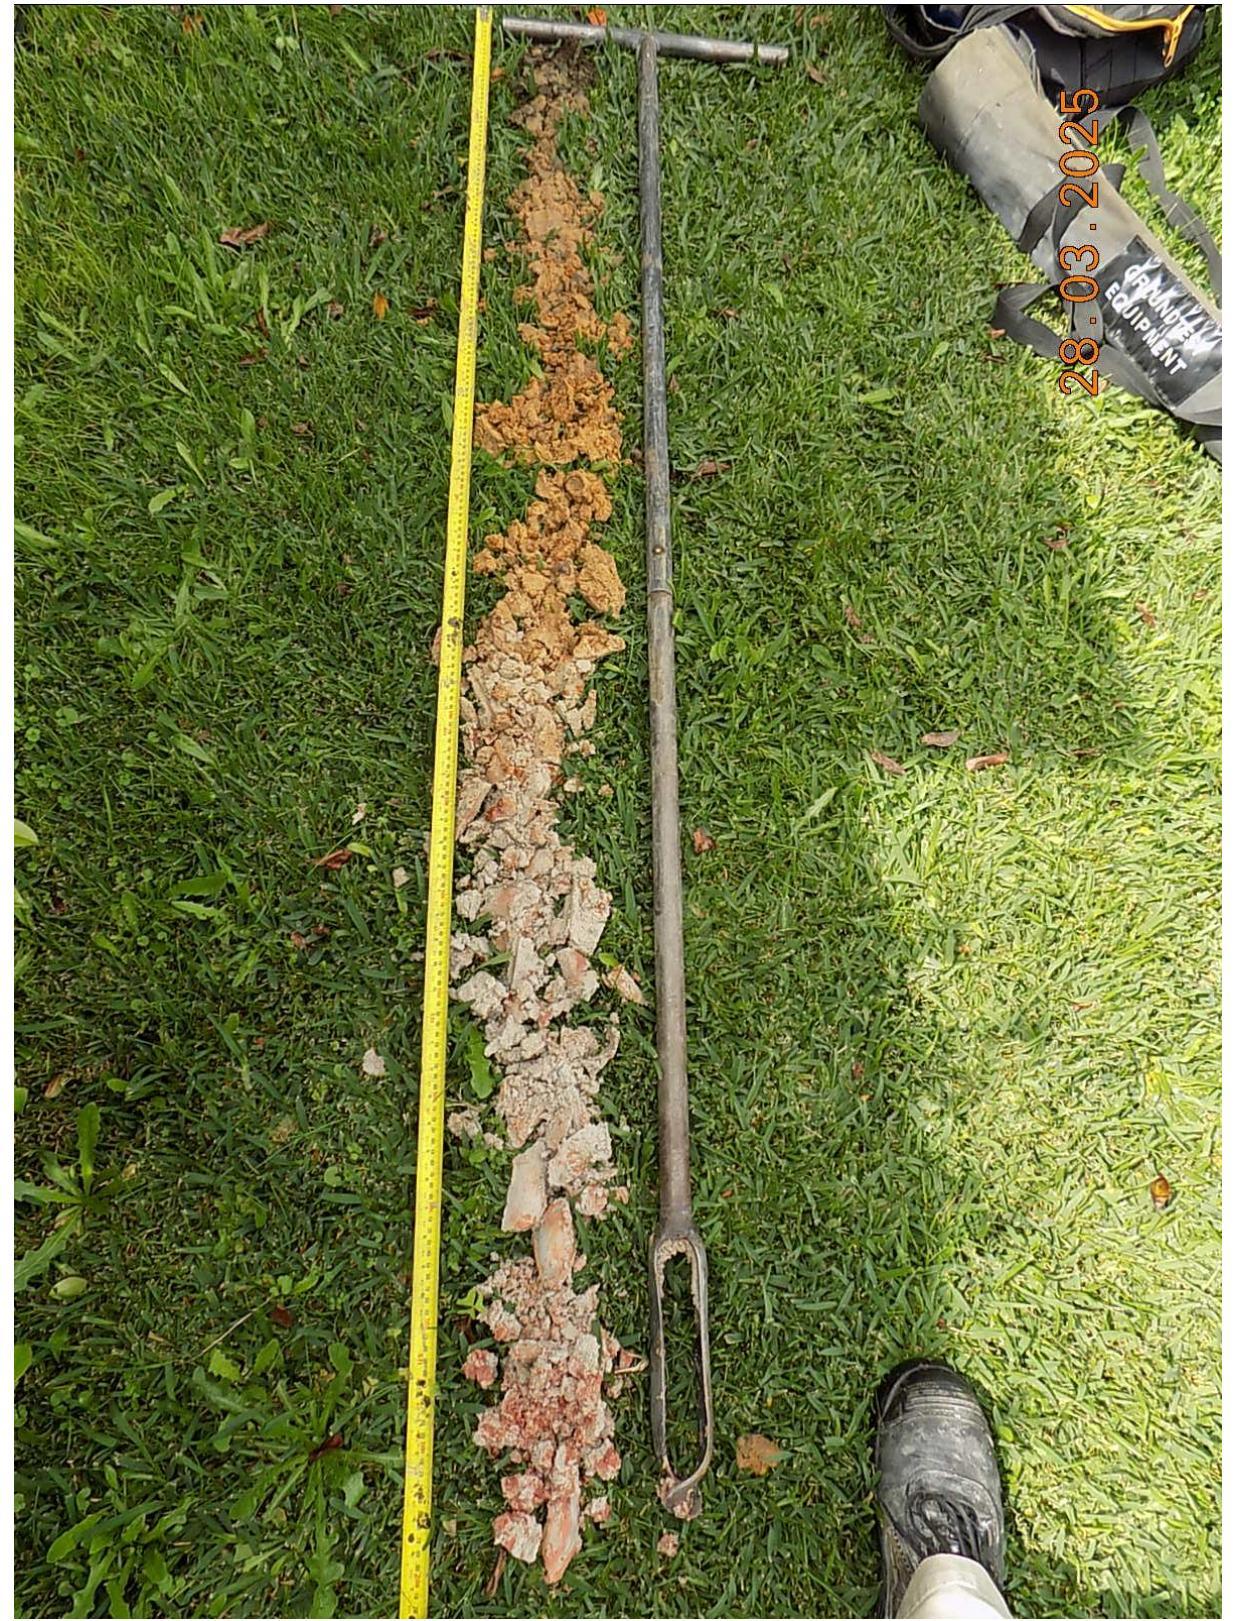
AUGER HOLE 1 (~RL85.5) - AH1 (Photo 4)

Depth (m)	Material Encountered
0.0 to 0.2	TOPSOIL , sandy clayey soil, brown, Very Soft damp, fine to medium grained.
0.2 to 1.7	RESIDUAL CLAY , derived from weathered sandstone, orange and grey to pink, Soft to Firm, damp, fine to coarse, bright orange rock fragments included.
1.7 to 2.0	VERY LOW STRENGTH ROCK , grey to pink, Firm to Hard, damp, fine to coarse.

Photo 4 – downhole is top to bottom
