J4211. 29<sup>th</sup> April, 2022. Page 1.

# PRELIMINARY GEOTECHNICAL ASSESSMENT:

# 3 Orlando Road, Cromer

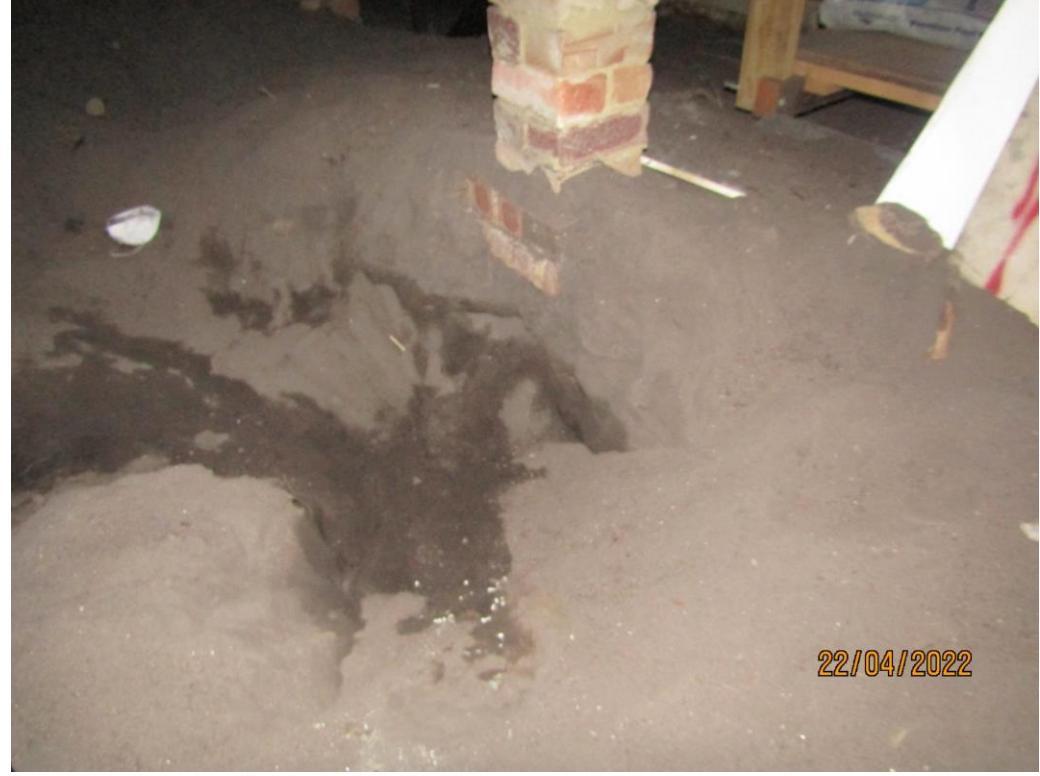
Photo 1

The natural slope rises across the property at an average angle of ~7°. At the road frontage, a concrete driveway runs up the slope to a garage attached to the house. Minor filling provides a level platform for a lawn and garden area between the road frontage and the house. The single storey brick and timber clad house with garage below is supported by brick walls and brick piers. One of the supporting piers is slightly undercut (Photo 1). One of the supporting walls displays stepped cracking through the mortar (Photo 2). The sandy soil in the foundation space displayed significant moisture at the time of inspection. See **'Section 5.0** Recommendations' regarding the undercut pier and cracked wall.

It is interpreted that water seepage in the foundation space has formed a hole in the sandy soil under the undercut pier (Photo 1) and has caused settlement of the cracked brick wall (Photo 2). Drainage measures could be installed on the N and E sides of the house to reduce water seepage in the foundation space. We can provide drainage advice upon request.

It is recommended the undercut pier (Photo 1) be underpinned to 400mm below the base of the hole/washed out soil area or to the top of Medium Strength Rock, whichever comes first.
