67 Marine Parade, Avalon

Comments on Updates to Plans

GEOTECHNICAL INVESTIGATION:

Alterations and Additions at 67 Marine Parade, Avalon

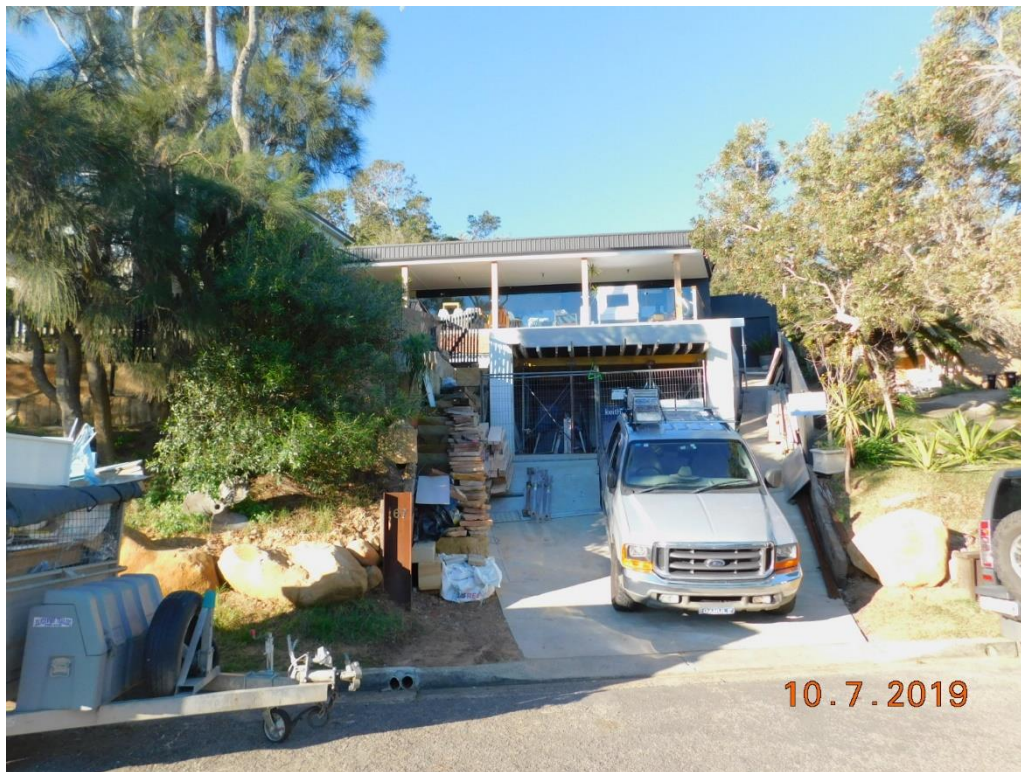
Photo 1

- 2.3** At the road frontage, a concrete driveway runs up the slope to a garage on the downhill side of the house (Photo 1). A dimensioned sandstone block wall up to 2.5m high runs E-W and retains a cut for the driveway (Photo 2). A shallow fill has been added for a lawn area above the cut and is supported by a ~0.6m dimensioned sandstone block wall on its downhill side (Photo 3). Both walls appear well-constructed. The single-storey brick and clad house is supported on brick walls and brick piers (Photo 4). No significant signs of movement were observed in its supporting brick walls or brick piers. A cut has been made into the slope on the uphill side of the

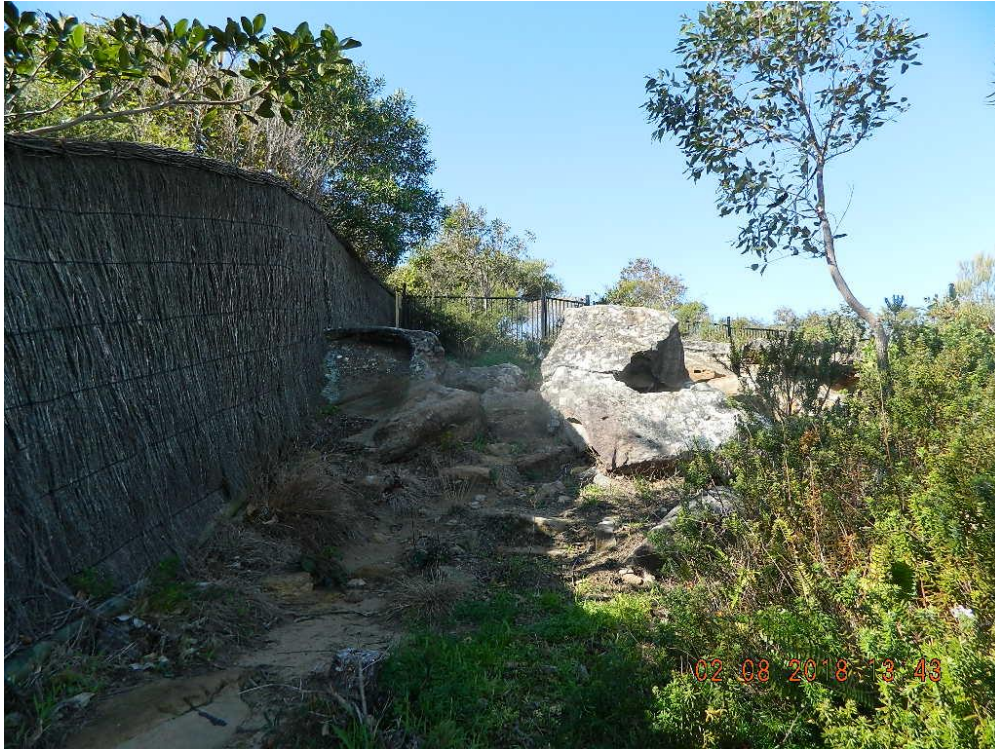
Photo 7

Sandstone bedrock outcrops at the sea cliff face to the E of the property and is visible outcropping down the slope to the house (Photo 7). This is an unusually thick sandstone bed

within the Narrabeen Group of rocks. The rock is overlain by natural sandy soils and sandy clays. In the test locations, rock was encountered at depths of between 0.3 to 3.3m due to the presence of fill (DCP1), but more so the variable and stepped nature of the rock. The bedrock underlying the area of the proposed development is expected to be variably ranging from very low strength to medium strength. See Type Section attached for a diagrammatical representation of the expected ground materials.

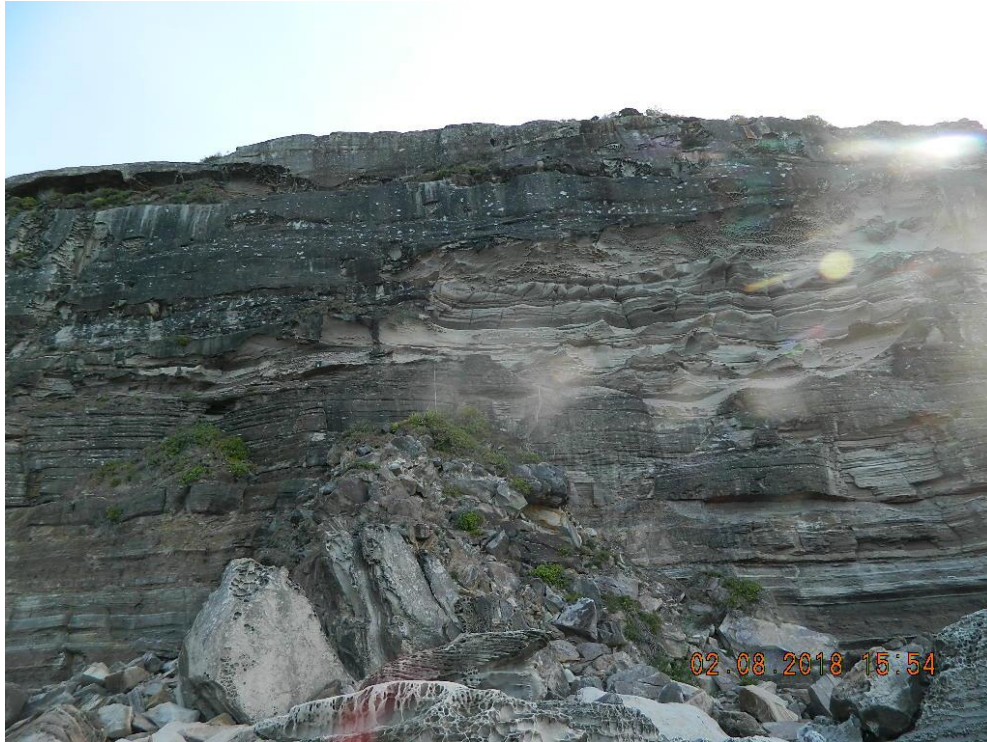
Photo 10

The vertical sea cliff on the upper boundary of the property falls from elevations of ~RL51.0 to ~RL5.0 to a rock platform below (Photos 10). The rock platform extends ~45m to the ocean line and has a covering of dislodged joint blocks. The proposed extension will be at a horizontal distance of ~27m from the base of the sea cliff. The lowest elevation of the piers for the proposed extension is expected to be ~RL38.0 so are some 33m above the base of the cliff.

Considering the large width of the rock platform, the large volume of armouring sandstone rubble at the cliff base, and distance and elevation to the proposed works, the current accepted predicted sea level rise for the next century is not expected to lead to significant undercutting that could impact the proposed works.
