Arboricultural Impact Assessment Report

Site Address: 128A Elanora Road, Elanora Heights NSW

Report on trees at: 128A Elanora Road, Elanora Heights NSW

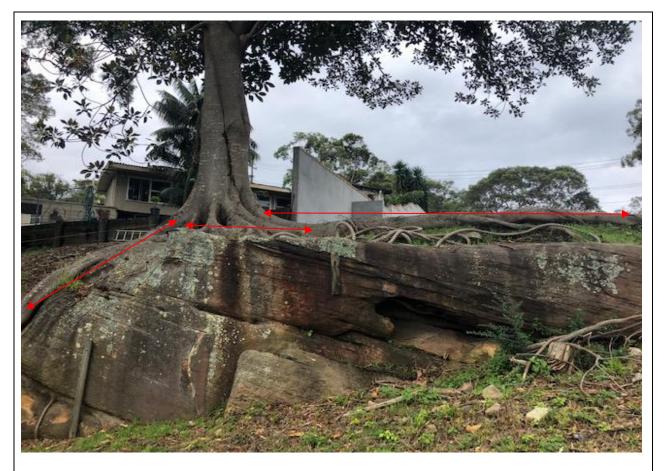
Photo a: Tree 1 with its orientation of roots clearly visible.

- 10.9 The proposed entry to the dwelling is recommended to be constructed to allow a sub-floor space capable of retaining the large diameter surface root below and provide a minimum 100 millimetres clearance. All works are to be carried out in consultation with the project Arborist.

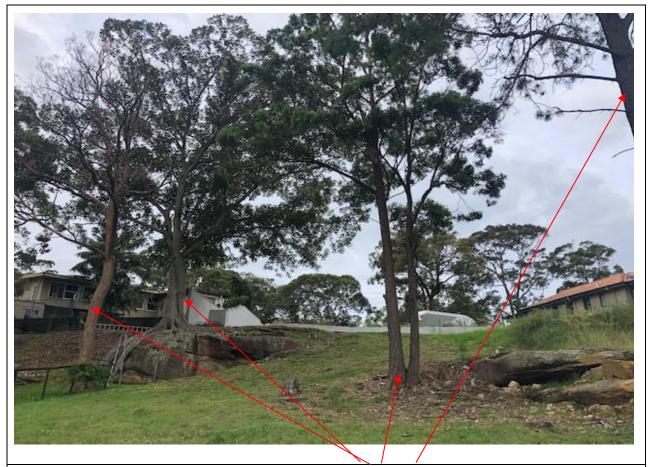
Photo b: Overview of the proposed development area and trees 1,2,3 and 4.

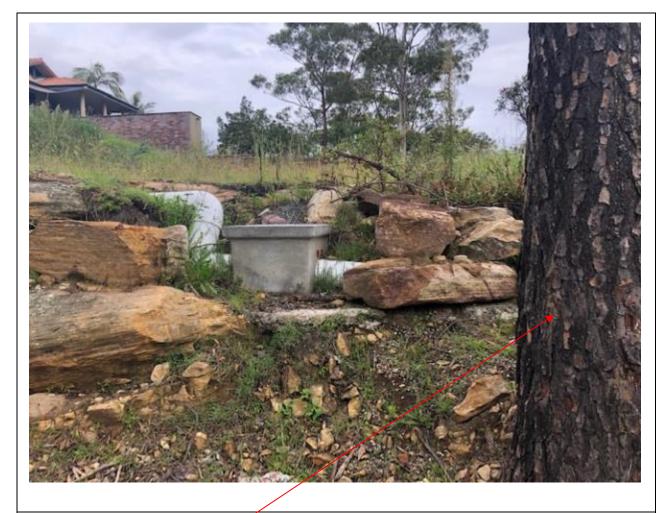
Photo f: Existing site disturbance and tree 4 trunk.
