## **Report on Geotechnical Investigation**

**Proposed Boat Shed**

**60 Hudson Parade, Clareville, NSW**

**Project 215034.01**

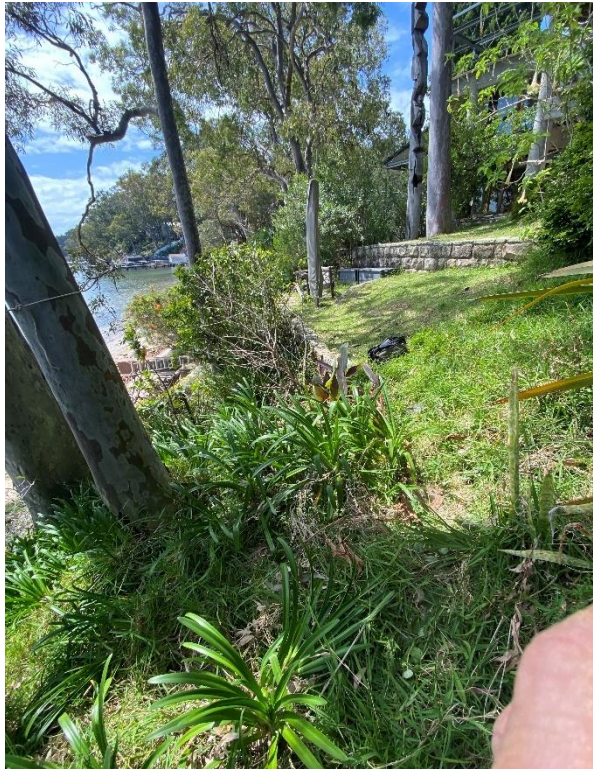
- The area surrounding the house has been terraced in areas with a series of small, stacked rock retaining walls (see Photos 1-7). Some of the walls are slightly tilting and bulging (see Photos 1 and 4). The movement appears to be due to the wall construction rather than slope instability;
- Some large sandstone boulders (or ‘floaters’) were observed on the property, probably fallen from cliffs upslope thousands of years previously;
- Medium to high strength, fine grained sandstone bedrock was exposed along the Pittwater foreshore (see Photos 2, 3, and 6); and
- No leaning trees or evidence of creep movement were observed.

Photo 1: view of the site, looking north-east

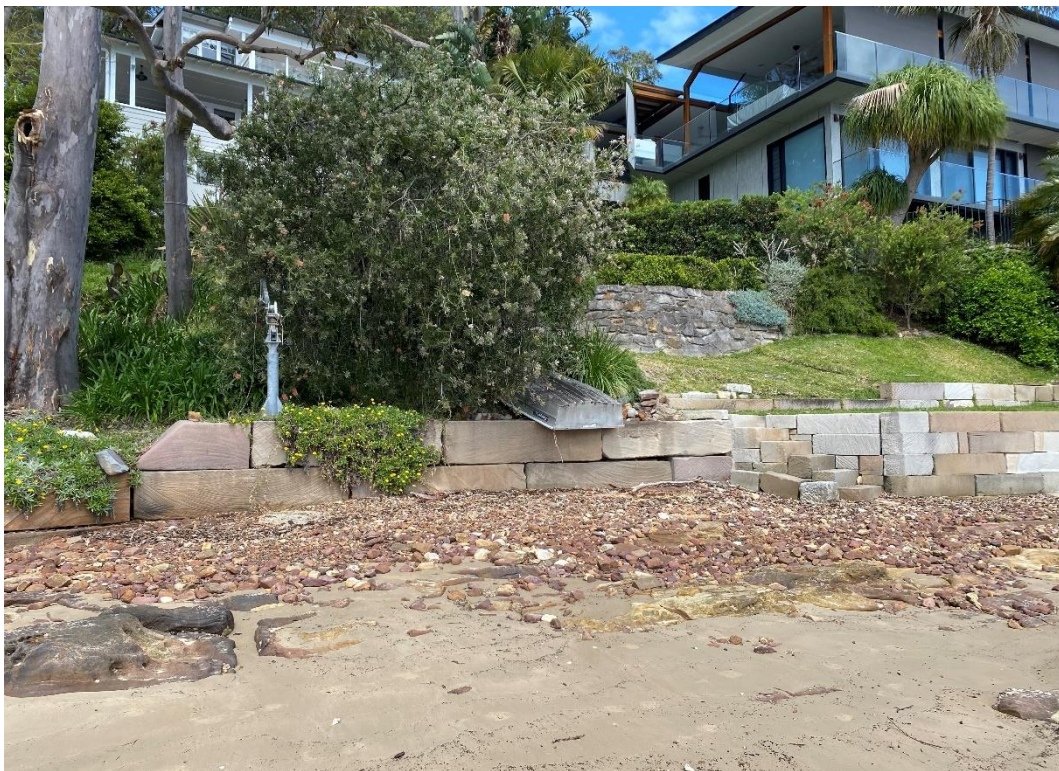
Photo 2: View of the site from the Pittwater foreshore, looking south-east

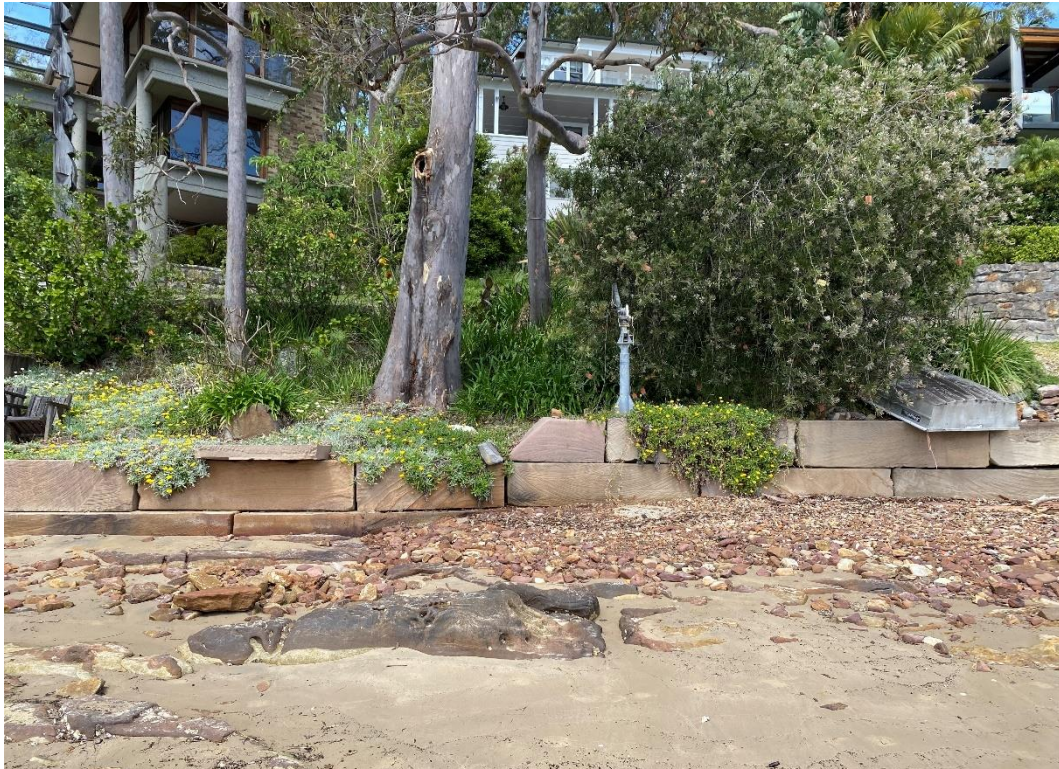
Photo 3: View of the site from the Pittwater foreshore, looking south-east

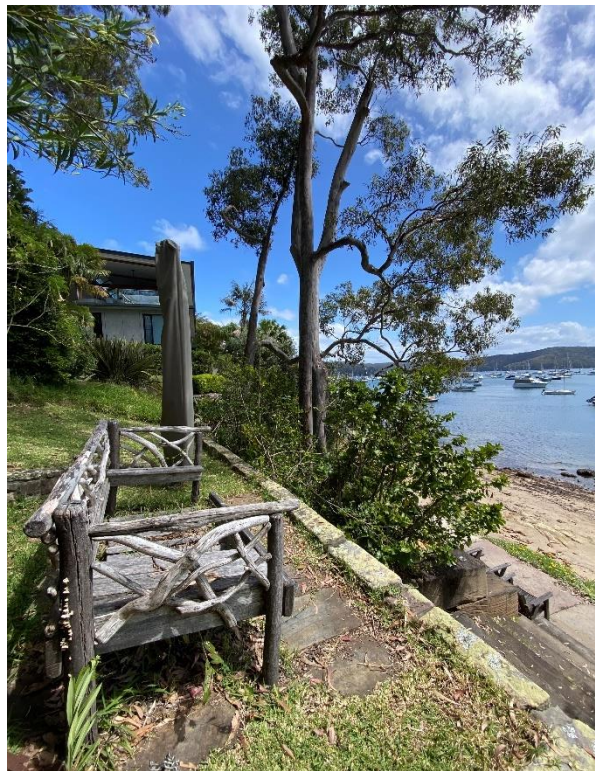
Photo 4: View of existing retaining walls, looking south-west

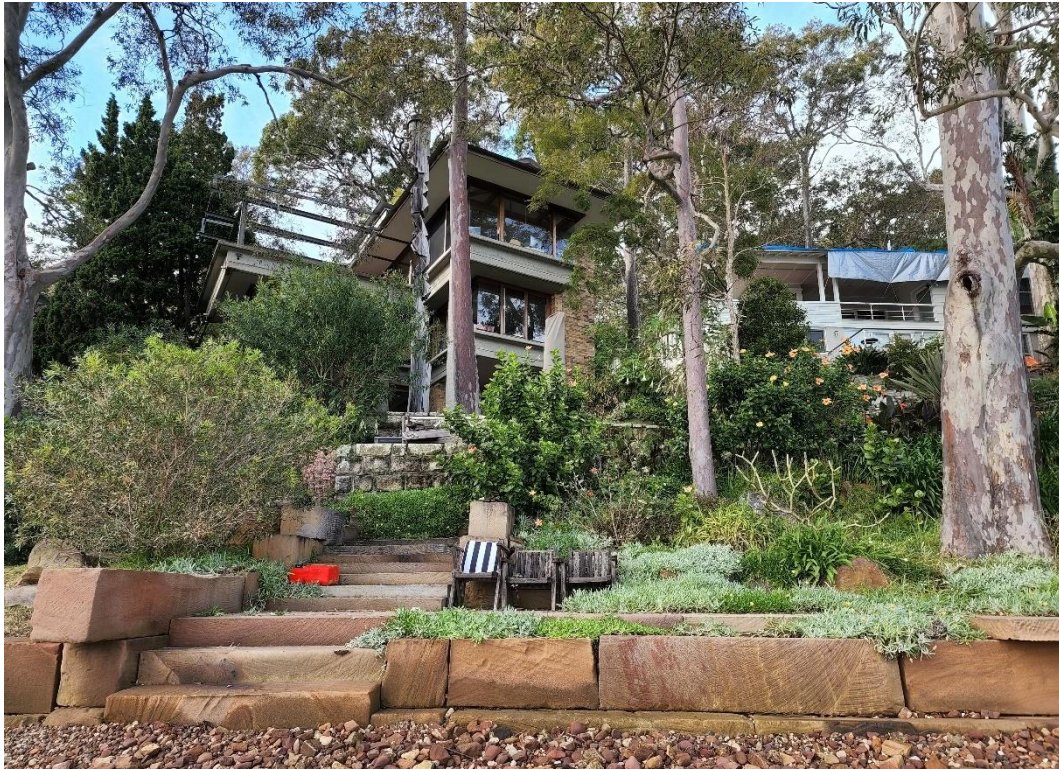
Photo 5: View of the site from the Pittwater foreshore, looking east

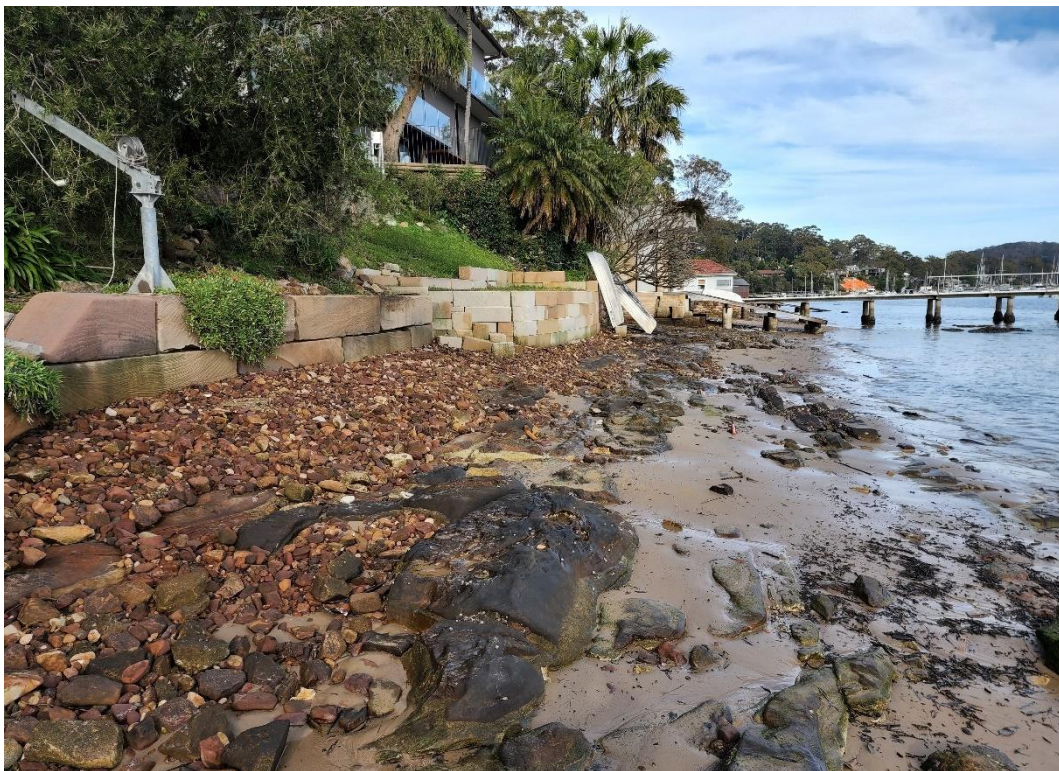
Photo 6: View of the Pittwater foreshore, looking south
