2 December 2021

RE: FURTHER INSPECTION OF CREEK, 255 CONDAMINE STREET, BALGOWLAH, NSW

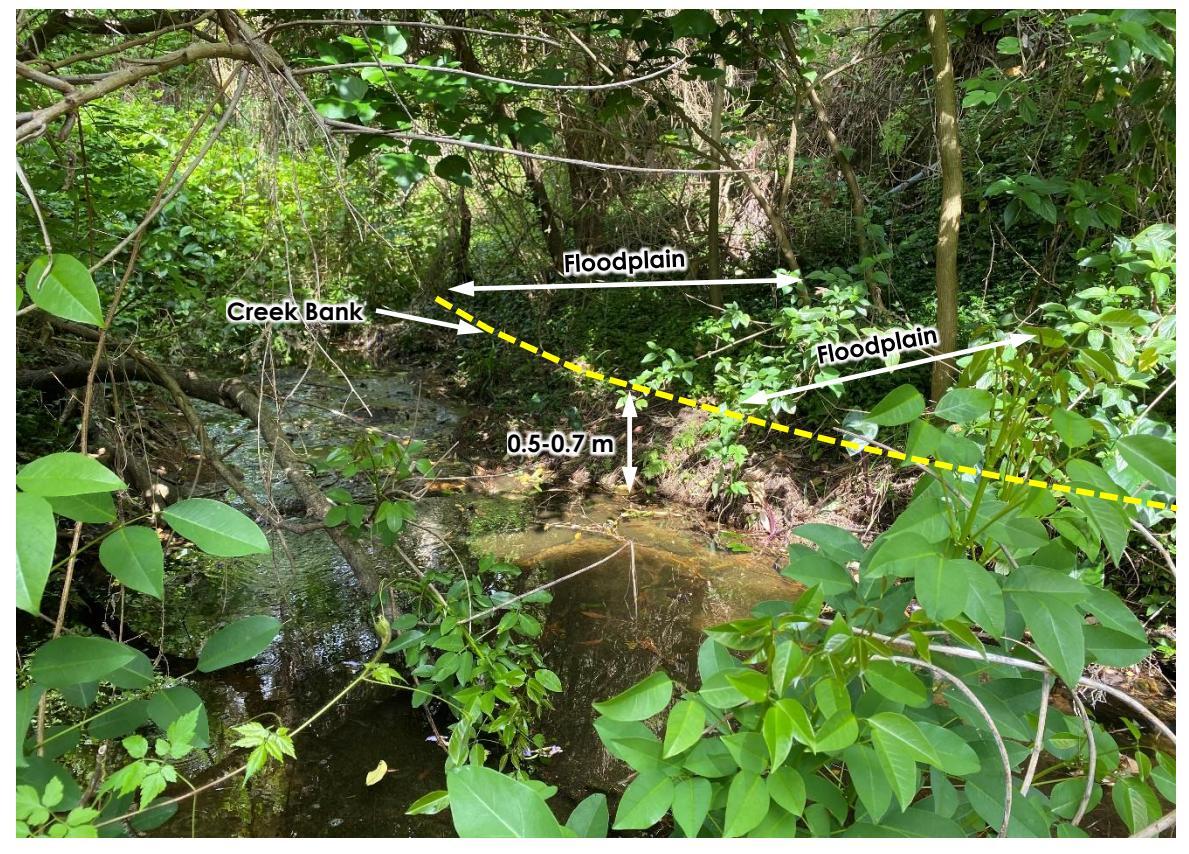
- 1. Creek bank: The creek bank is approximately 0.5 0.7 m above the permanent water line. The bank is expressed as a clear break in slope between the near vertical slope to the water's edge and the flat grade of the adjoining floodplain. The creek bank was comprised of largely sandy materials held together with plant roots and some clay content.
- 2. Floodplain: There is a distinctly developed floodplain behind the creek bank. This is variably expressed depending on location, being widest upslope of the site (where it reaches > 5 m width). The floodplain is characterised by sandy sediment which has been deposited by floods (refer to Figure 4). Floodplain vegetation to the west of the site is well established and consists largely of non-endemic species including trees, understorey and ground cover.

Figure 1: Northern creek bank and floodplain upstream of site looking west (17 November 2021).

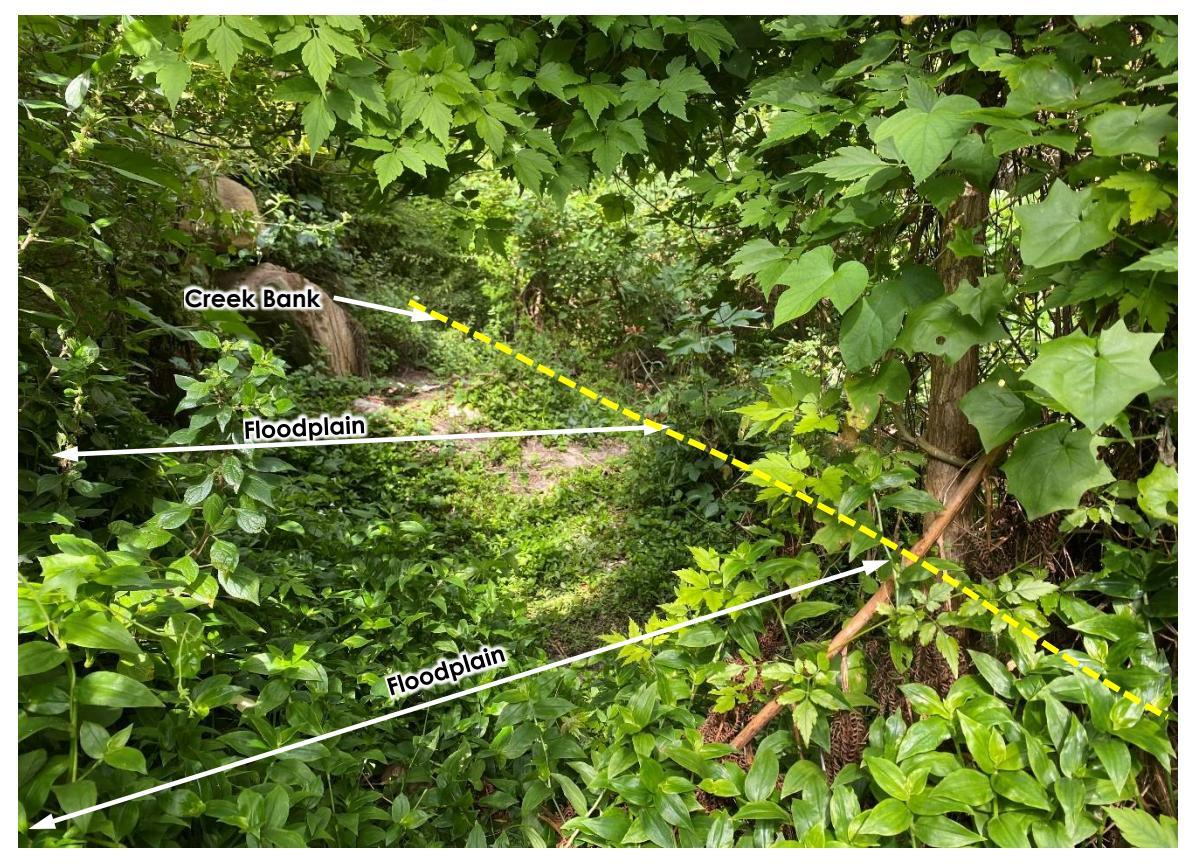
Figure 2: Southern creek bank and floodplain upstream of site looking west (17 November 2021).

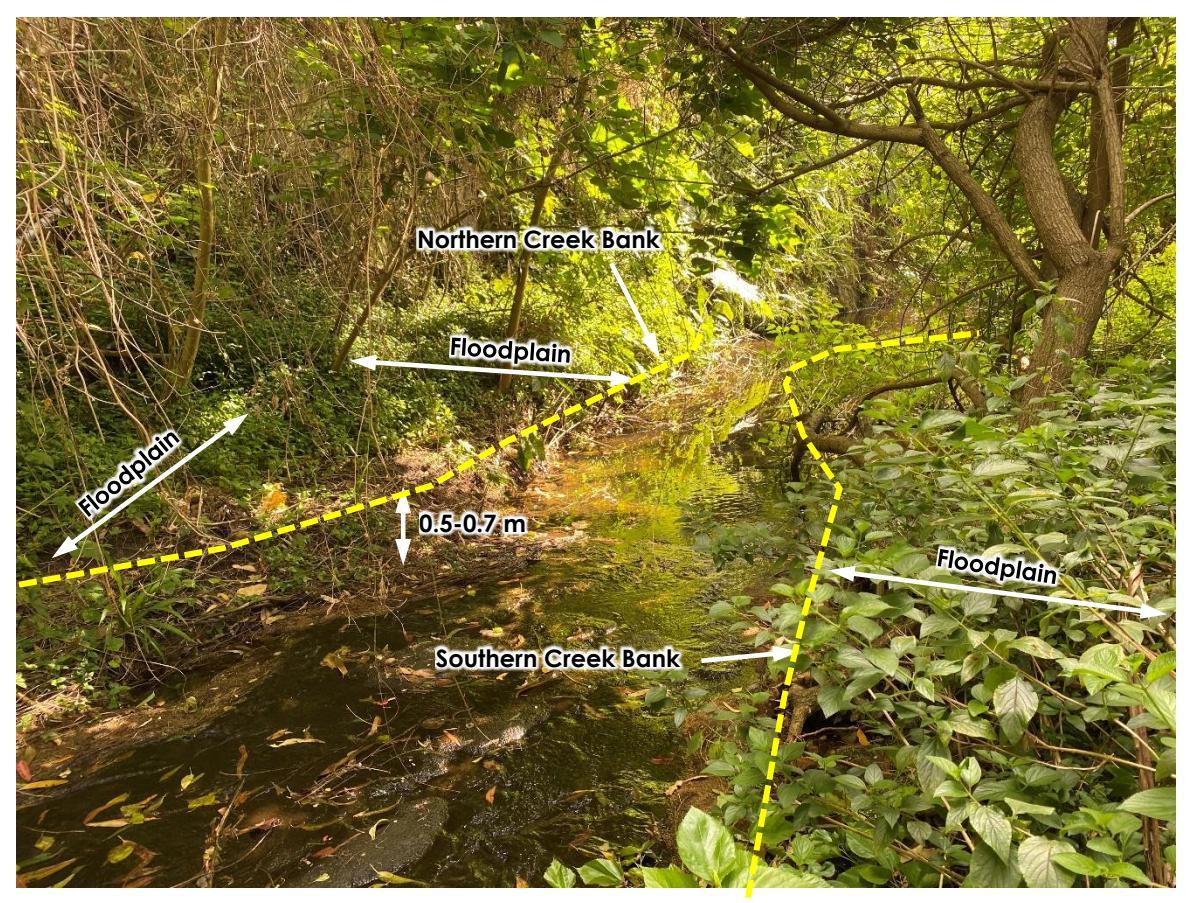
Figure 3: Creek banks and floodplain upstream of site looking east (17 November 2021).

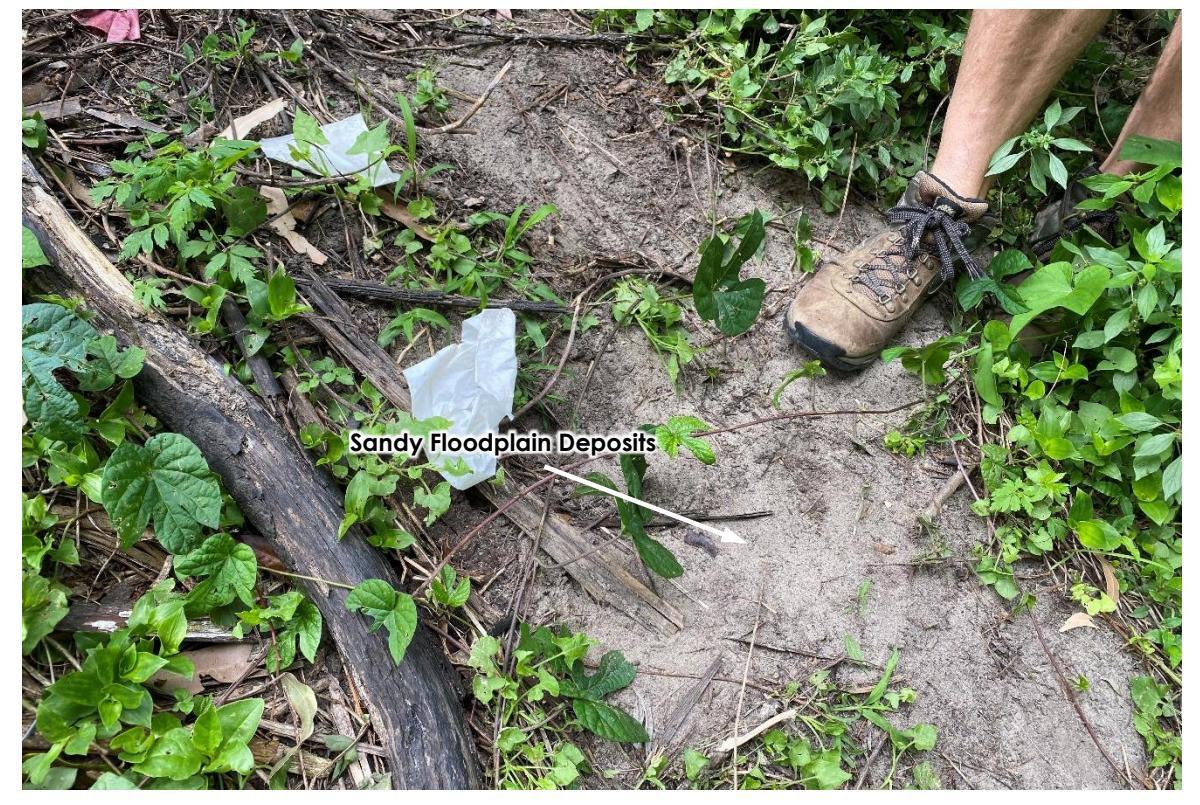
Figure 4: Sandy floodplain sediment on southern bank (17 November 2021).

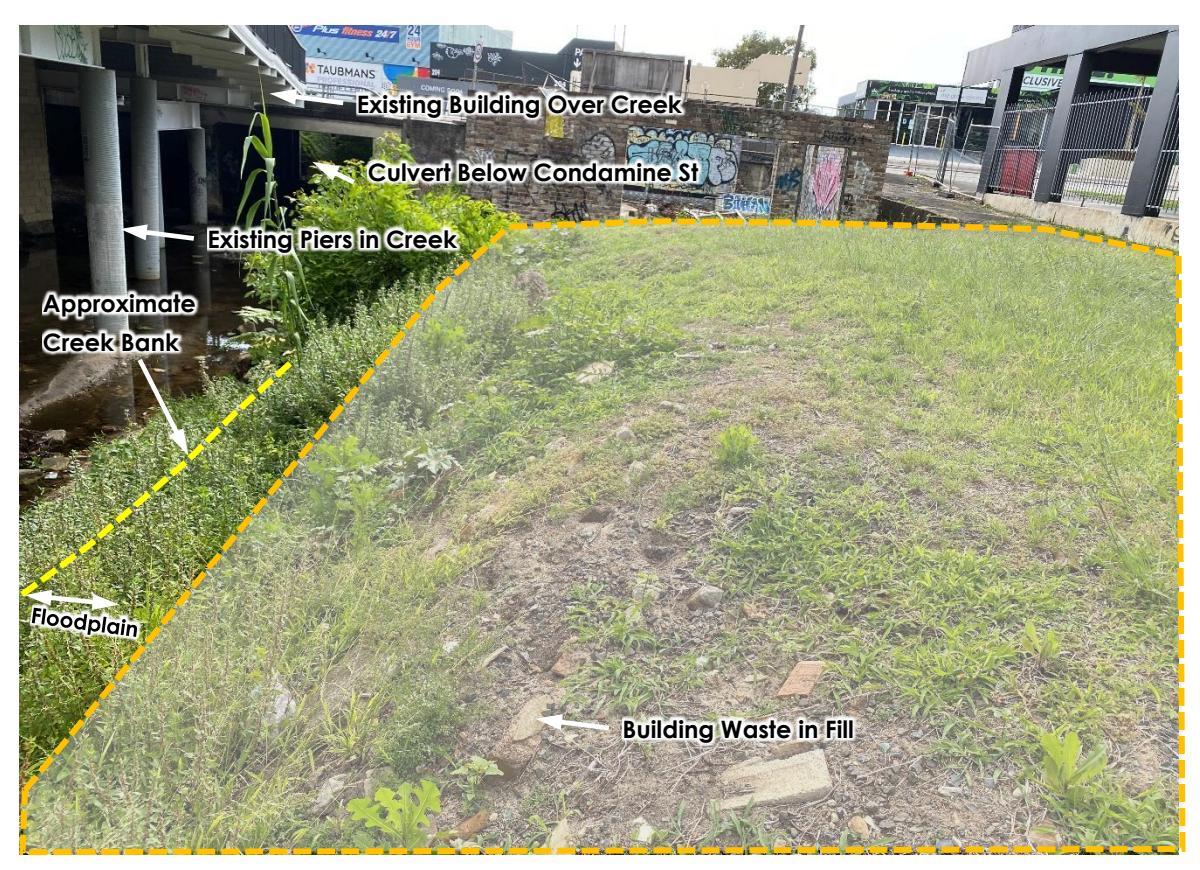
By contrast, the fill embankment within the site is entirely anthropogenic, containing a range of fill and waste materials (refer to Figure 5 and Figure 6), likely having been placed near to the time that the existing derelict building was constructed.

Figure 5: Fill embankment behind creek bank within site looking east (17 November 2021).

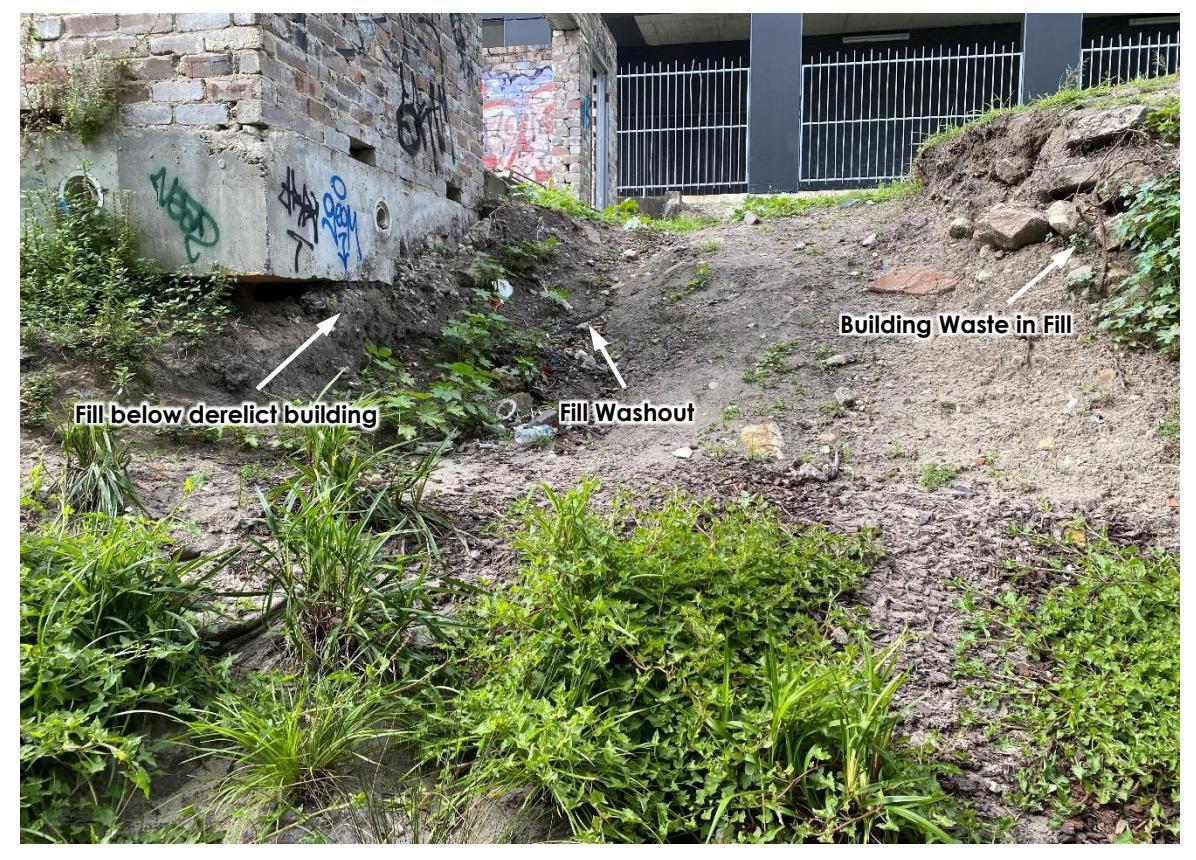
During the 17/11/2021 inspection I observed that the bank had continued to fail, with evidence of several recent slope failures. These have led over time to portions of the anthropogenic fill being transported to the creek bank below and into the creek (refer to Figure 6 and Figure 7). Implementation of the recommendations contained within our Waterway Assessment Report will provide the means of stabilising the southern creek bank.

Figure 6: Fill embankment adjacent to derelict building within site (17 November 2021).

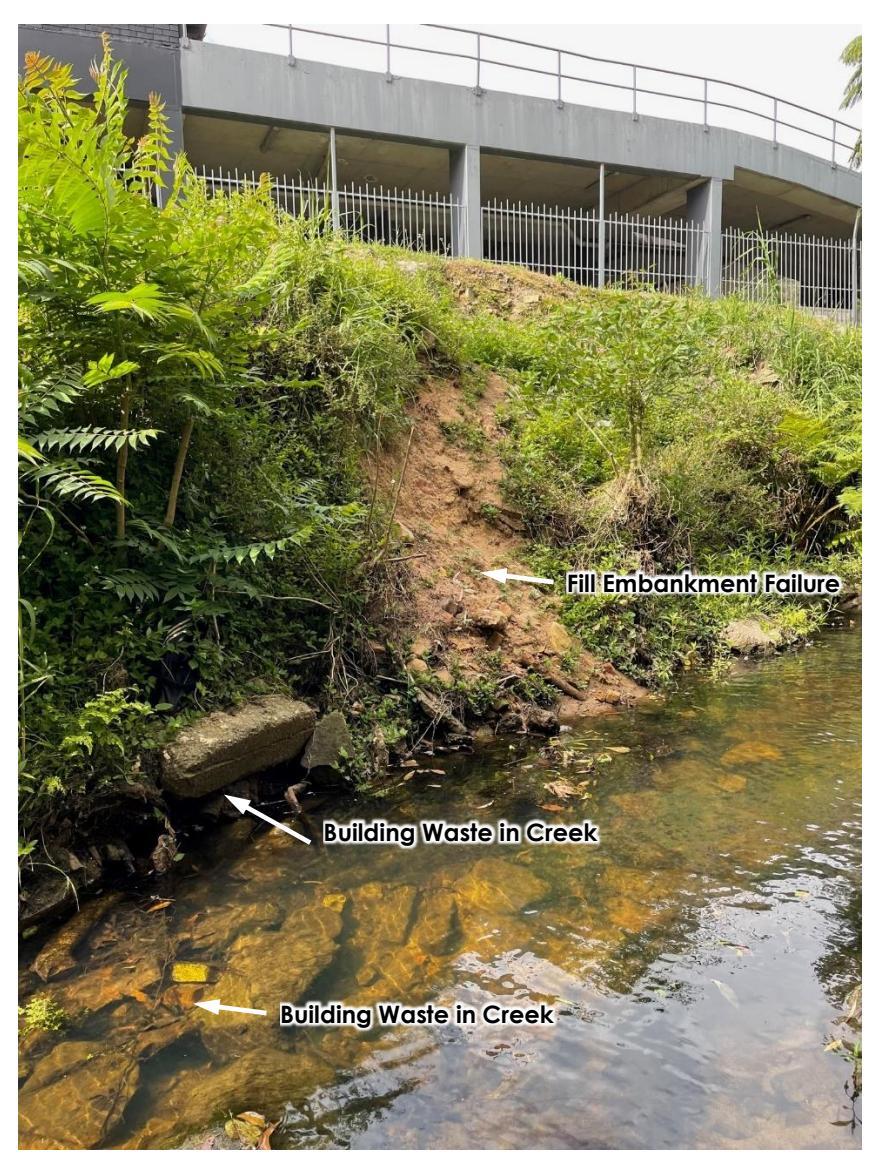
Figure 7: Fill embankment failure and waste in creek within site (17 November 2021).

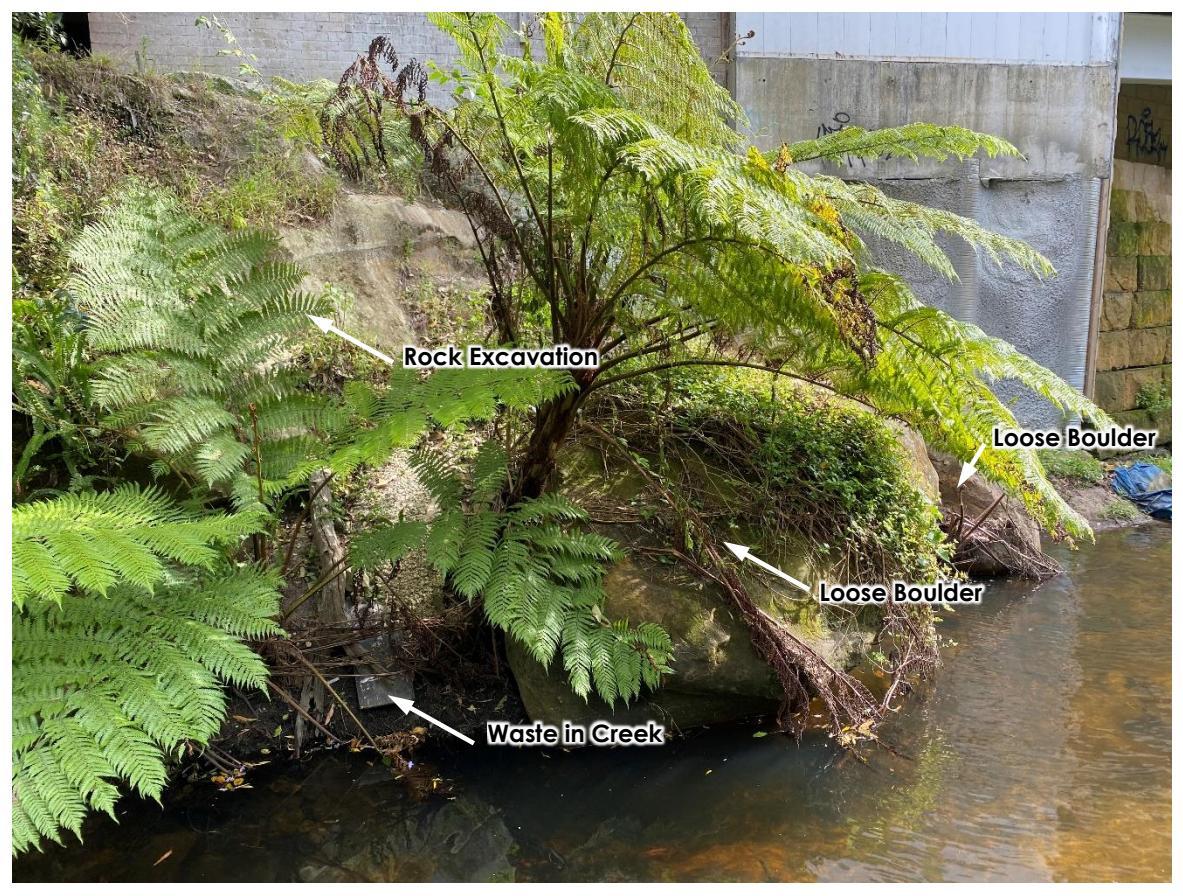
- 1. The bank is not a natural bank but rather has been constructed by soil and rock excavation.
- 2. The bank is impacted by anthropogenic filling, including concrete over pours (refer to Figure 8).
- 3. The bank is unstable with evidence of recent bank instability (refer to Figure 9 and Figure 10). In particular, there has been a boulder slide with movement of two large boulders into the creek, likely caused by erosion of unconsolidated material below and around the boulders. These materials are likely to continue to move into the creek and obstruct flow in coming high flow / flood events, this leading to further bank erosion. Bank stabilisation and reconstruction is recommended.

Figure 8: Northern Creek bank and embankment within site (17 November 2021).

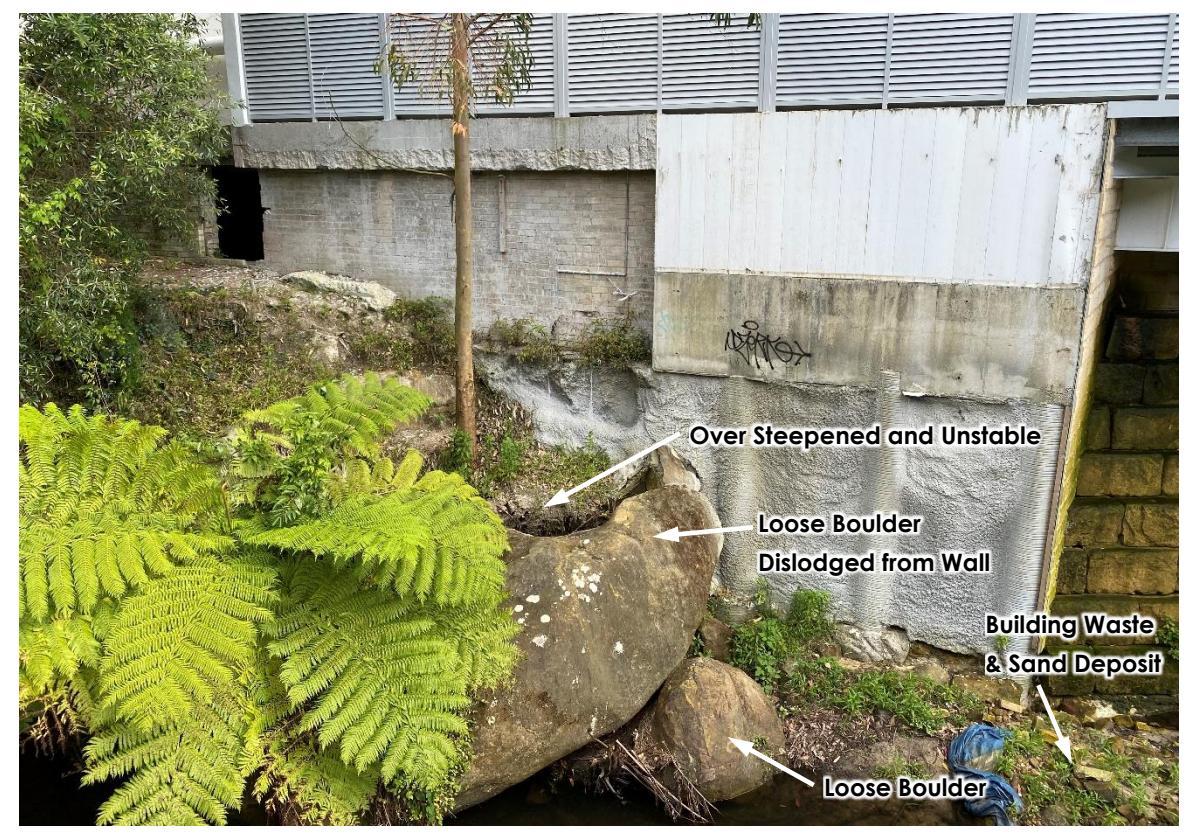
Figure 9: Northern Creek bank and embankment within site (17 November 2021).

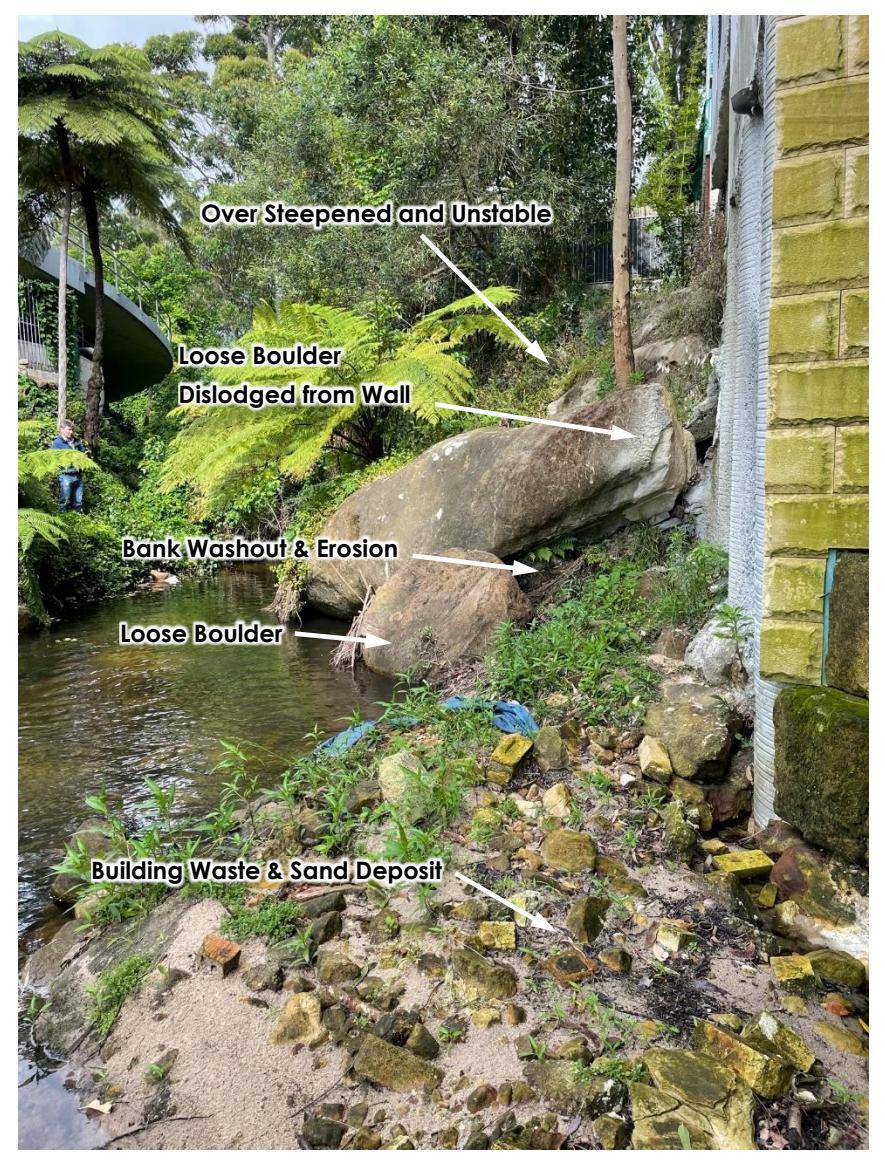
Figure 10: Northern Creek bank and embankment showing bank failure (17 November 2021).
