Arboricultural Impact Assessment and Management Plan

189 Riverview Road, Avalon Beach.

Dated: **November, 2021.**

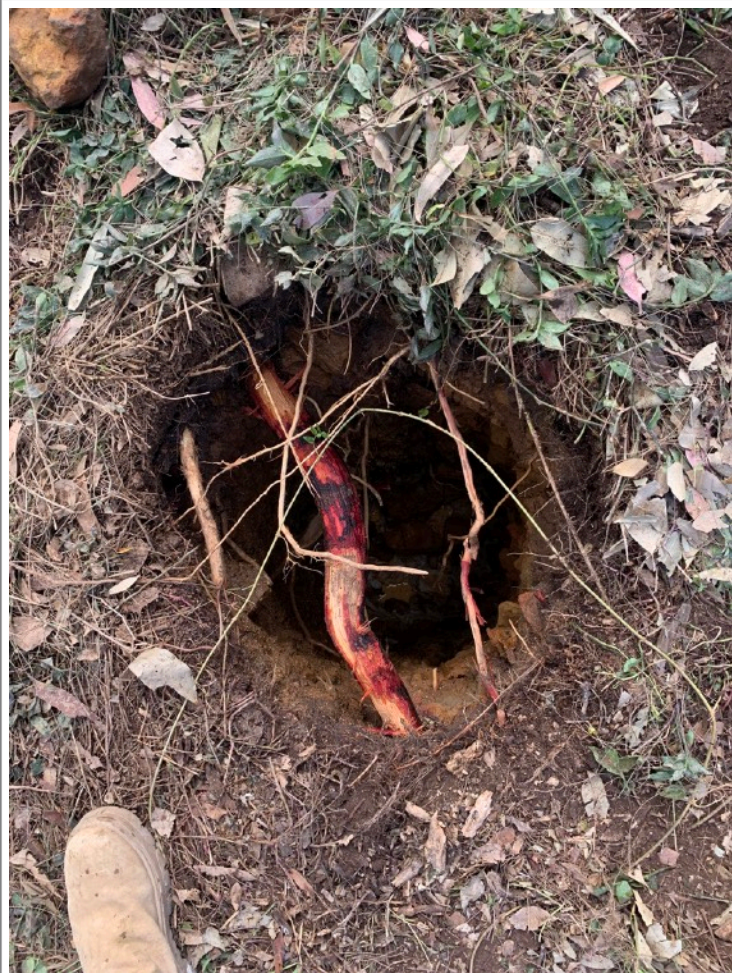
4.4 Hole 1 has been dug to a depth of 1.7m before locating the underlying bedrock. This excavation is over 400mm in diameter and represents the location of the proposed support pier required for the carport slab. This structure will be elevated above existing ground levels. See **Figure 1**.

Figure 1 Shows Hole 1.

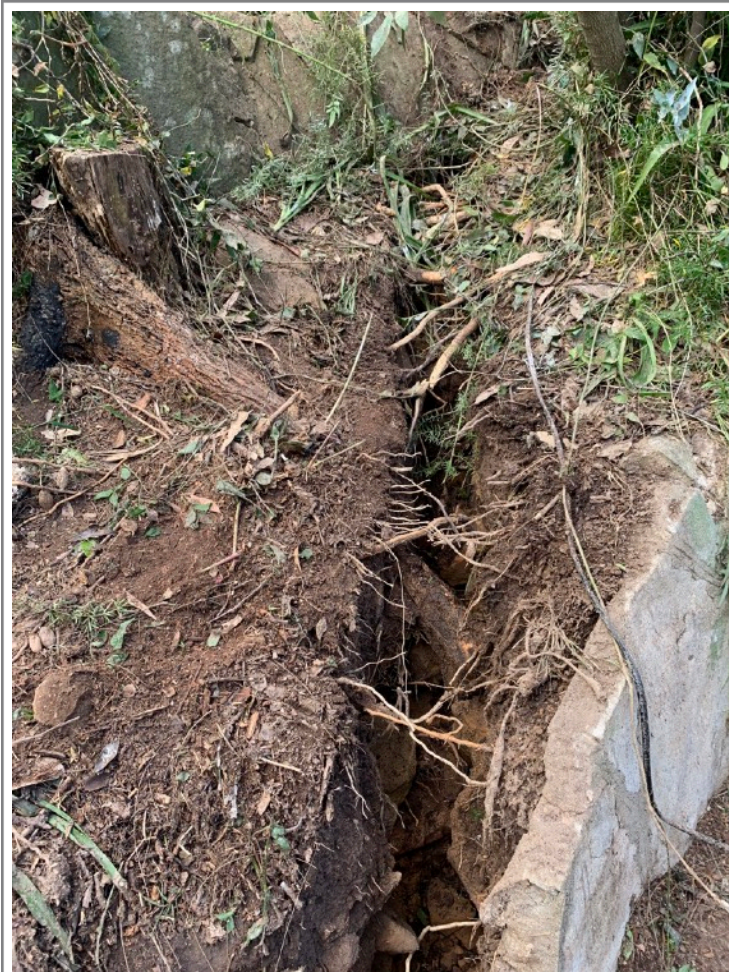
4.5 Trenches A and B have been excavated within the TPZ of both Trees 13 and 22. These trenches were both excavated to bedrock and did not expose any larger diameter Spotted Gum roots. This portion of the construction footprint represents the location of the proposed lift. See **Figures 2 + 3**.

Figure 2 Shows Trench A.

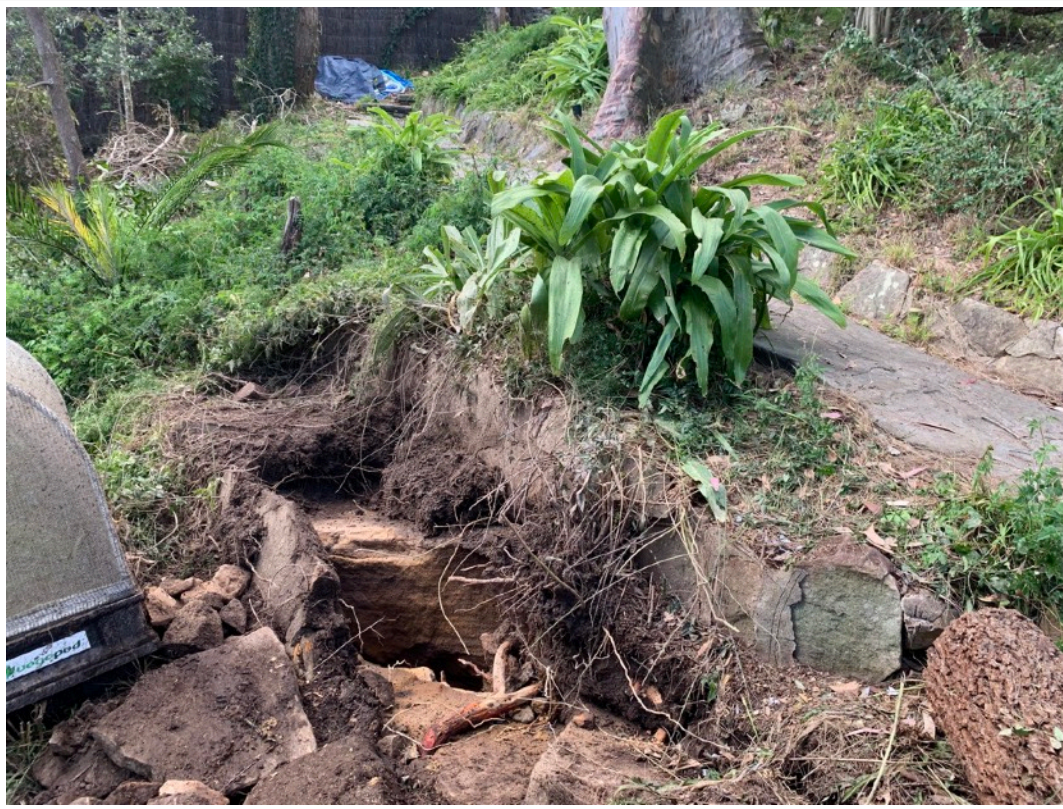
5.3 Excavation to allow for the installation of the lift is within 3m of Tree 13. This is within the tree's theoretical SRZ and cannot involve the removal of any larger diameter roots. As noted the excavation here uncovered bedrock at less than 200mm below the soil surface and no larger diameter *Corymbia* roots were located. The construction of the adjacent walkway is likely to have been built on this underlying bedrock and will have affected the spread and development of roots. The trenching exposed a number of smaller diameter (10mm) feeder roots that are likely to be from surrounding vegetation.

Figure 3 Shows exposed bedrock at Trench B and the base of Tree 13.

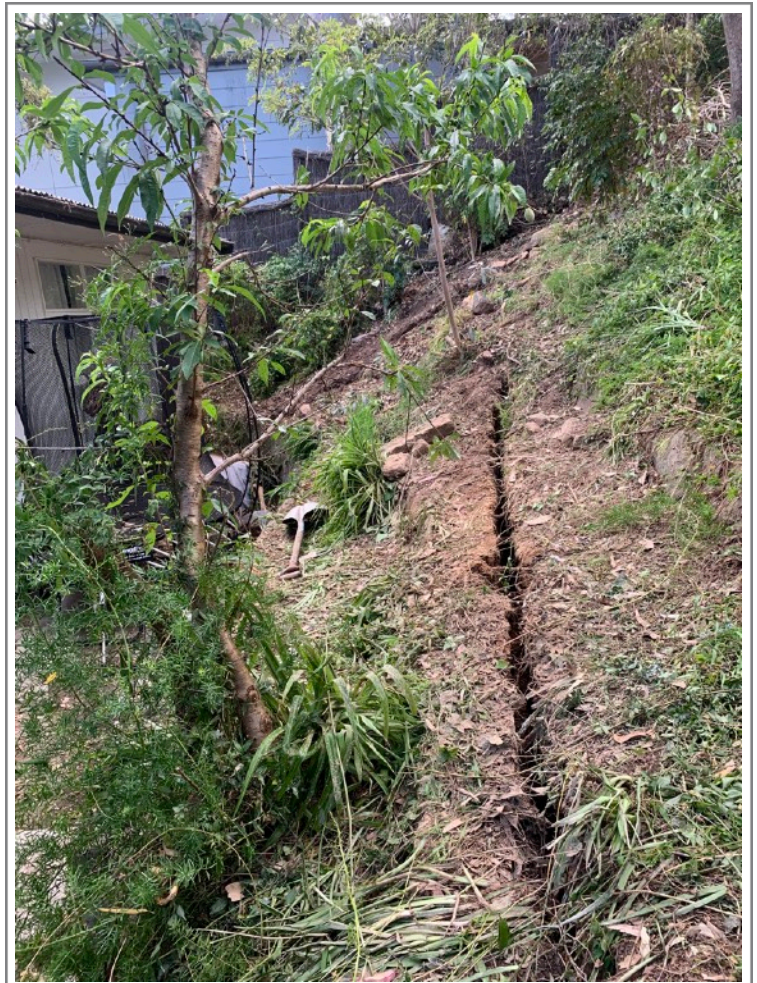
4.6 Trench C is the largest of the excavations. This exposed a number of feeder roots less than 10mm in diameter. These were not identified as being of any single species. Their smaller diameter will represent more recent growth. The exposed soil also contained building material indicating that it will have been altered and raised as part of historical construction.

5.4 Additional excavation within the TPZ of Tree 13 is represented by Trench C. As noted, this exposed a number of smaller diameter, compensatory feeder roots as well as imported fill. No larger diameter *Corymbia* roots were found. The development of tree roots in this area is likely to have been affected by the construction of both the concrete path and the importation of fill.

Figure 4 Shows Trench C and the existing construction footprint.

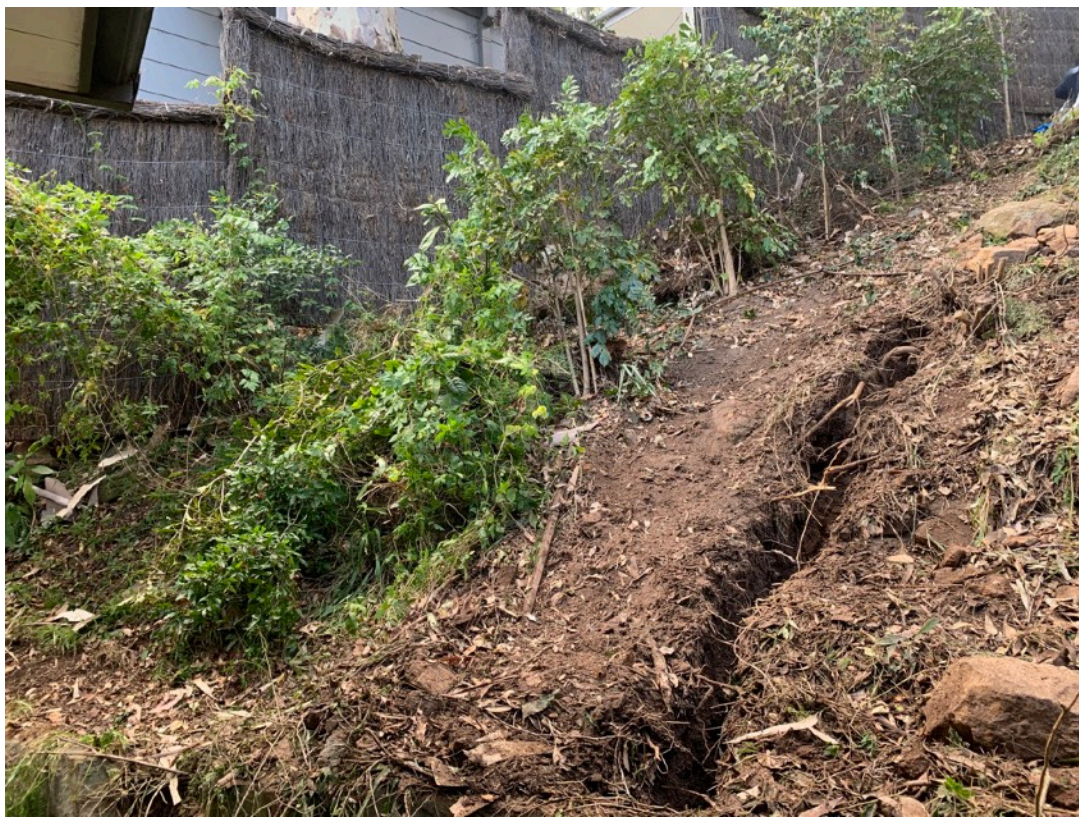
4.7 Trench D is within 3m of the neighbouring Spotted Gum documented as Tree 17. Excavation again went to the underlying bedrock and uncovered a number of smaller diameter surface roots as well as indications of imported fill. No larger diameter or structural roots were uncovered.

Figure 5 Shows
Trench D and the
neighbouring Spotted
Gum (Tree 17)

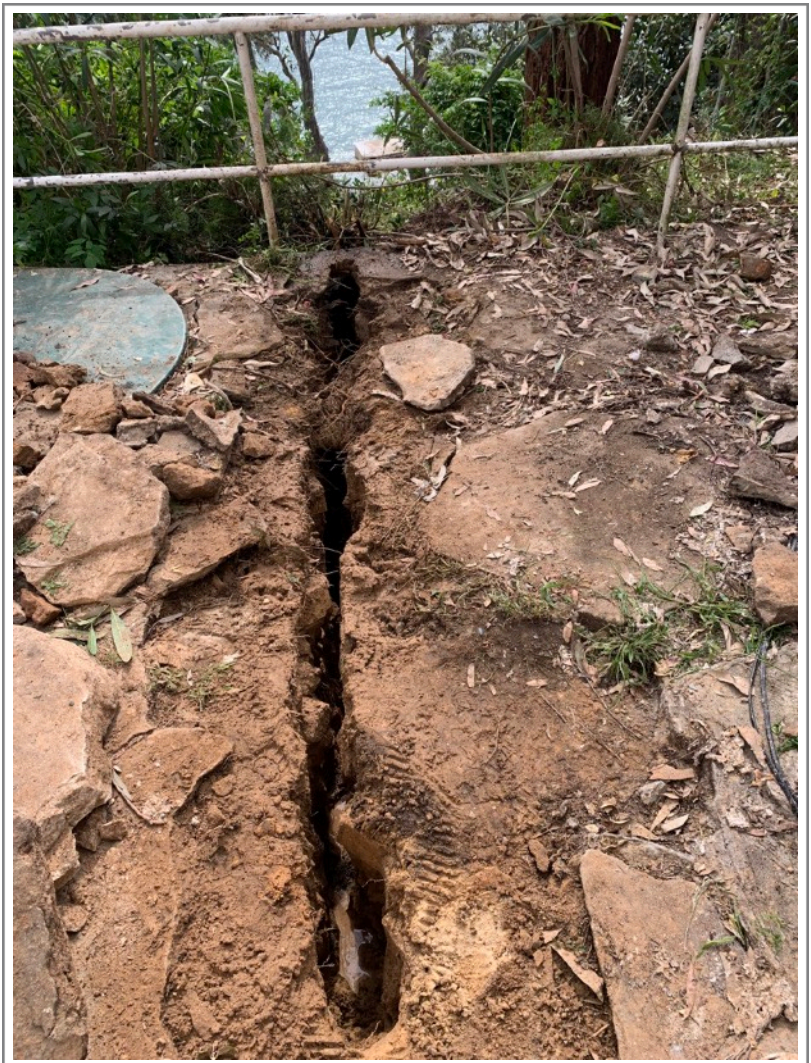
4.8 Trench E was dug within the existing construction footprint. This portion of the site is supported by a retaining wall and all exposed soil dominated by construction fill. This trench was dug to approximately 900mm and did not get to the underlying bedrock. Excavation to allow for the construction is less than 500mm with the remaining structure cantilevered.

Figure 6 Shows Trench E and the adjacent
sewage pit.

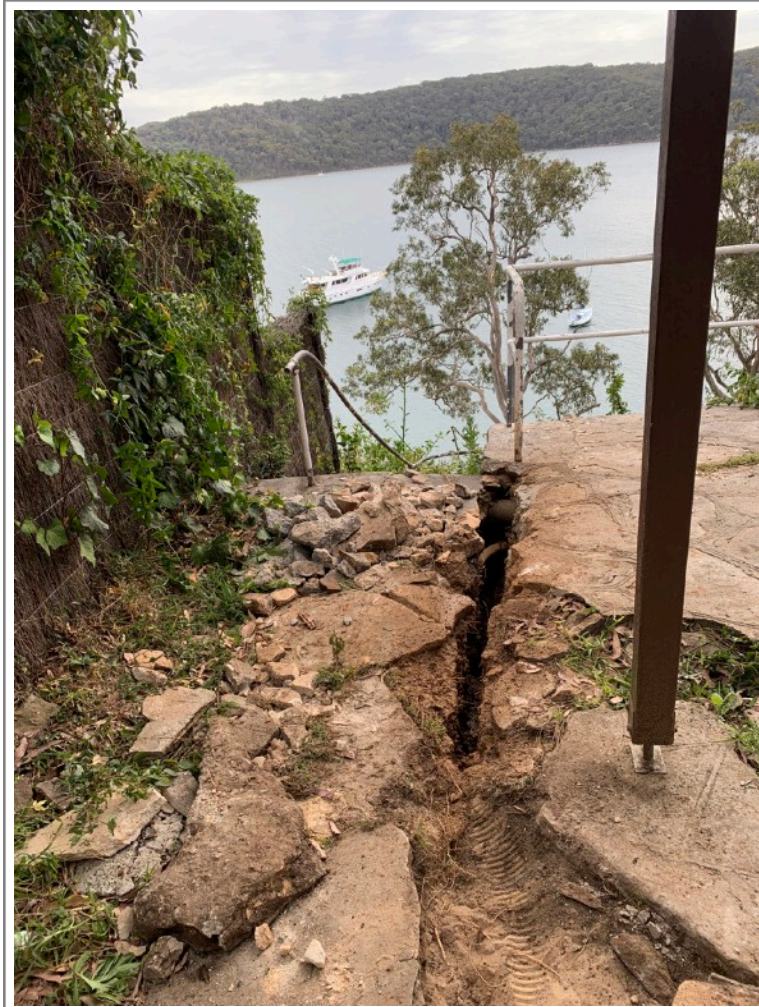
4.9 Trench F was again excavated within the existing construction footprint and the exposed soil profile dominated by fill. The larger diameter root exposed and detailed in **Figure 7** comes from a neighbouring Jacaranda.

Figure 7 Shows the final Trench F.

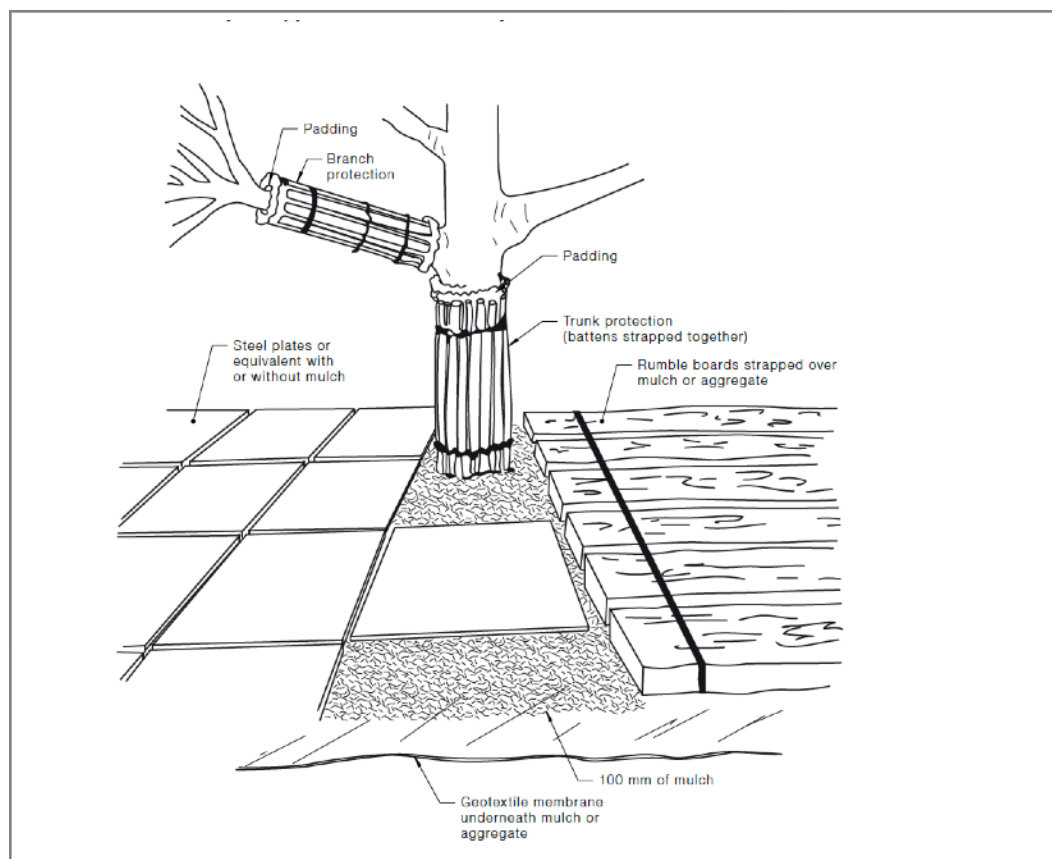
Figure 8 Shows AS4970 Ground Protection, including rumble boards, branch protection and mulching.

6.2 The demolition and excavation portions of the construction process will require the establishment of an excavator onto site. This will require the traversing of the north eastern portion of the site. This is with the theoretical SRZ and TPZ of a number of important trees and will need to consider the impacts of compaction on the underlying soil profiles. Rumble boards will be required to limit compaction and soil disturbances here. See **Figure 8**.
