## ***Arboriculture Impact Assessment & Site-Specific Preliminary Plan of Management***

**30 October 2024 updated November 2024**

**99 Riverview Road Avalon Beach NSW 2107**

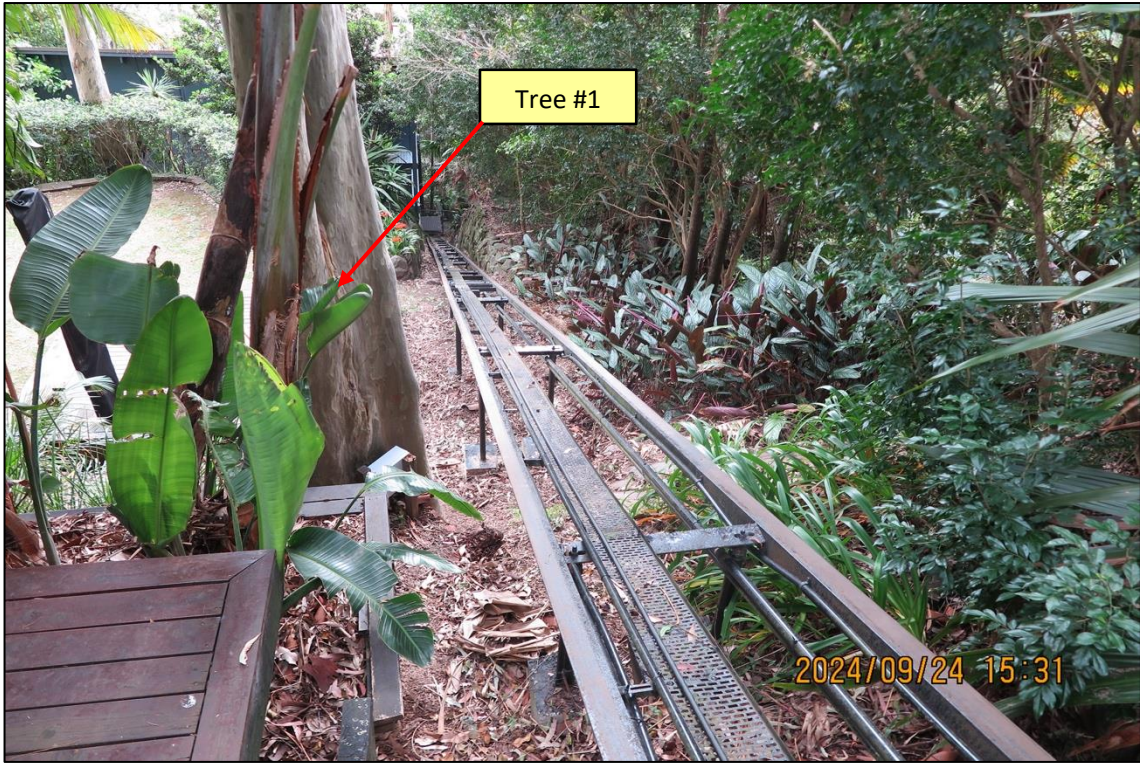
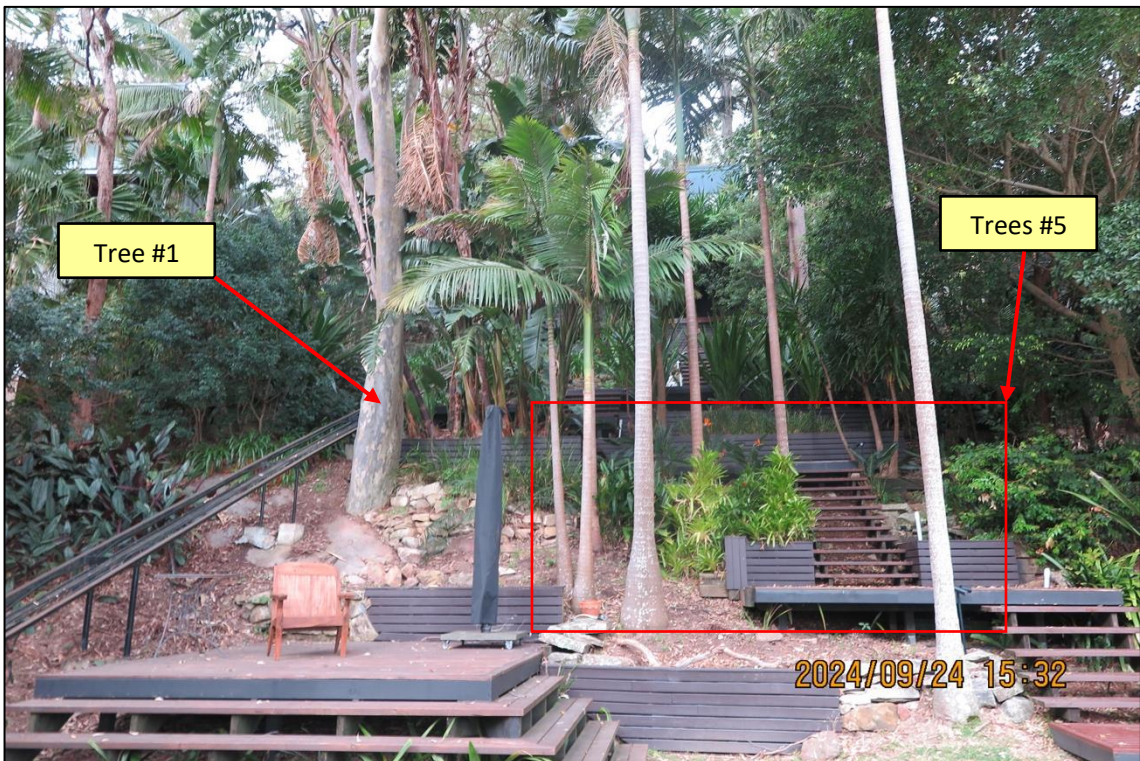
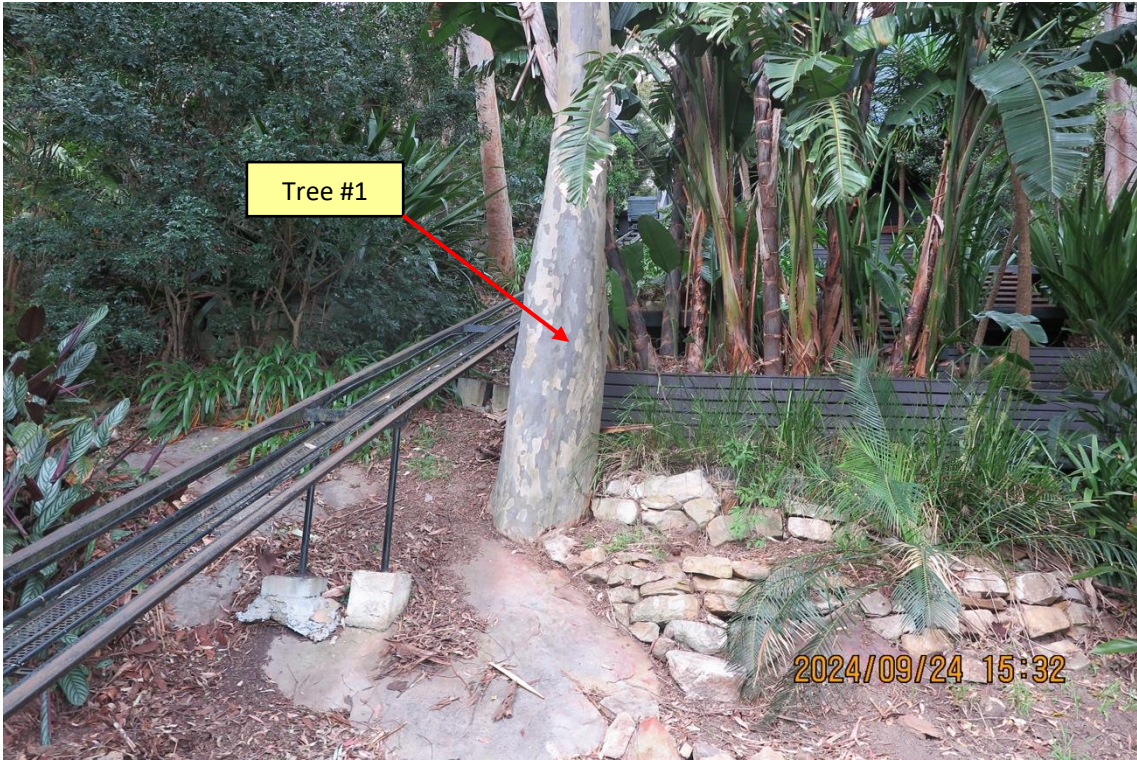
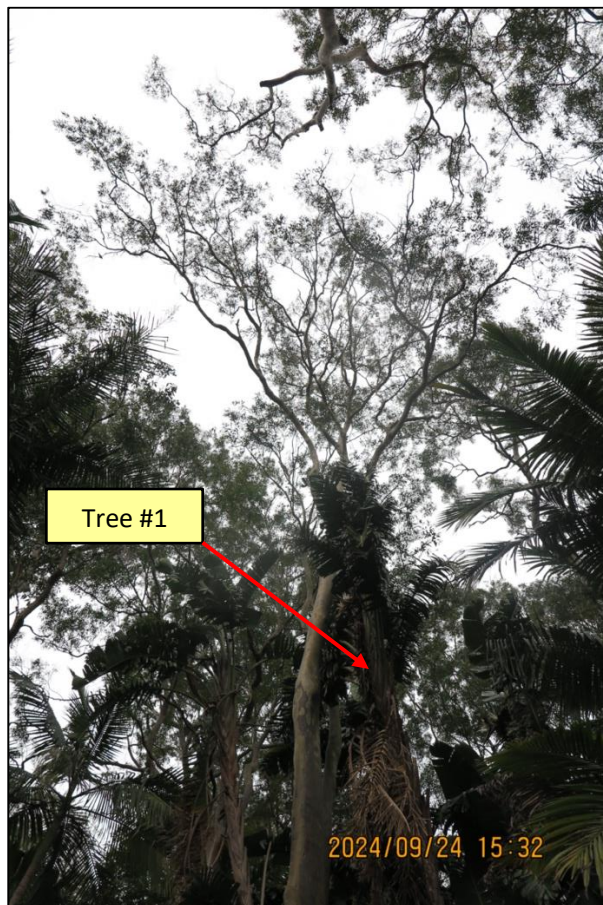
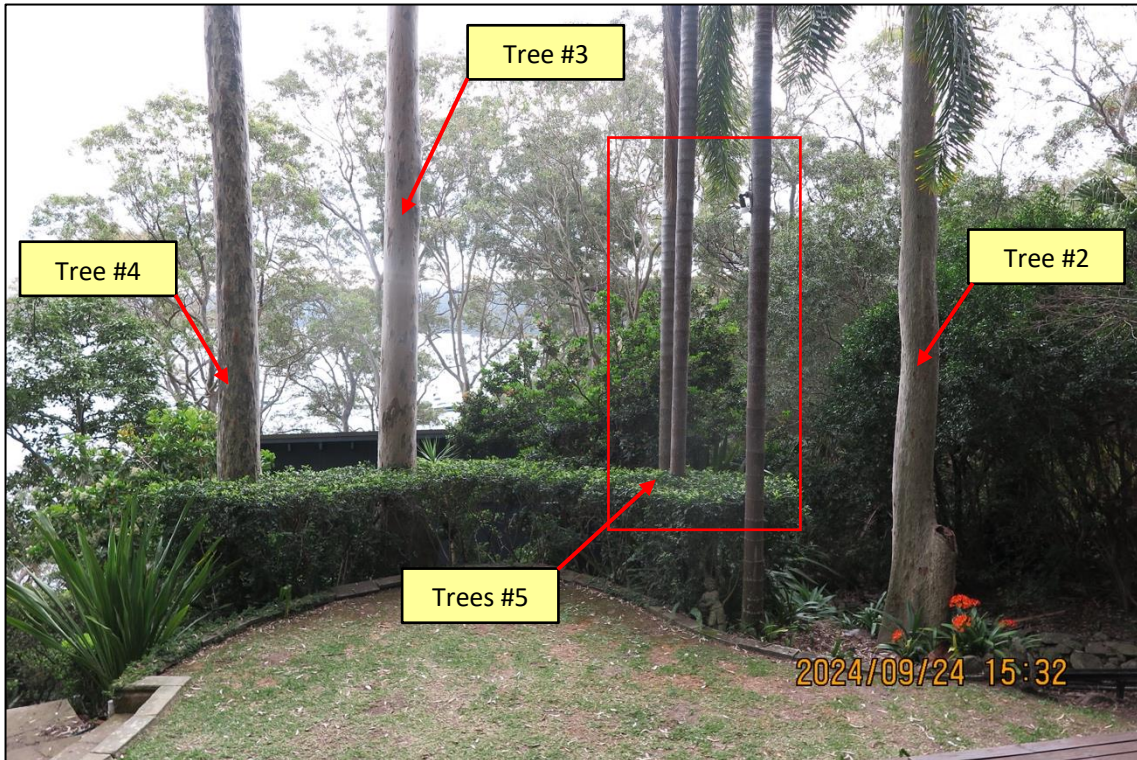
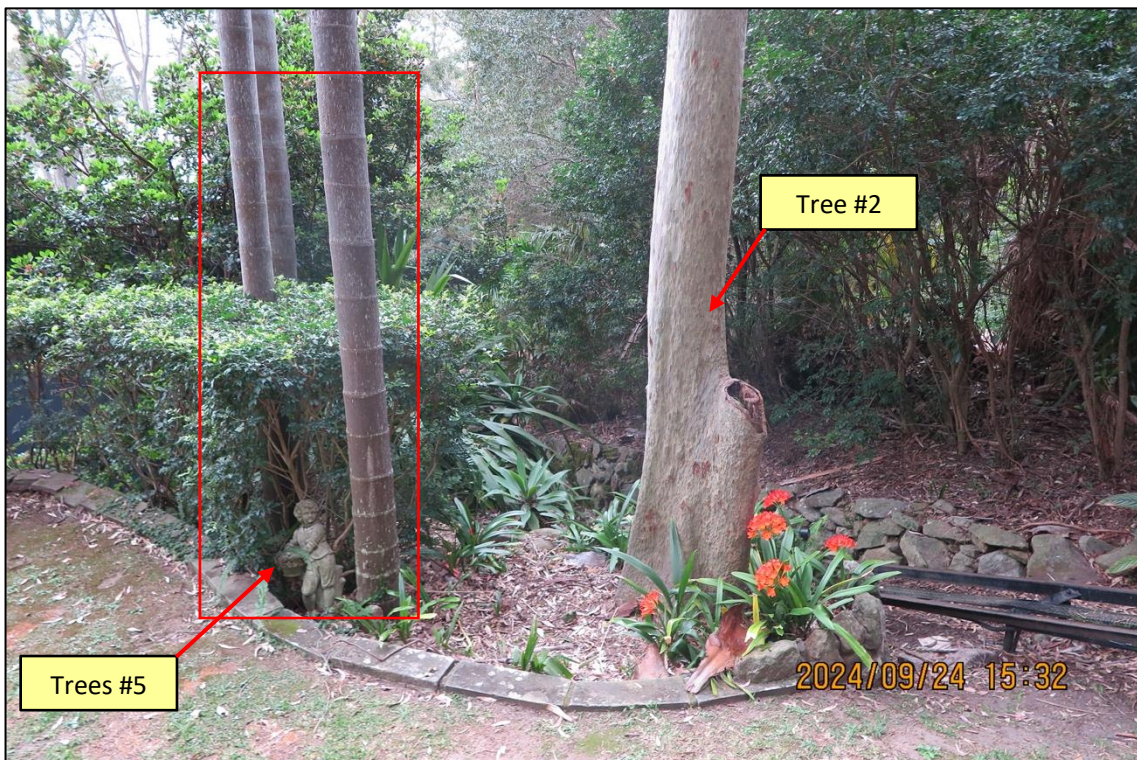
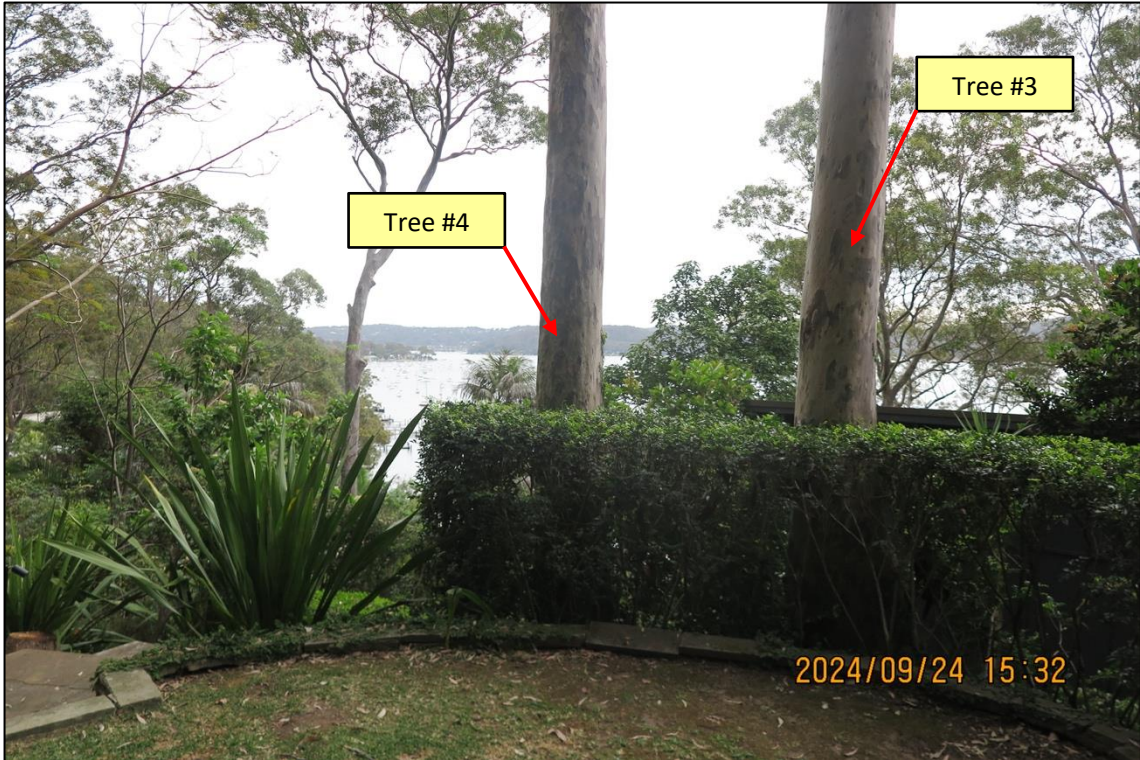
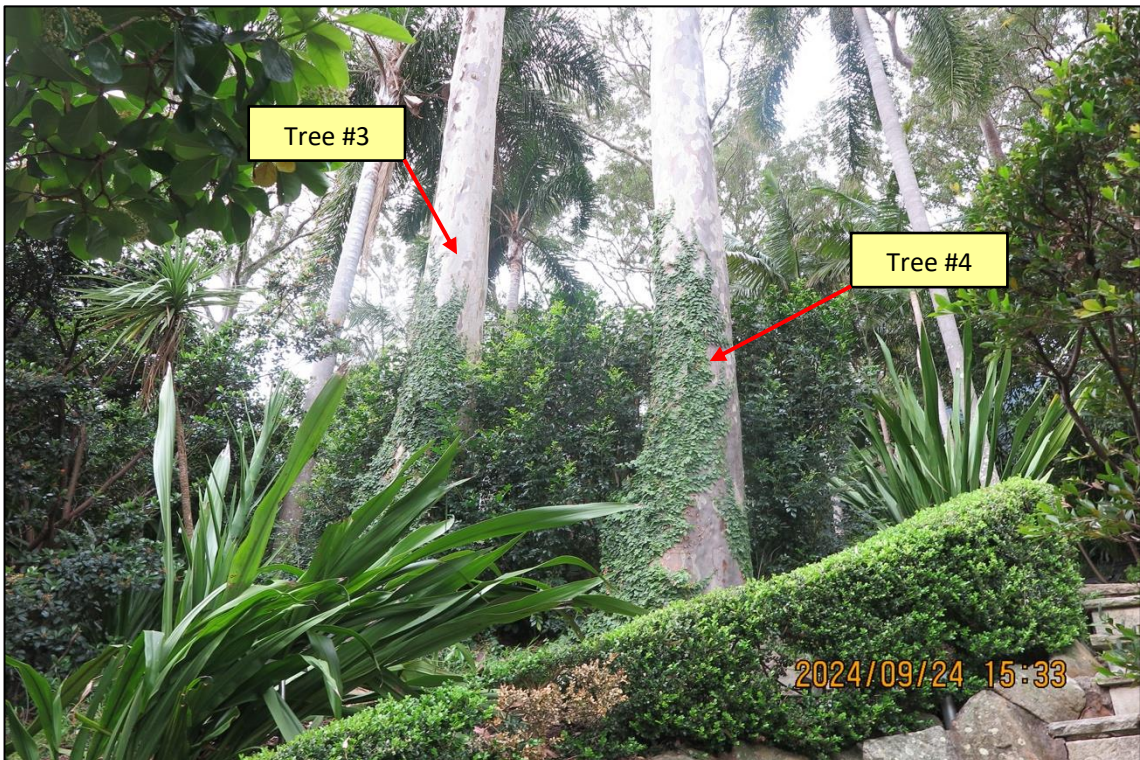
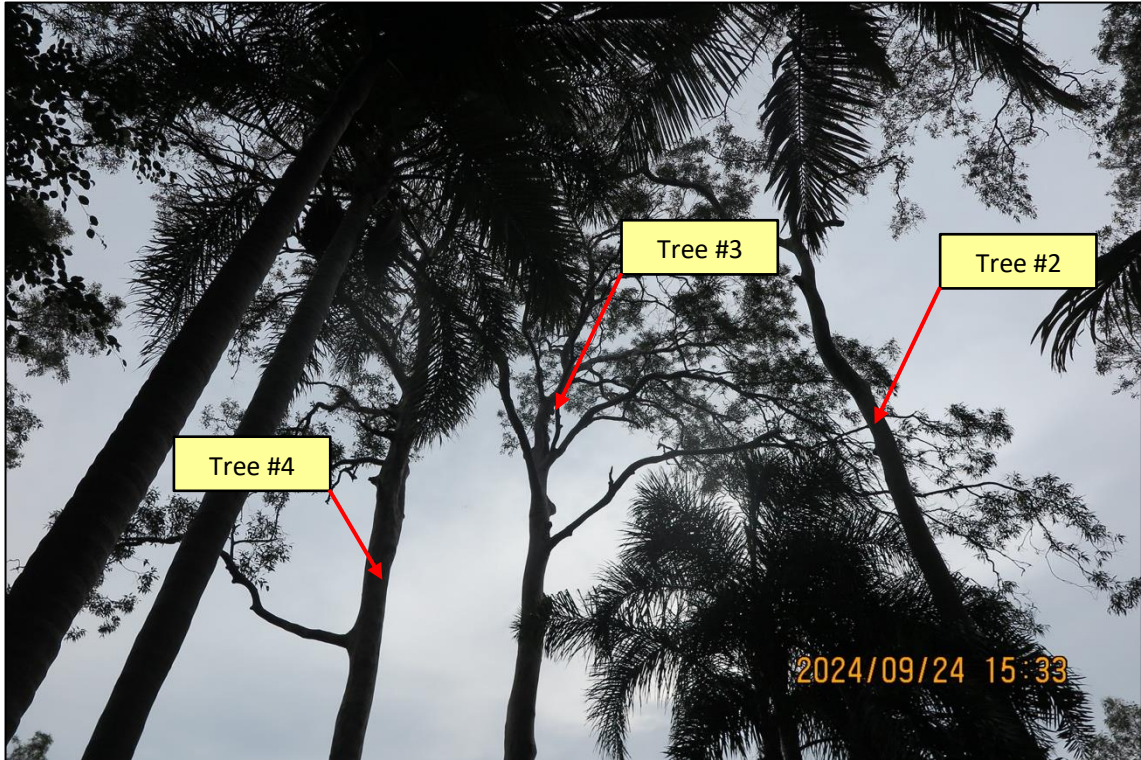
FIGURE 14: ABOVE & PREVIOUS PAGE PHOTOGRAPHS ILLUSTRATES THE FIVE (5) DISCUSSED TREES LOCATIONS & SITE FEATURES

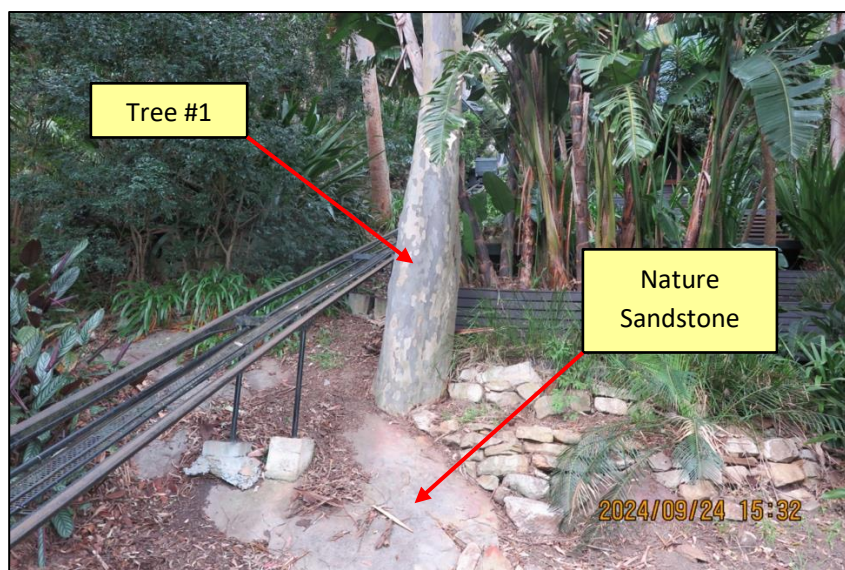
Tree #1 is located within the subject site surround the exiting filled up decking area. The proposed new swimming pool & surroundings are confirmed to breach the TPZ & SRZ total surface area for Tree #1.

By our calculation, the total TPZ surface area of Tree #1 is 209.01m<sup>2</sup>. The proposed works equates to an approximate 42.37m<sup>2</sup> mathematical disturbance of total TPZ surface area for Tree #1. This mathematically equates to approximately 20.3% of total TPZ surface area, (defined by AS4970-2009 as a Major Encroachment).

Factually, the mathematical percentage of Major Encroachment can be very significantly reduced to a manageable percentage of the total TPZ surface area breach, which refers to the excavation plan of landscape architectural design (see page 18). Part of the proposed works is specified as being supported by flexibly located footings/piers, which reduces the disturbance to 5.8%. Additionally, Tree #1 is growing between the natural sandstone, and the cut at the show on the west side of Tree #1 SRZ are very unlikely to find significant diameter (defined in this situation as being greater than 50mm) 'live roots' from Tree #1.

On this basis, we can support Tree #1 is viable to be retained by intensive management during the proses of the proposed construction. Should any significant diameter 'live root/s' (greater than 50mm in diameter), be exposed that are unable to be avoided, the direct input & documentation with supporting evidence photographs from the retained project arborist is essential to confirm as close as possible to best Arboriculture Practice being applied.

Tree #1 is additionally specified to require TPZ temporary 'temporary metal mesh fencing with ground level support' as well as native tree mulch being instated within the subject site ground level where proposed works are within the Tree #1 total TPZ surface area.

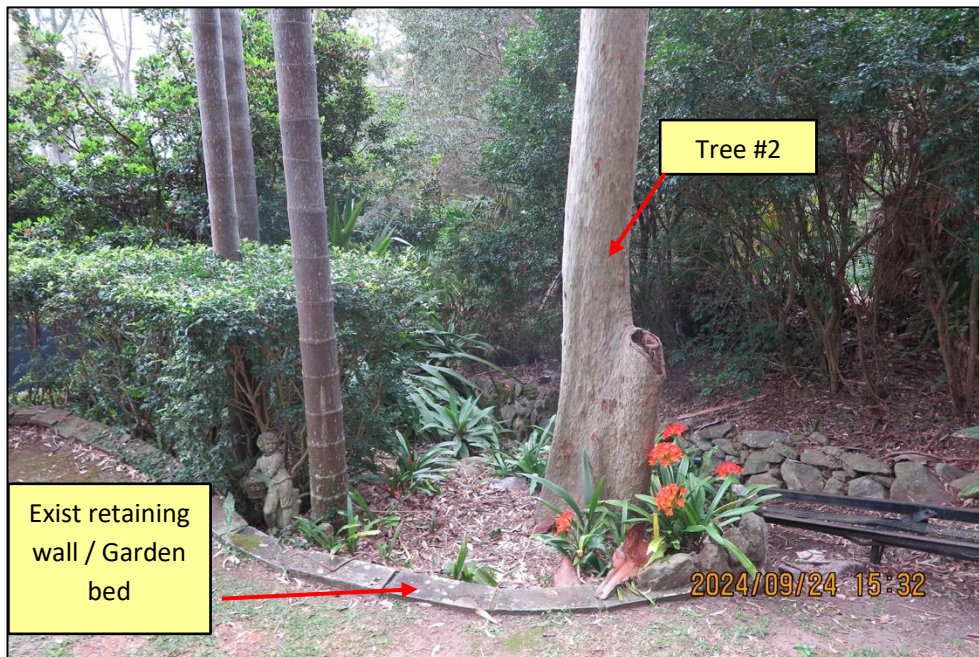
Tree #2 is located within the subject site surround the exiting filled up decking area. The proposed new swimming pool & surroundings are confirmed to breach the TPZ & SRZ total surface area for Tree #2.

By our calculation, the total TPZ surface area of Tree #2 is 91.53m<sup>2</sup>. The proposed works equates to an approximate 32.17m<sup>2</sup> mathematical disturbance of total TPZ surface area for Tree #2. This mathematically equates to approximately 35.1% of total TPZ surface area, (defined by AS4970-2009 as a Major Encroachment).

Factually, the mathematical percentage Major Encroachment the reality is this can be very significantly reduced to a manageable percentage of total TPZ surface area breach refers to the excavation plan of landscape architectural design (see page 18). There is a part of proposed works is specified as able to be supported by flexible located footings/piers, which reduce the disturbance to 17.5%. The entire extent of the proposed deck structure is elevated and open to preserve essential gaseous exchange and water penetration to tree roots. There is an existing retaining wall / garden bed around Tree #2, which create separation between Tree #2 'live root' system the proposed works.

On this basis, we can support Tree #2 is viable to be retained by intensive management during the proses of the proposed construction. Should any significant diameter 'live root/s' (greater than 50mm in diameter), be exposed that are unable to be avoided, the direct input &

documentation with supporting evidence photographs from the retained project arborist is essential to confirm as close as possible to best Arboriculture Practice being applied.

Tree #2 is additionally specified to require TPZ temporary 'temporary metal mesh fencing with ground level support' as well as native tree mulch being instated within the subject site ground level where proposed works are within the Tree #2 total TPZ surface area.
