ARBORICULTURAL IMPACT ASSESSMENT REPORT

44 Lovett Street Manly Vale

Watermark Construction Group

3rd February 2020

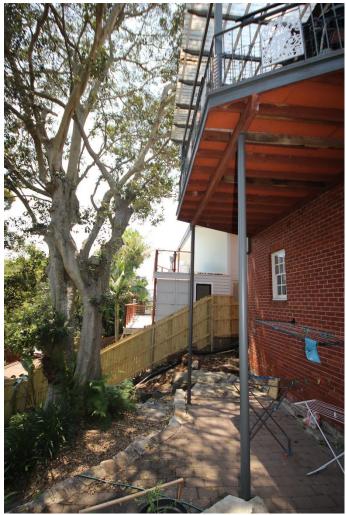
Plate 1 – existing deck with clearance to tree 1

1. Tree 1 *Ficus rubiginosa* shows good vitality with an elevated form – refer plate 1. The proposed deck will be constructed on posts anchored to the existing rock which will not impact the root system of this tree, then constructed the deck with care. It is noted, no branch pruning is required to build the deck. All work is within the TPZ & SRZ of this tree, but by locating the posts on existing rock, the encroachment is considered acceptable as defined by AS 4970 – 2009. The new posts installation shall be supervised by the Project Arborist to ensure no damage occurs to this tree. Otherwise the work can proceed with care.

Note this tree for retention and protection (temporary fence around the base of the tree) in the Tree Management Plan.

- a) Retain the following tree on site: Tree 1;
- b) Install the following Tree Protection Measures around the retained tree: Tree 1, tree protection measures shall be a temporary fence of chain wire panels 1.8 metres in height (or equivalent), supported by steel stakes or concrete blocks as required and fastened together and supported to prevent sideways movement. Existing boundary fences or walls are to be retained shall constitute part of the tree protection fence where appropriate. A sign is to be erected on the tree protection fences of the trees to be retained that the trees are covered by Council's tree preservation orders and that "No Access" is permitted into the tree protection zone refer Annexure D;
