Reference: 23079 19 June 2024

RE: 29 Wandeen Road, Clareville Vehicle Turning Bay and Driveway Assessment

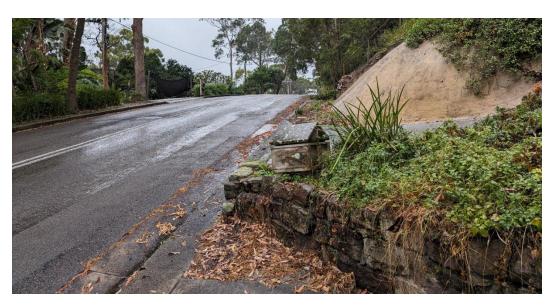
a) Limited visibility due to close proximity of a crest: The driveway is approximately 30m west of a crest on Wandeen Road. See the following photos for views to the crest east of the driveway.

View of the Crest from 1m Inside the Driveway

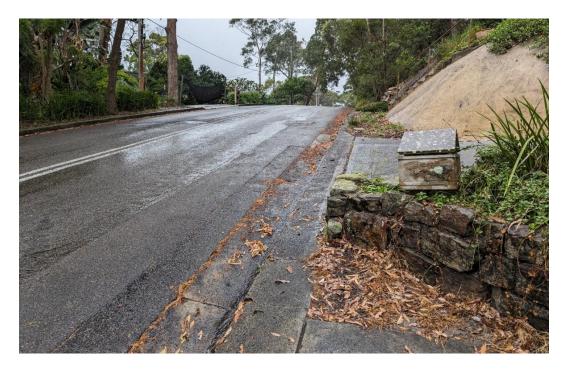
View of the Crest at the Start of the Driveway

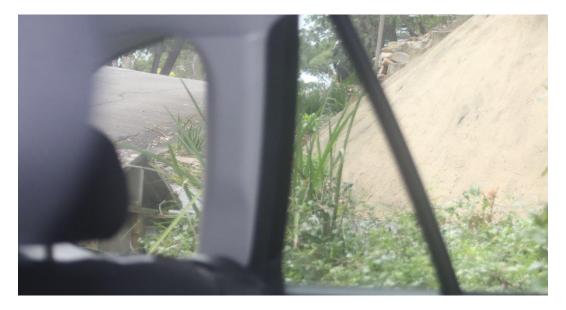
A driver reversing out of the driveway will have limited visibility and will not be able to see approaching westbound vehicles on Wandeen Road until the vehicle has partially entered Wandeen Road. The lack of visibility prior to the vehicle entering the carriageway increases the risk of a collision or accident. See the following photos from a car reversing out of the driveway.

View through Rear Passenger Window with the Vehicle within the Driveway

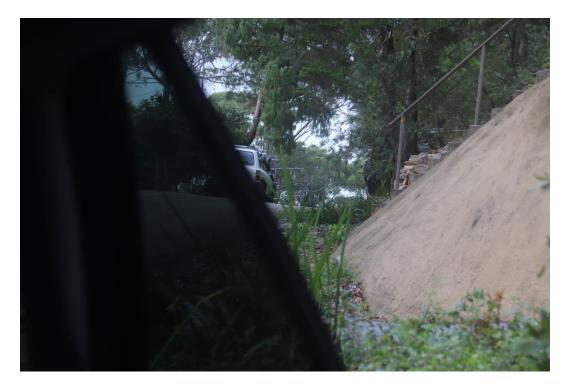
View through Rear Passenger Window with the Vehicle Partially on Road to Achieve Sightline 1

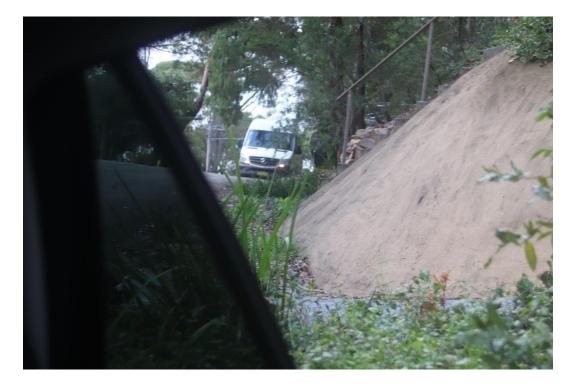
View through Rear Passenger Window with the Vehicle Partially on Road to Achieve Sightline 2

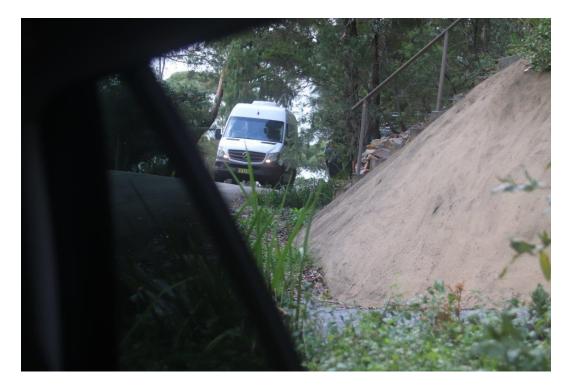
View through Rear Passenger Window with the Vehicle Partially on Road to Achieve Sightline 3

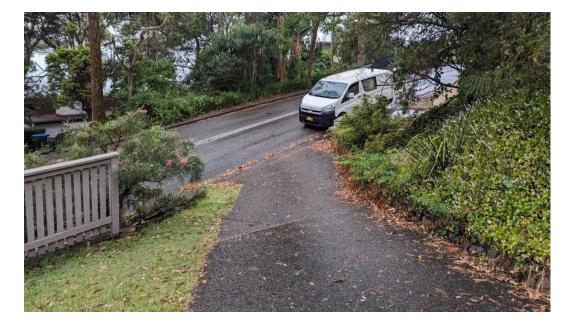
It is noted that the sightline to the crest is further restricted by the on-street parking directly to the east of the driveway and the off-street parking of neighbouring property at 31 Wandeen Road. See the following photos of the on-street parking and off-street parking activities.

On-Street Parking Activities to the East of the Driveway

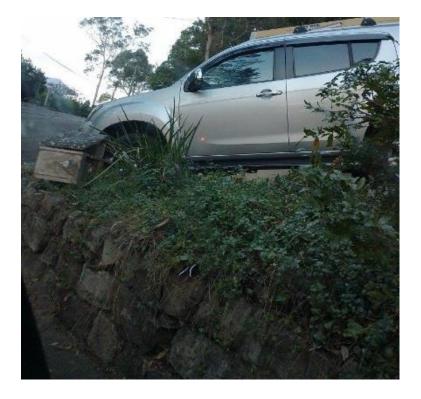
View from Passenger Side of Reversing Vehicle with View Obstructed by Neighbour's Off-Street Parking Activities

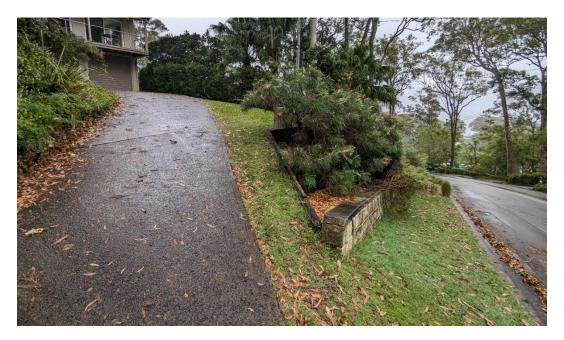
b) Limited visibility due to close proximity of a horizontal curve: The driveway is approximately 35m east of a horizontal curve on Wandeen Road. See the following photos for the views to the curve west of the driveway.

View of the Curve from 1m Inside the Driveway

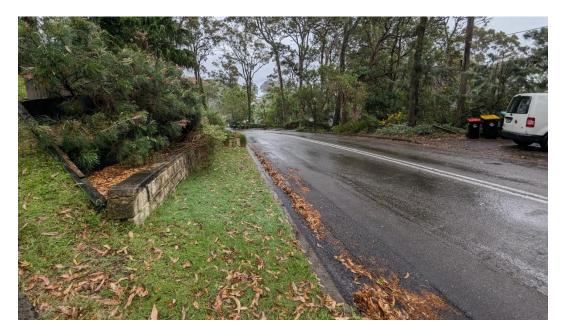
View of the Curve at the Start of the Driveway

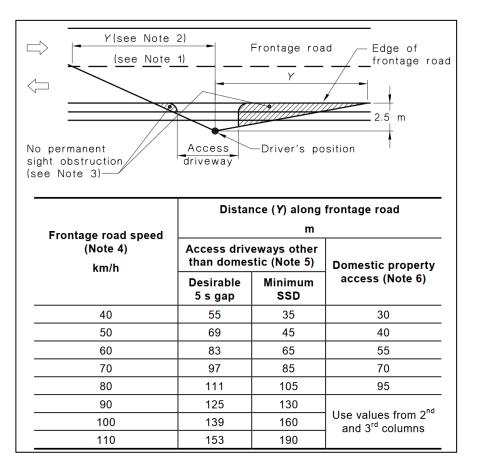
c) Non AS2890.1 compliant sightline: The sight distance analysis has been provided in accordance with Figure 3.2 of AS2890.1:2004, reproduced below.

Based on Figure 3.2 of AS2890.1, the minimum SSD for an access driveway for domestic property access for a 50 km/h frontage road is 40m. Based on the sight distance, the existing driveway on Wandeen Road does not comply with the minimum SSD from Figure 3.2 of AS2890.1.

While the existing driveway does not comply with the minimum distance requirements, the risk can be mitigated by allowing the drivers to safely drive out in a forward direction instead of reversing out of the driveway.

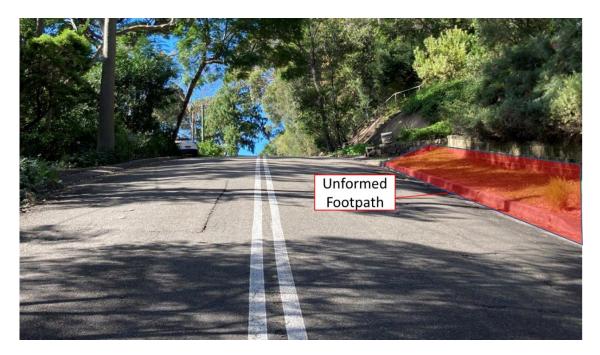
- d) Narrow Frontage Road: The narrow Wandeen Road (with a 3.2m-wide lane) and double lines along Wandeen Road mean that the westbound vehicle approaching from the crest will not be allowed to overtake the exiting vehicle from the driveway and must stop instantaneously to avoid the vehicle.
- e) Loss of control: When reversing down a steep driveway, it can be easy for the driver to lose control of the vehicle.
- f) Safety concerns: Reversing down a steep driveway presents an increased safety risk for some drivers, especially those with limited mobility, vision, or experience. Moreover, the pedestrians walking on the verges (which act as an unformed footpath) along the southern side of Wandeen Road may be injured as the driver may not see them while reversing out from the driveway. See the following photo.

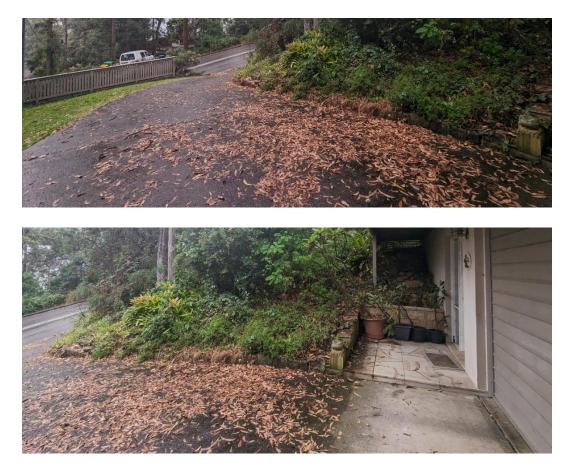
• Maintenance Challenges: Clareville is prone to saltwater corrosion, which can affect the mechanical components of the turntable system. Similarly, the driveway and carpark area are surrounded by several mature and leafy trees and currently experience issues with falling leaves and debris getting into the machinery, potentially causing malfunctions or breakdowns. See the following photos.

• Environmental Factors: Coastal areas are subject to harsh weather conditions, such as strong winds and storms, which could pose a risk to the stability and operation of turntable carpark systems. Additionally, the presence of sand and salt in the air can accelerate wear and tear on the equipment.

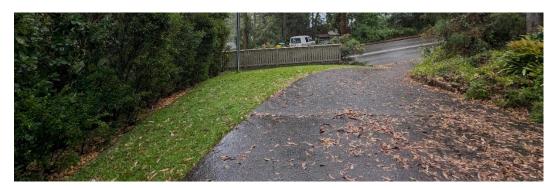
• Gradient Limitations: Turntable carpark systems typically require a level surface to operate effectively. While they may function on a maximum gradient of 5%, it's generally recommended to install them on a flat surface to ensure smooth and reliable operation. It should be noted that the site has significantly steeper (>5%) gradients at the proposed turntable locations. See the following photo.

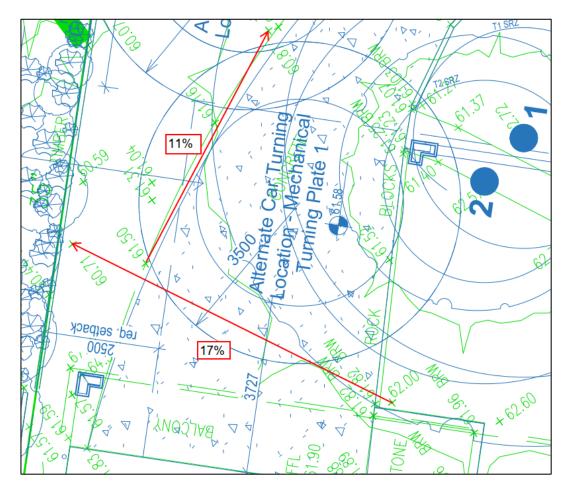
- A significant gradient could cause issues with the rotation mechanism, potentially leading to uneven weight distribution, increased wear and tear on components, and difficulty in parking or retrieving vehicles. Additionally, safety concerns may arise if the gradient is too steep, affecting the stability of the turntable system. In addition to the steep gradients, the site presents an additional challenge with two cross gradients (north-south and east-west). In order to accommodate a turntable, it's necessary to entirely eliminate one of these gradients and then reduce the other to within the 5% threshold. This is because the turntable can only function within a single gradient of 5%. Based on the survey plan, the following cross-gradients are present:
 - Location 1: north-south gradient of 11%, east-west gradient of 17%

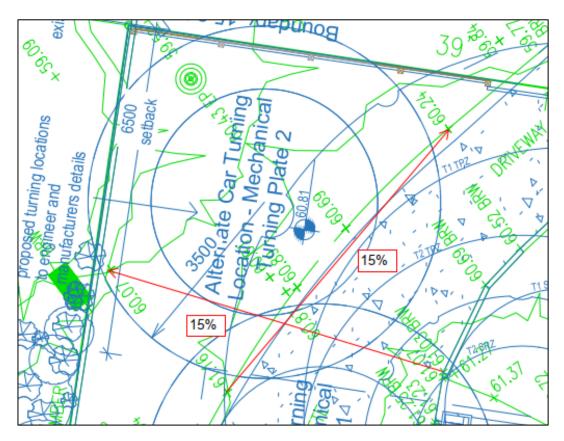
Location 2: north-south gradient of 15%, east-west gradient of 15%

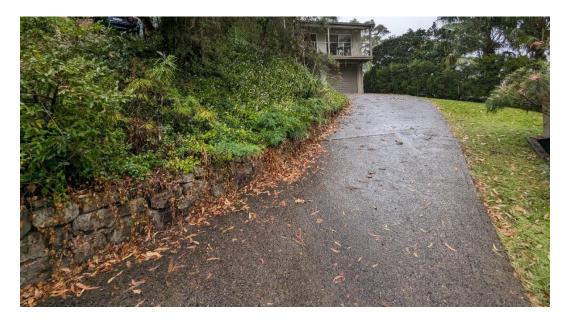
The driveway currently has a gradient of up to 20% over a length of 9m. See the following photo.

To achieve the AS2890.1 compliant maximum change of grades of 12.5% (crest) and sag (15%), as well as the maximum 5% gradient of the turntable, the driveway will need to be redesigned to be steeper than 20%. This will result in:

- The 20% gradient exceeding 25%, therefore, deviating from the AS2890.1 and Council Standard Drawings – Driveway Profile – Extra High
