Tree Assessment

Proposed incline lift

**60 Cabarita Road
Avalon**

Report Prepared by Julia Stanton
Syncarpia Vegetation Management
24 Windsor Street Tarbuck Bay 2428
juliastanton@ozemail.com.au
Mob:04173980
April 2021

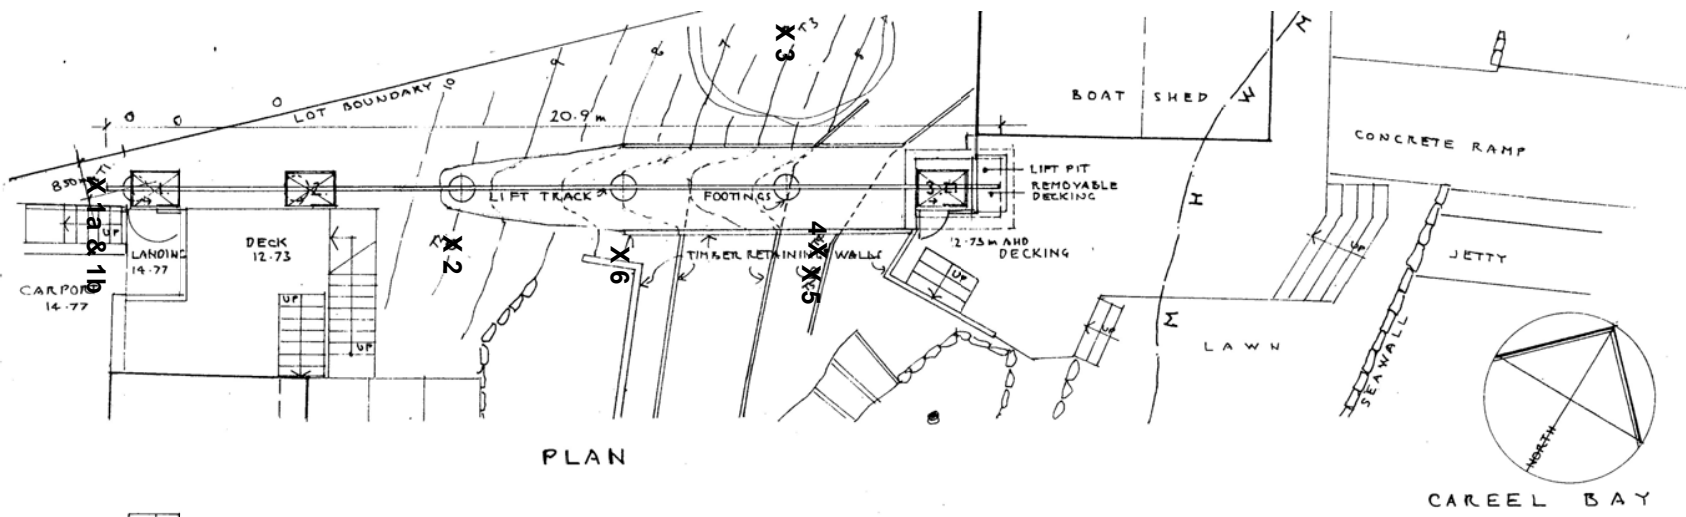
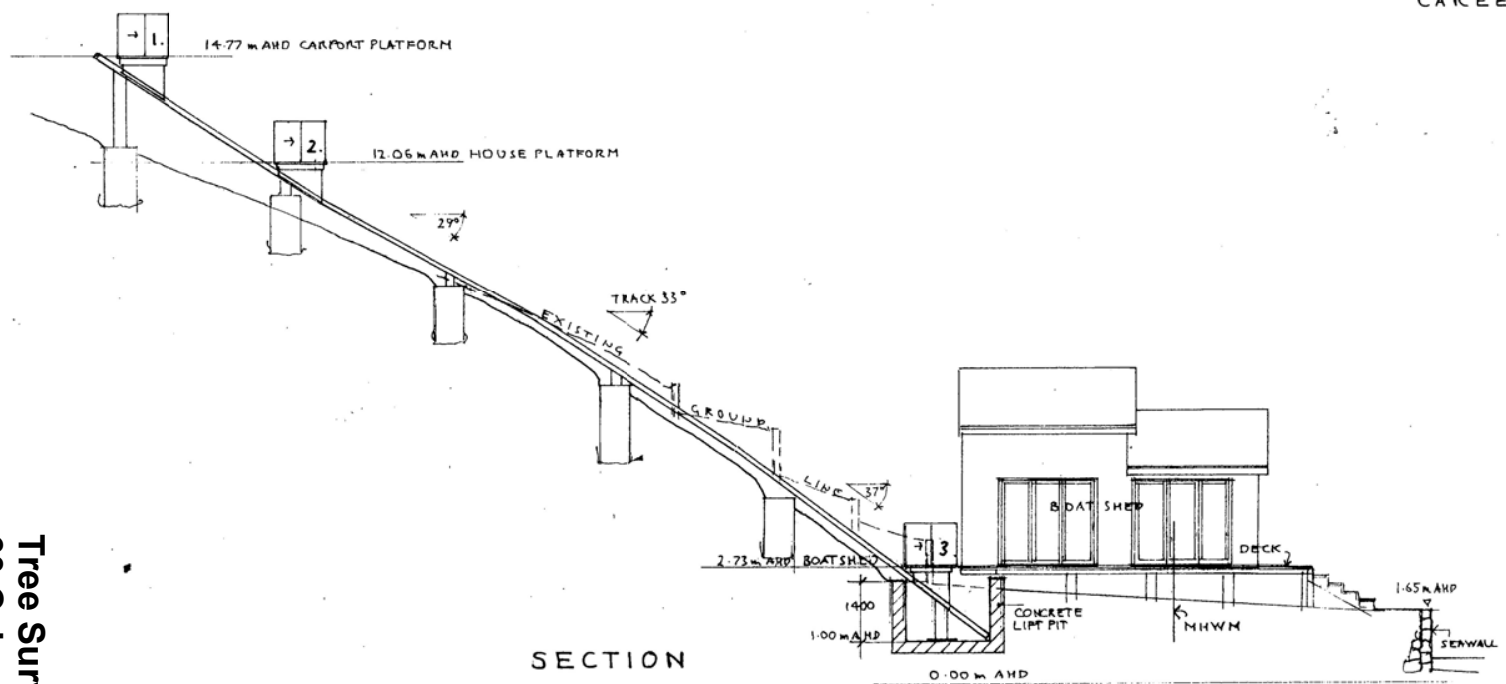
Figure 1

Tree Survey
60 Cabarita Rd
Avalon
