Syncarpia Vegetation Management

Lot 121 DP 12749, 57 Robertson Road Scotland Island.

Boundary Fence – Harwood & metal & wire with 150mm footings

This report provides recommendations for tree management & protection in relation to construction of boundary fence.

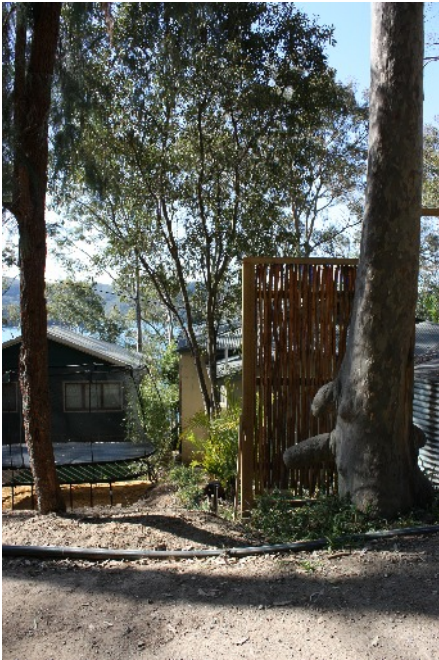
Photo 1 Trees 1, 2 & 3

Tree 1 is a semi-mature specimen of *Corymbia maculata* (Spotted Gum) in fair health & condition, adjacent to electricity wires, existing road & existing boundary fence. (Height 16m, Crown: 5m DBH: 380mm). Multiple lower branch stubs, sparse reduced crown, with some tip dieback & epicormics growth. First footing is approximately 2.5m from this tree, within calculated TPZ.

Tree 2 is an immature specimen of *Allocasuarina torulosa* (Forest Oak) in fair health & poor – fair condition, adjacent to existing road & electricity wires. Large basal trunk wound with a sparse reduced crown. (Height: 7m, Crown: 1.5m, DBH: 150mm). Located 2m from proposed boundary fence and footing. Footing located outside calculated TPZ

Tree 3 is a semi-mature specimen of African Olive in good health & condition. This is listed as an exempt species.

- **All excavation within 5m of existing trees to be undertaken by hand.**
- **Footings to be relocated to avoid cutting roots greater than 50mm if encountered during excavation.**

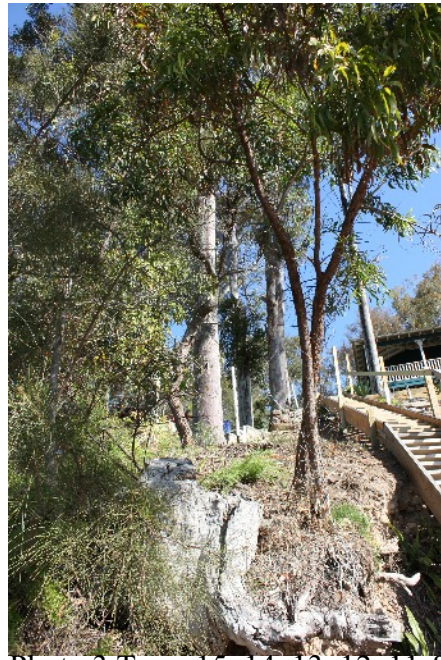
Photo 3 Trees 15, 14, 13, 12, 11 & 10

Tree 10 is a mature specimen of *Corymbia maculata* (Spotted Gum) in good health & condition (Height: 28m, Crown: 13m, DBH: 500mm) located on the adjacent property, 2m from proposed fence & 2.5m from footing. Footing located within calculated TPZ.

Tree 11 is a mature specimen of *Corymbia maculata* (Spotted Gum) in fair health & condition, with some deadwood, tip dieback & epicormics growth located 2m from boundary fence & 2.5m from footing. (Height: 20m, Crown: 9m DBH: 500mm). Footing located within calculated TPZ.

Tree 12 mature specimen of *Corymbia maculata* (Spotted Gum) with canopy removed, Epicormic foliage on trunk. Located 3m from boundary fence.

Tree 13 is a mature specimen of *Corymbia maculata* (Spotted Gum) in poor health & condition, with a significantly reduced crown, dieback & epicormics growth on trunk. (Height 17m, Crown: 6m, DBH: 450mm) Located 4m from proposed boundary fence. Footing located within calculated TPZ

Tree 14 is a mature specimen of *Corymbia maculata* (Spotted Gum) in good health & condition located adjacent to stairs 1.5m from proposed boundary fence, 2m from proposed footing (Height 22m, Crown: 12m, DBH: 480mm). Footing located within calculated CRZ.

Tree 15 is a semi mature specimen of *Acacia implexa* (Hickory Wattle) in good health & fair condition, (Height 6m,Crown: 6m, DBH: 200mm)located 1m from proposed boundary fence, 2m from footing. Footing located within calculated TPZ.

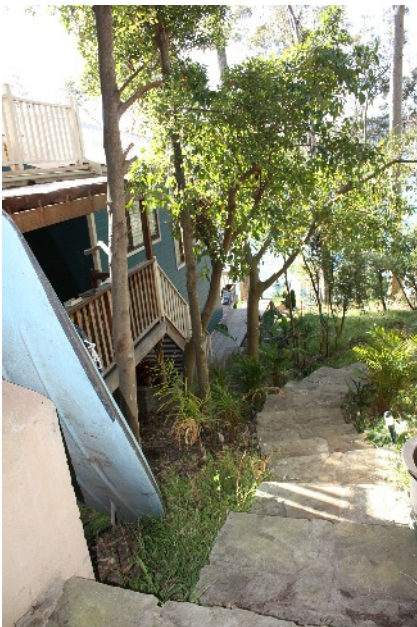
Photo 2 Trees 4, 5, 6 & 7

Trees 4, 5, 6 & 7 are small trees / large shrubs that provide boundary screening between the adjacent properties. All four specimens have been lopped and pruned multiple times.

Tree 4 is a semi-mature specimen of *Elaeocarpus reticulatus* (Blue Berry Ash) in good health & fair condition, which has been previously lopped (Height: 6m, Crown: 3m, DBH: 120mm). This tree is located 2m from proposed boundary fence.

Tree 5 is a semi-mature specimen of *Ficus coronata* (Sandpaper Fig) in good health & fair condition, which has been previously lopped (Height: 6m, Crown: 2m, DBH: 130mm). This tree is located 2m from proposed boundary fence.

Tree 6 is a semi-mature specimen of *Ficus coronata* (Sandpaper Fig) in good health & fair condition, which has been previously lopped (Height: 5m, Crown: 2m, DBH: 160mm). This tree is located 1.5m from proposed boundary fence.

Tree 7 is a semi-mature specimen of *Ficus coronata* (Sandpaper Fig) in good health & fair condition, which has been previously lopped (Height: 3.5m, Crown: 6m, DBH: 180mm). This tree is located 2m from proposed boundary fence
