# Geotechnical Assessment

**Project:** Swimming Pool  
60 Cabarita Road, Avalon Beach NSW

**Ref:** AG 24287  
7 February 2025

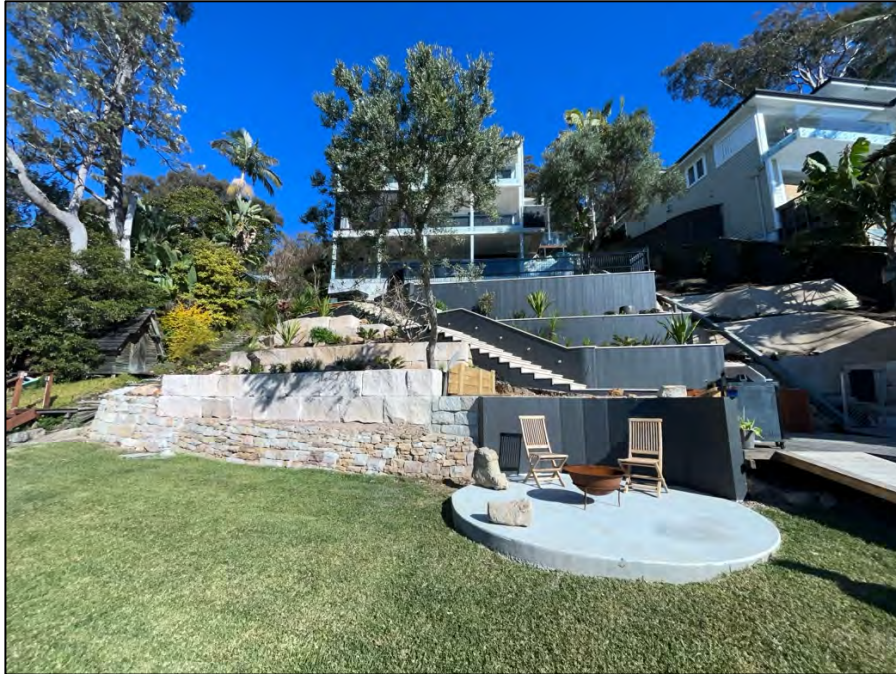
**Photo 1:** Residence rear and area of the proposed works – existing round slab

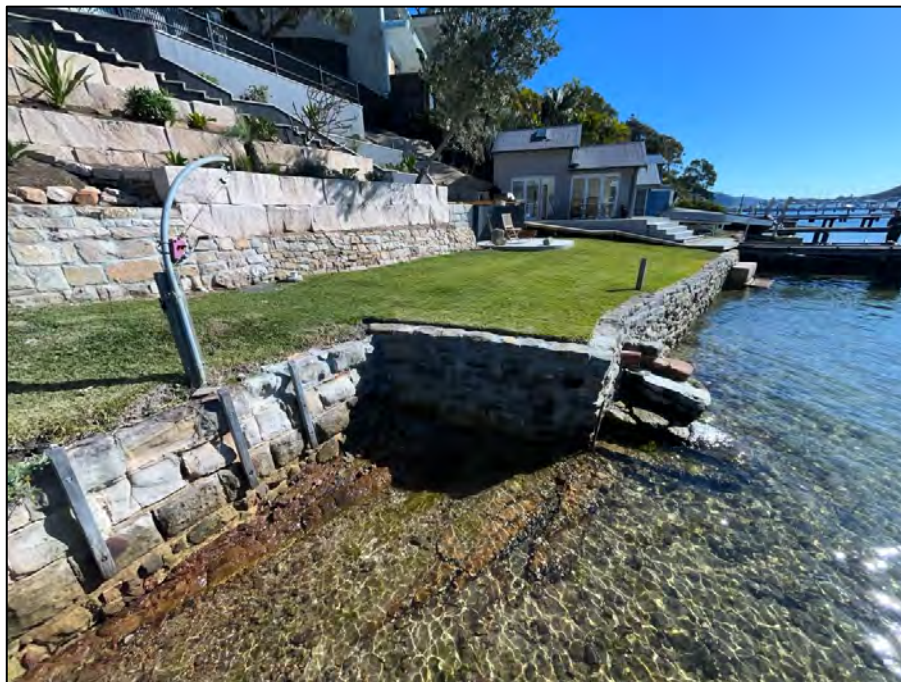
**Photo 2:** Careel Bay waterfront and area of the proposed works
