Arboricultural Impact Assessment

Prepared for Alex Hill
Site Address: 91 Florida Road Palm Beach
27th December 2021 amended under DA2021/0164

Date	Revision	Changes	Stage
15/7/2020	A	Pre DA	Pre DA
28/1/2021	B	Plan changes	DA
27/12/2021	C	Plan changes	DA 2021/0164

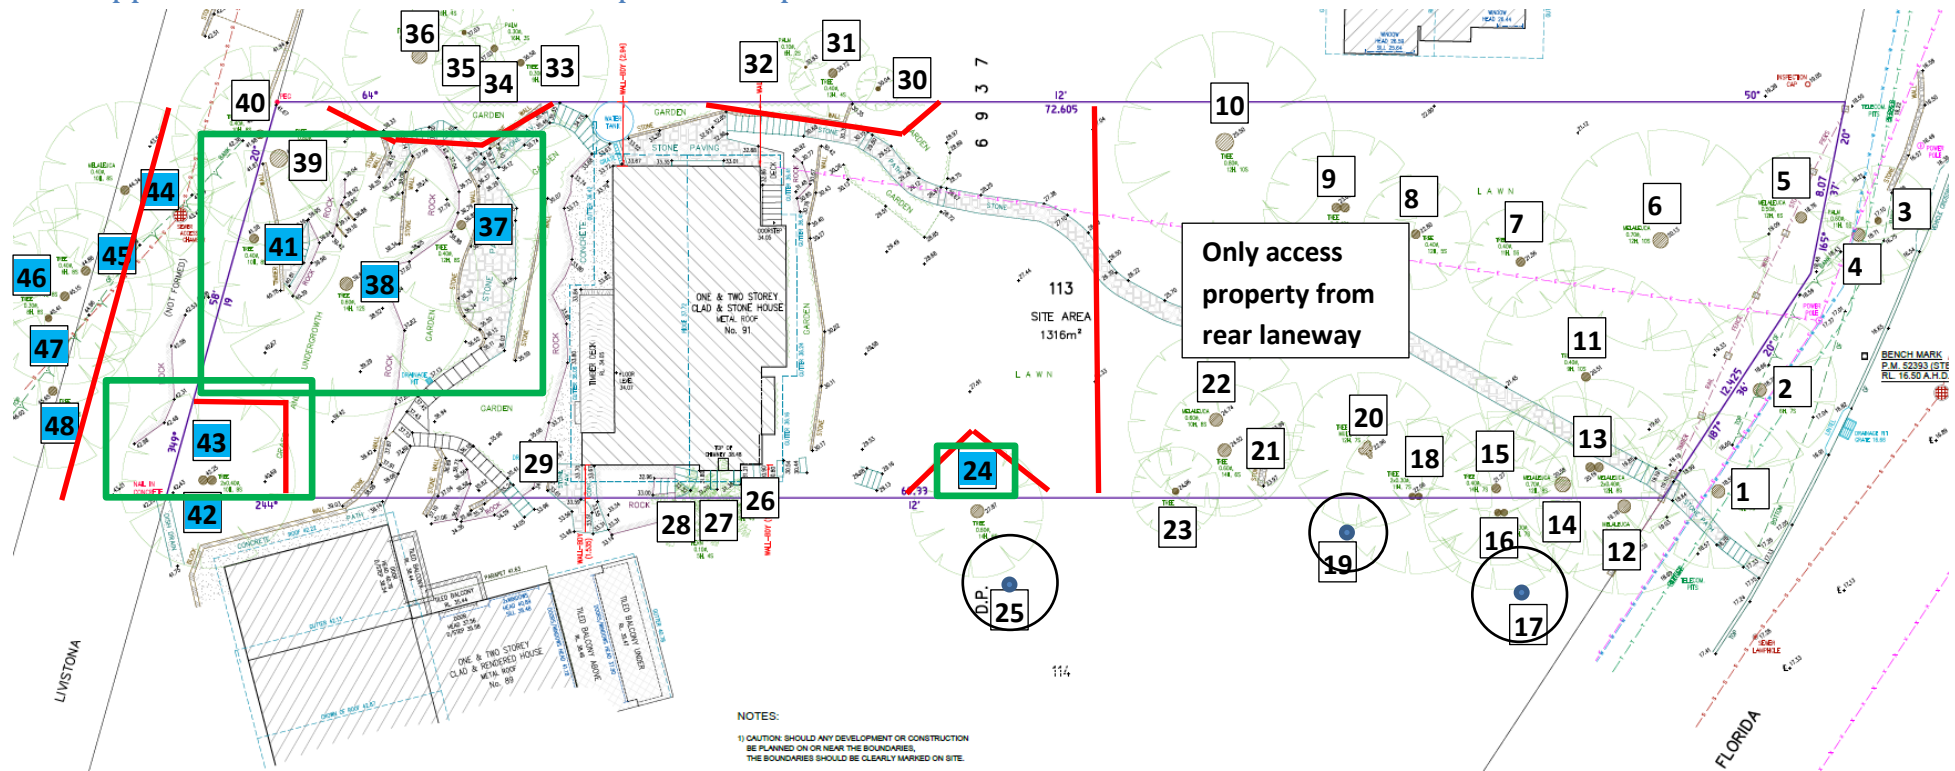
6.1 Appendix B Tree locations and tree protection plan

Trees 12, 16, 17, 18, 19, 24, 25, 27, 28 are located in the property of 89 Florida Road Palm Beach. Tree 18 is located directly on the boundary and as such any works to the tree will need joint approval from owners of 89 and 91 Florida Road Palm Beach. Trees 12, 16, 17, 18, 19, 25, 27 and 28 are unaffected by the proposal.

The proposed raised lawn area constructed beside tree 24 occupies 11.7% of the TPZ of this tree. This is marginally above the 10% recommended in AS4970-2009. As this area within the TPZ will be raised tree roots will not die immediately. This tree will have time to counteract the impact and replace its lost root structure. This tree will be retained and protected.

Trees 30, 31, 32, 33, 34, 35 and 36 are located in the property of 93 Florida Road Palm Beach. There is no projected impact to these trees. This is in accordance with AS4970-2009. They are to be retained and protected.

Trees 40 and 44 are located on Livingstonia Lane (not formed and council owned). It is proposed tree 40 is removed to construct the laneway providing access to the proposed garage. This tree is of moderate retention value due to its declining health. The estimated incursion of tree 44 is 21.2%, this is greater than is accepted in AS 4970-2009, however this species is drought tolerant and can withstand 21.2% incursion into the root system (Serbesoff-King, K., 2003). This tree also develops tree root densities much greater than other native tree species giving it increased stability and tolerance. (Lopez-Zamora et al, 2004).

Trees 45, 46, 47 and 48 are located in the property 137 Pacific road Palm Beach. There is no projected impact to tree 47, the incursion of the TPZ to trees 46 and 48 is less than 10%, this conforms to AS 4970-2009. The incursion to tree 45 is 11.1% this is only marginally greater than 10% and is acceptable.

Trees 5, 6, 7, 8, 9, 10, 11, 13, 14, 15, 20, 21, 22, 23, 26, 29, 37, 38, 39, 41, 42 and 43 are located within 91 Florida Road Palm Beach. Of these trees, numbers 5, 6, 7, 8, 9, 10, 11, 13, 14, 15, 20, 21, 22, 23, 29 have no incursion into the root zones. Tree 26 has 15% incursion; this tree is young and should tolerate the root disturbance. It is also readily replaced if required.

1. Removal of trees 39 and 40.
2. Retain trees 1-38 and 41-48.
3. Ensure fill does not encroach within 2.5 metres of tree 41 and 3 metres of trees 42 and 43.
4. Install soak away uphill from tree 38 along boundary.
5. Tree removal should be conducted by an Arborist with a minimum (Australian Qualification Framework) AQF level 3.
6. Work must be undertaken as per the Code of Practice Amenity Tree Industry 1998.
7. The tree removal process and staff should be skilled and undertake the removal of the tree as per the minimum industry standards.
8. Appoint project arborist. Minimum AQF Level 5 with 5 years' experience.
9. Retain and protect trees as per tree protection plan section 6.1. This includes physical fencing of the retained trees, trunk protection and ground protection. See Section 7 Appendix G for specifications.

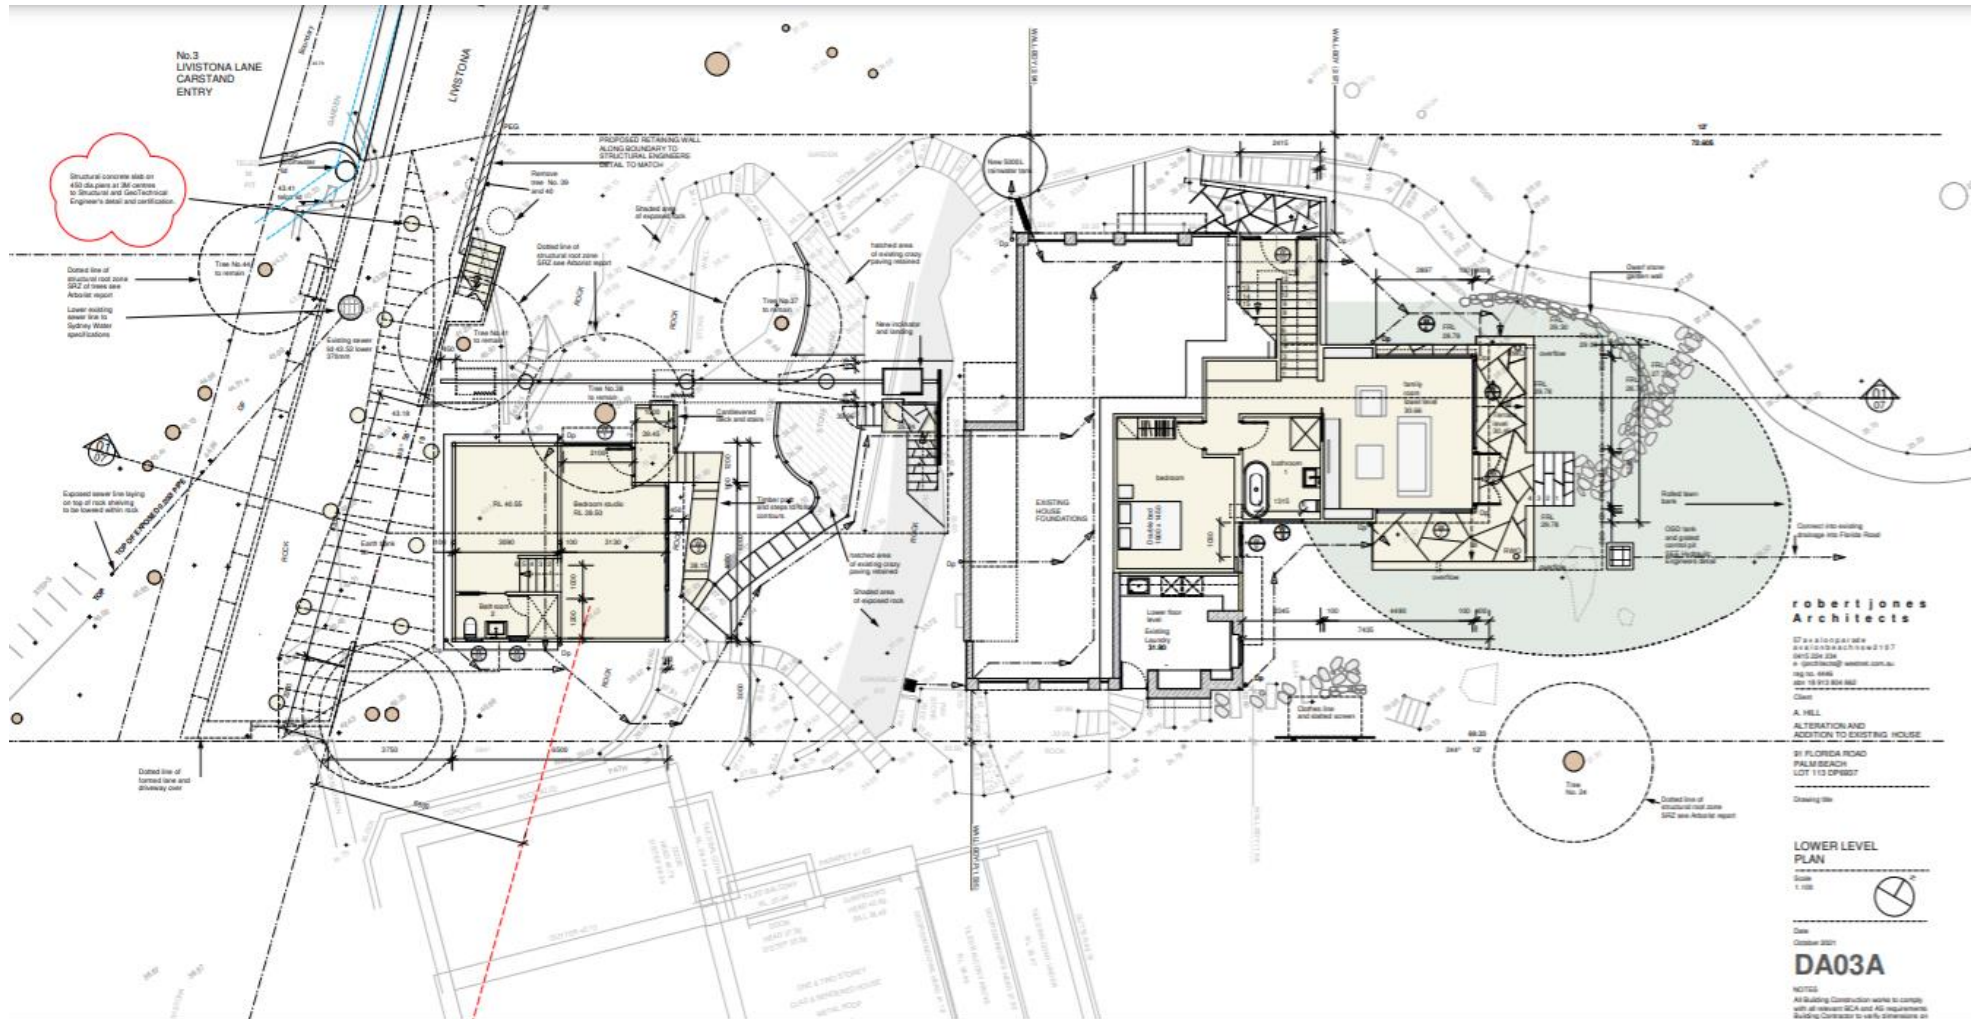
6.1.1 Lower level

The only proposed structure within the TPZ of tree 37 is a pier for the inclinator. This will have minimal effect on the tree. This tree is to be retained and protected.

It is proposed tree 38 is retained. The garage and inclinator are located within the TPZ, inclinator piers are located outside the SRZ. The proposed works will have minimal impact less than 10% to the TPZ. Subterranean water flows are maintained, however to compensate for loss of surface water, one down pipe from the garage roof should be directed into a soak away uphill from tree 38 along boundary.

It is proposed tree 39 is to be removed due to its low retention. This tree has approximately 10% foliage cover and is likely to be completely dead within 5 years. Although this tree is of high significance the tree is in extremely poor health and is not worthy of retention.

The impact to tree 41 is 36.8% due to the cut and fill created from the construction of the access road. Provided fill is excluded from within 2.5 metres and natural ground level is maintained within the TPZ of this tree, the impact is calculated at 10%. It is proposed this tree is retained.

Tree 42 has part of the TPZ covered by the carport, this is a piered structure. This will have minimal effect to the tree. The entry road is partially raised with areas of cut and fill, fill from under the road must not extend within 3 metres of this tree. Provided natural ground level to the west is retained within 3 metres of this tree the TPZ encroachment has been calculated at 9.8% and this is within the AS4970-2009 guidelines. The impact to tree 43 has been calculated at 4.2% encroachment. This tree is listed as low retention; however it will be retained.
