PRELIMINARY GEOTECHNICAL INVESTIGATION REPORT

PROPOSED SUBDIVISION

337 LOWER PLATEAU ROAD, BILGOLA PLATEAU, NSW

Project No.: 2022-214 October 2022

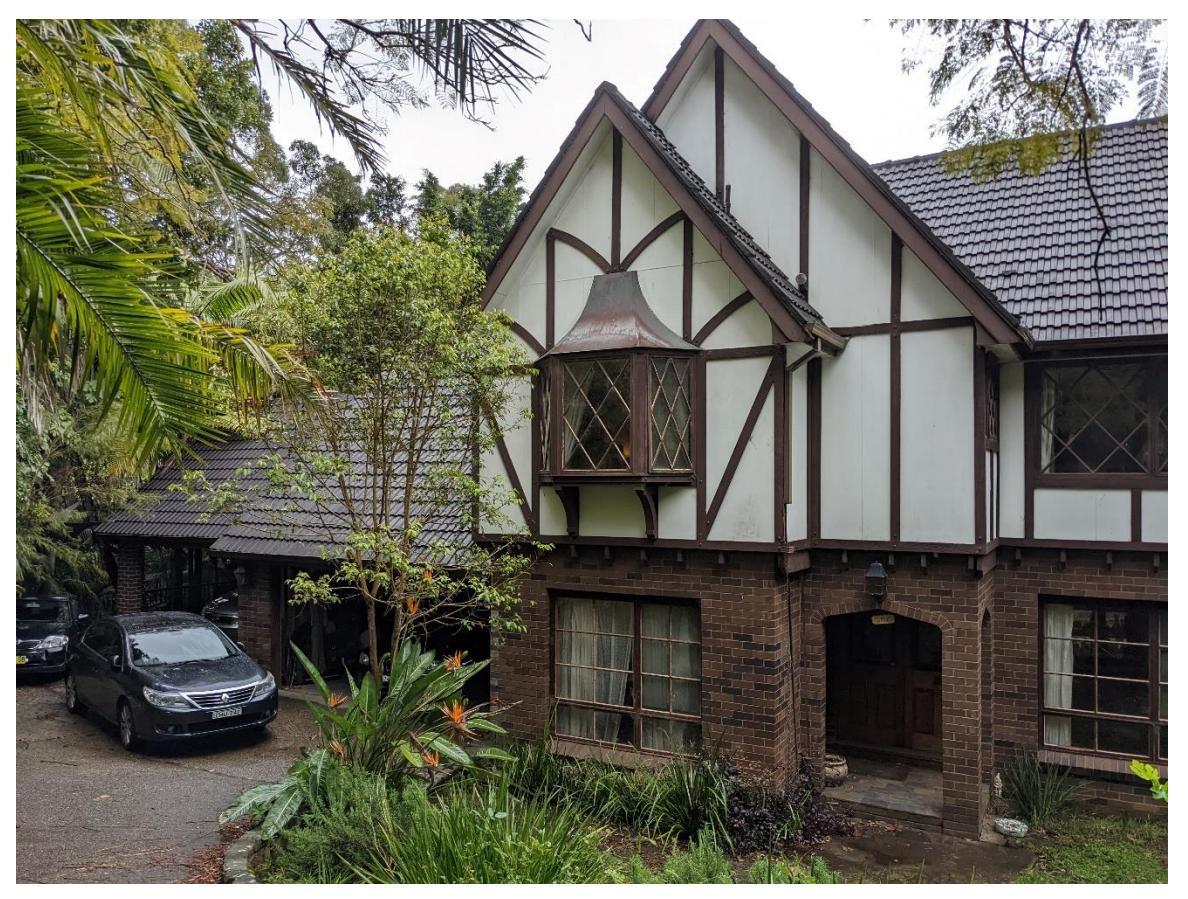
The site dwelling structure is a two and three storey brick and timber house positioned towards the east of the block at the base of the driveway, with a garage attached to the southern end and a concrete swimming pool to the north. Due to the sloping topography of the site the ground levels on the front, eastern side of the house are one level higher than the levels on the rear, western side. The structures appeared to be founded directly on sandstone bedrock which was outcropping adjacent and there were no indications of

excessive settlement or deflection in visible walls. Photograph 2 below shows the front of the house from the driveway.

Photograph 2: View of the front of the site dwelling structure from the driveway, looking roughly west

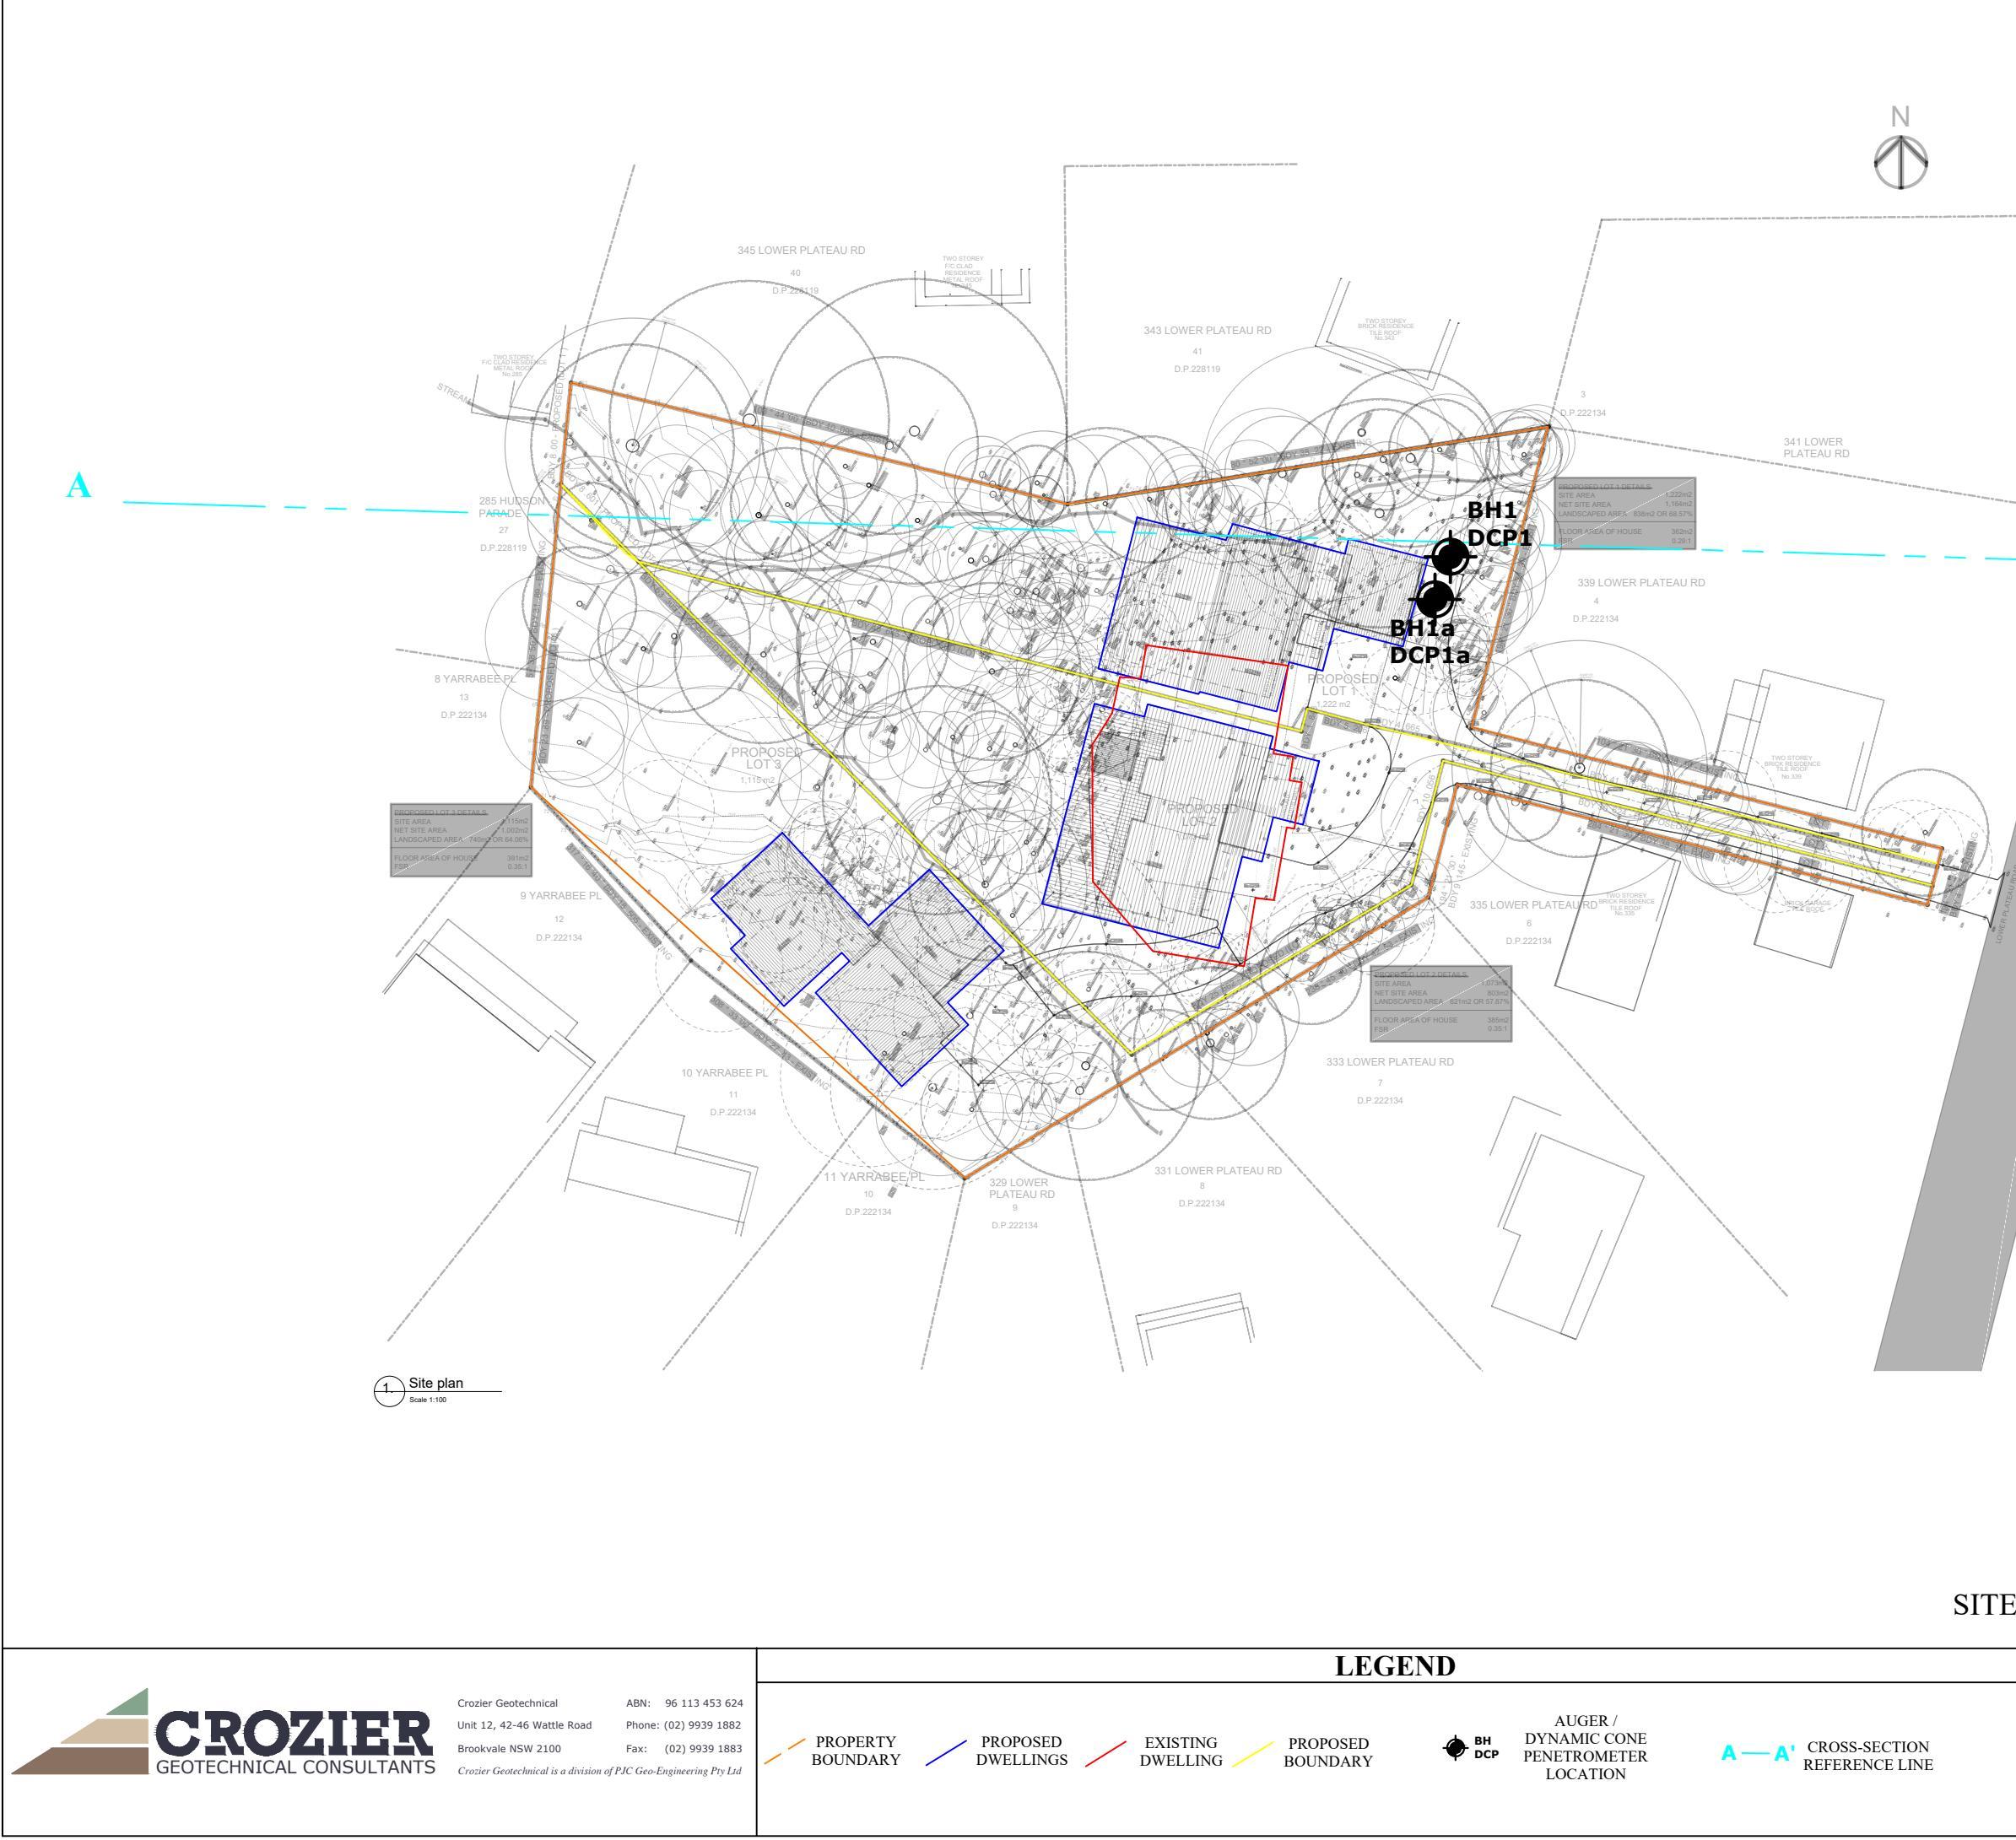
FIGURE 1.

SITE PLAN & TEST LOCATIONS
