60-62 Chisholm Avenue, Avalon Beach

Comments on Updates to Plans

GEOTECHNICAL INVESTIGATION:

New Driveway and Garage at **60-62 Chisholm Avenue, Avalon Beach**

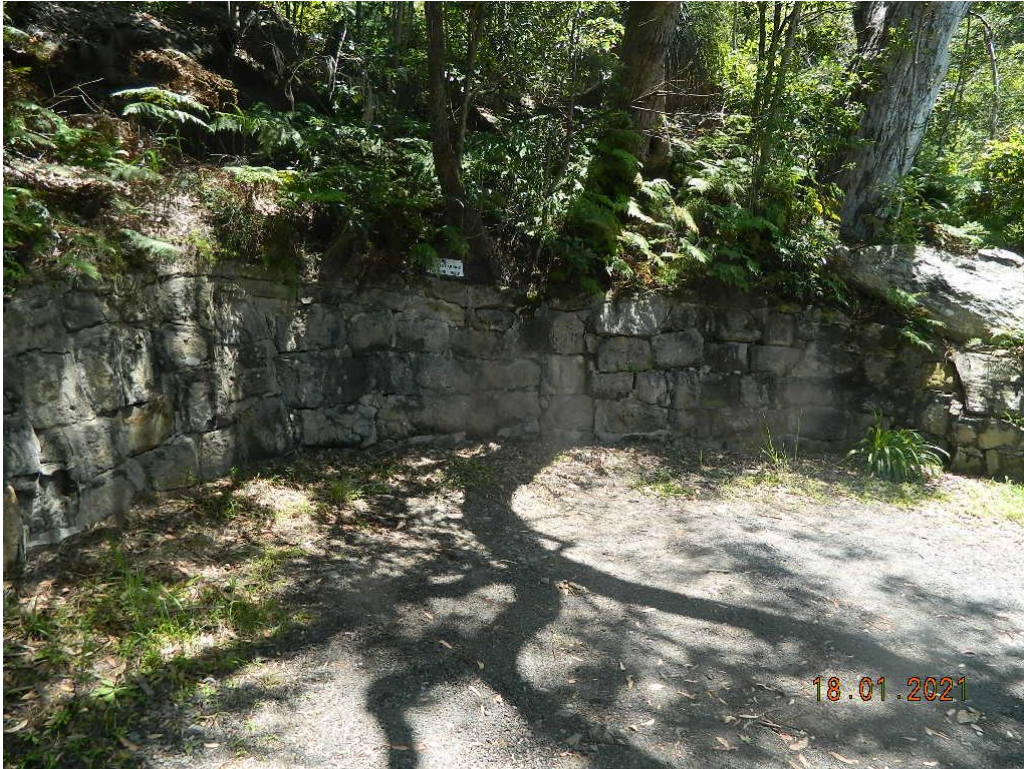
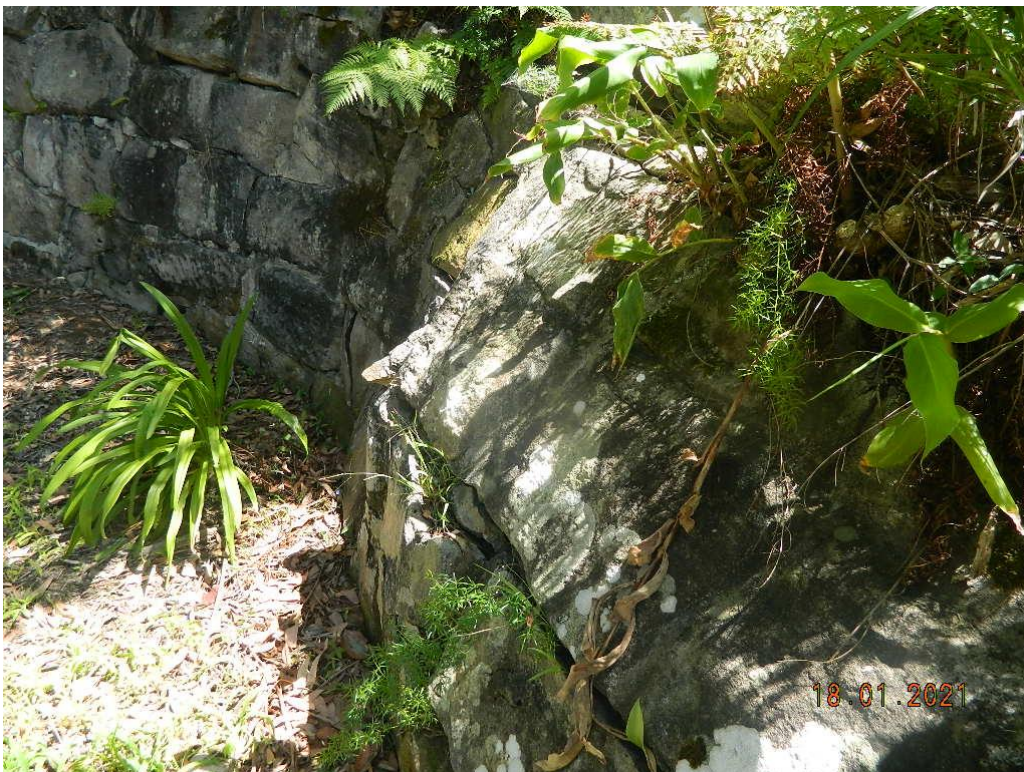
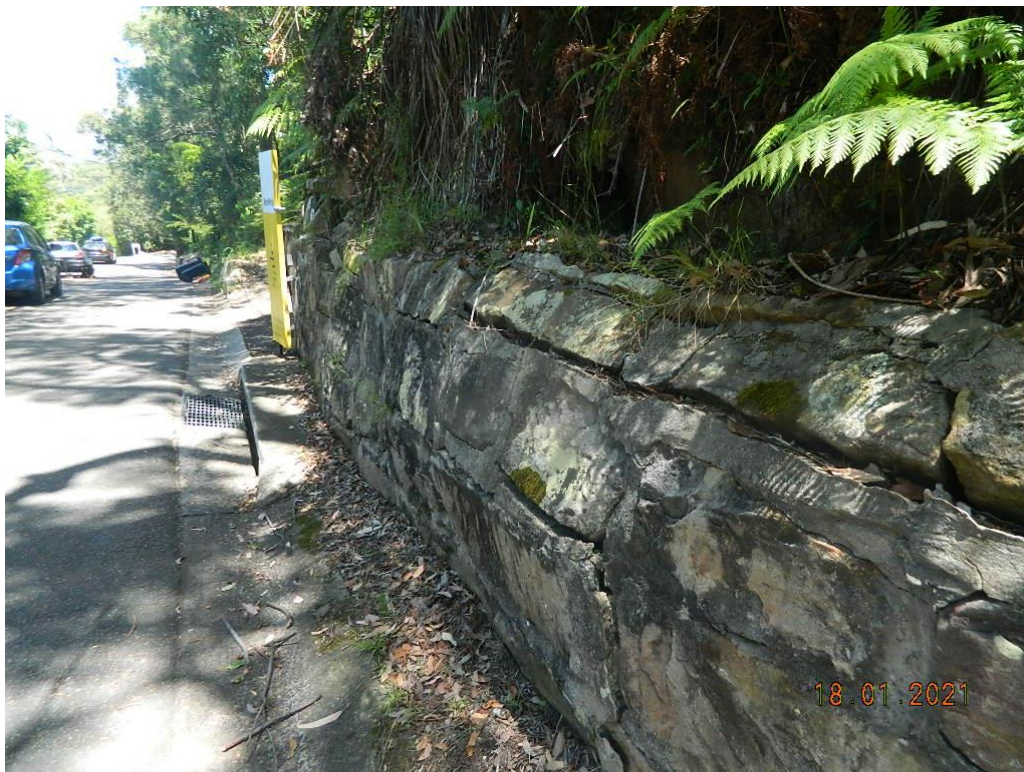
- 2.3** A turning circle is located at the road frontage (Photo 1). The cut for the road and turning circle is supported by a sandstone block retaining wall up to ~1.5m high. The wall displays bulging in places (Photos 2 & 3). See 'Section 16 Ongoing Maintenance'. Medium Strength Hawkesbury Sandstone Bedrock is outcropping at the road frontage (Photo 4). Sandstone bedrock is exposed at the surface and dislodged joint blocks are embedded in stable positions in the steep vegetated slope between the road frontage and the houses (Photos 5 to 7).

The excavation requires the removal of an existing sandstone block retaining wall (Photo 1). The wall is to be demolished from the top down prior to the excavation commencing. The soil and

Part of the bulging sandstone block retaining wall (Photos 1 to 3) will be demolished as part of the proposed works. The remaining portion is in poor condition. It is recommended it be repointed/rebuilt to meet current engineering standards as part of the works, if this is not already planned.

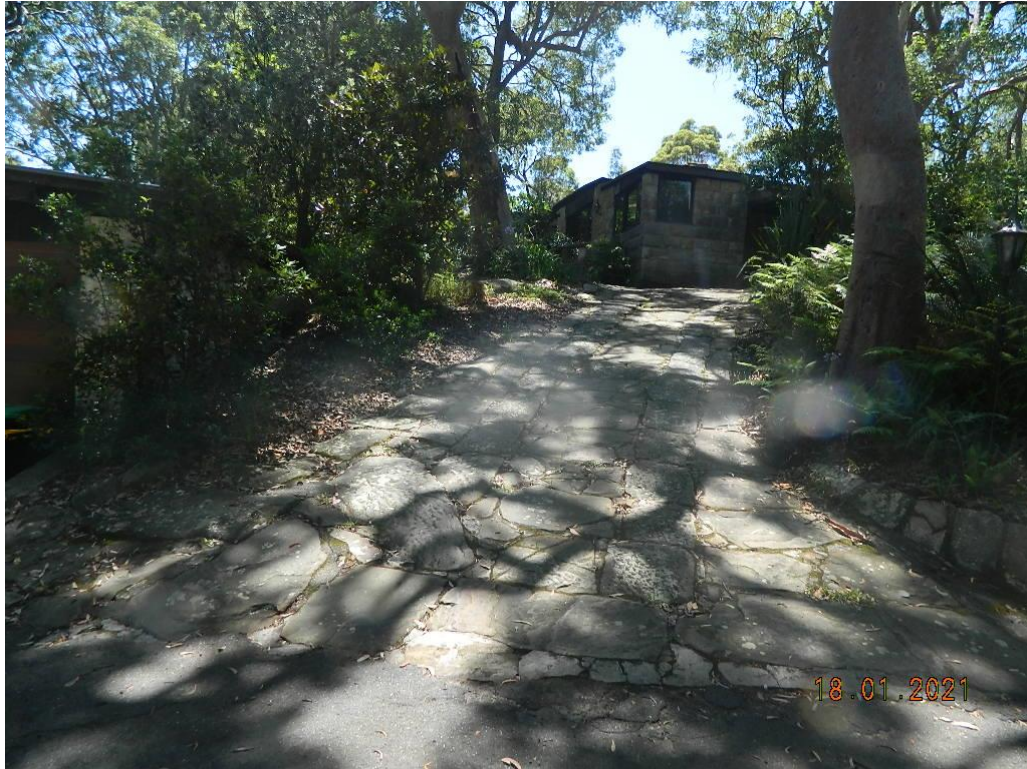
The house at 62 Chisholm Ave is accessed by a bitumen right of carriageway (ROW) and sandstone driveway (Photos 8 & 9). A sandstone dressed concrete block garage in good condition is located on the W side of the house (Photo 10). The old single storey sandstone block house is supported by sandstone block walls and sandstone piers (Photo 11). The supporting walls and piers stand vertical and display no significant signs of movement (Photo 12). The house is supported on exposed sandstone bedrock on the crest of the slope. A moderately sloping lawn on the NW side of the house is terraced by stable sandstone block retaining walls up to ~1.5m high. Sandstone bedrock is outcropping on the steep slope on the NW side of the property. A portion of the rock is undercut by up to ~3.5m (Photos 13 & 14). The undercut has a relatively thin cantilever arm in relation to its overhang length however has stood in its present state for at least hundreds of years. In the unlikely event that the undercut fails, it will fall onto the area immediately below. Given the location of the undercut and provided no one spends time under it, it is not considered a significant threat to life or property.

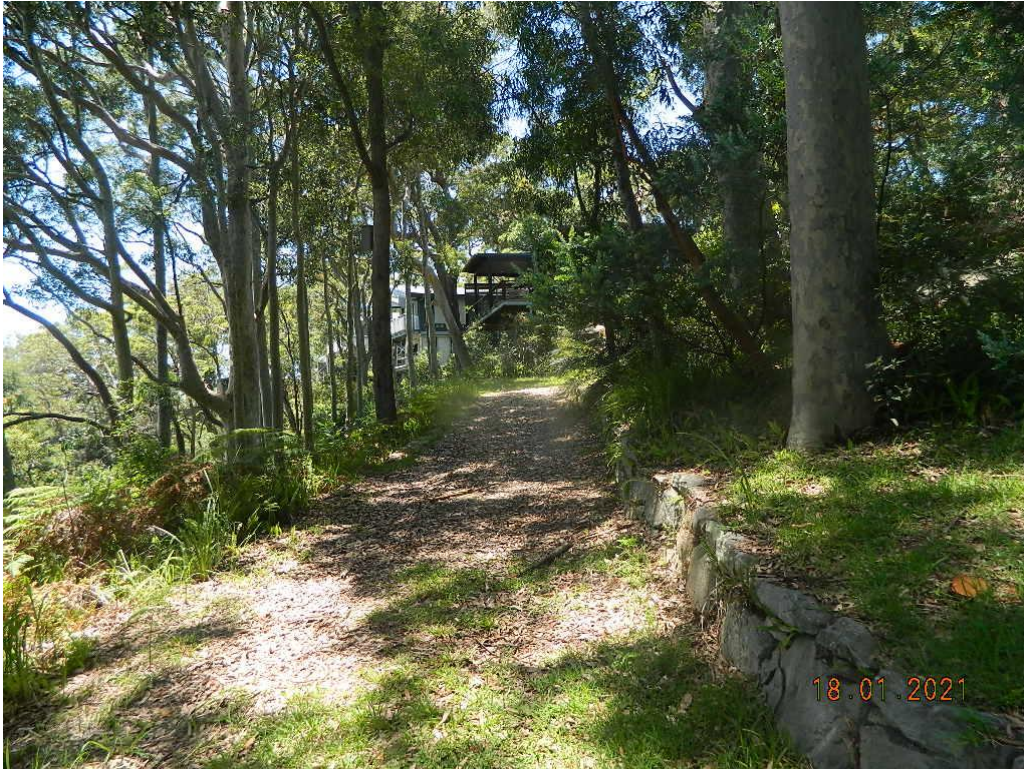
Photo 15

The ROW extends to the house at 60 Chisholm Ave (Photo 15). A pool in good condition is located on the W side of the house (Photo 16). A stable sandstone block retaining wall up to ~2.2m high supports fill on the downhill side of the pool. The part two storey timber clad house is supported by steel posts and concrete block walls (Photos 17 & 18). The supporting posts and walls stand vertical and show no significant signs of movement.

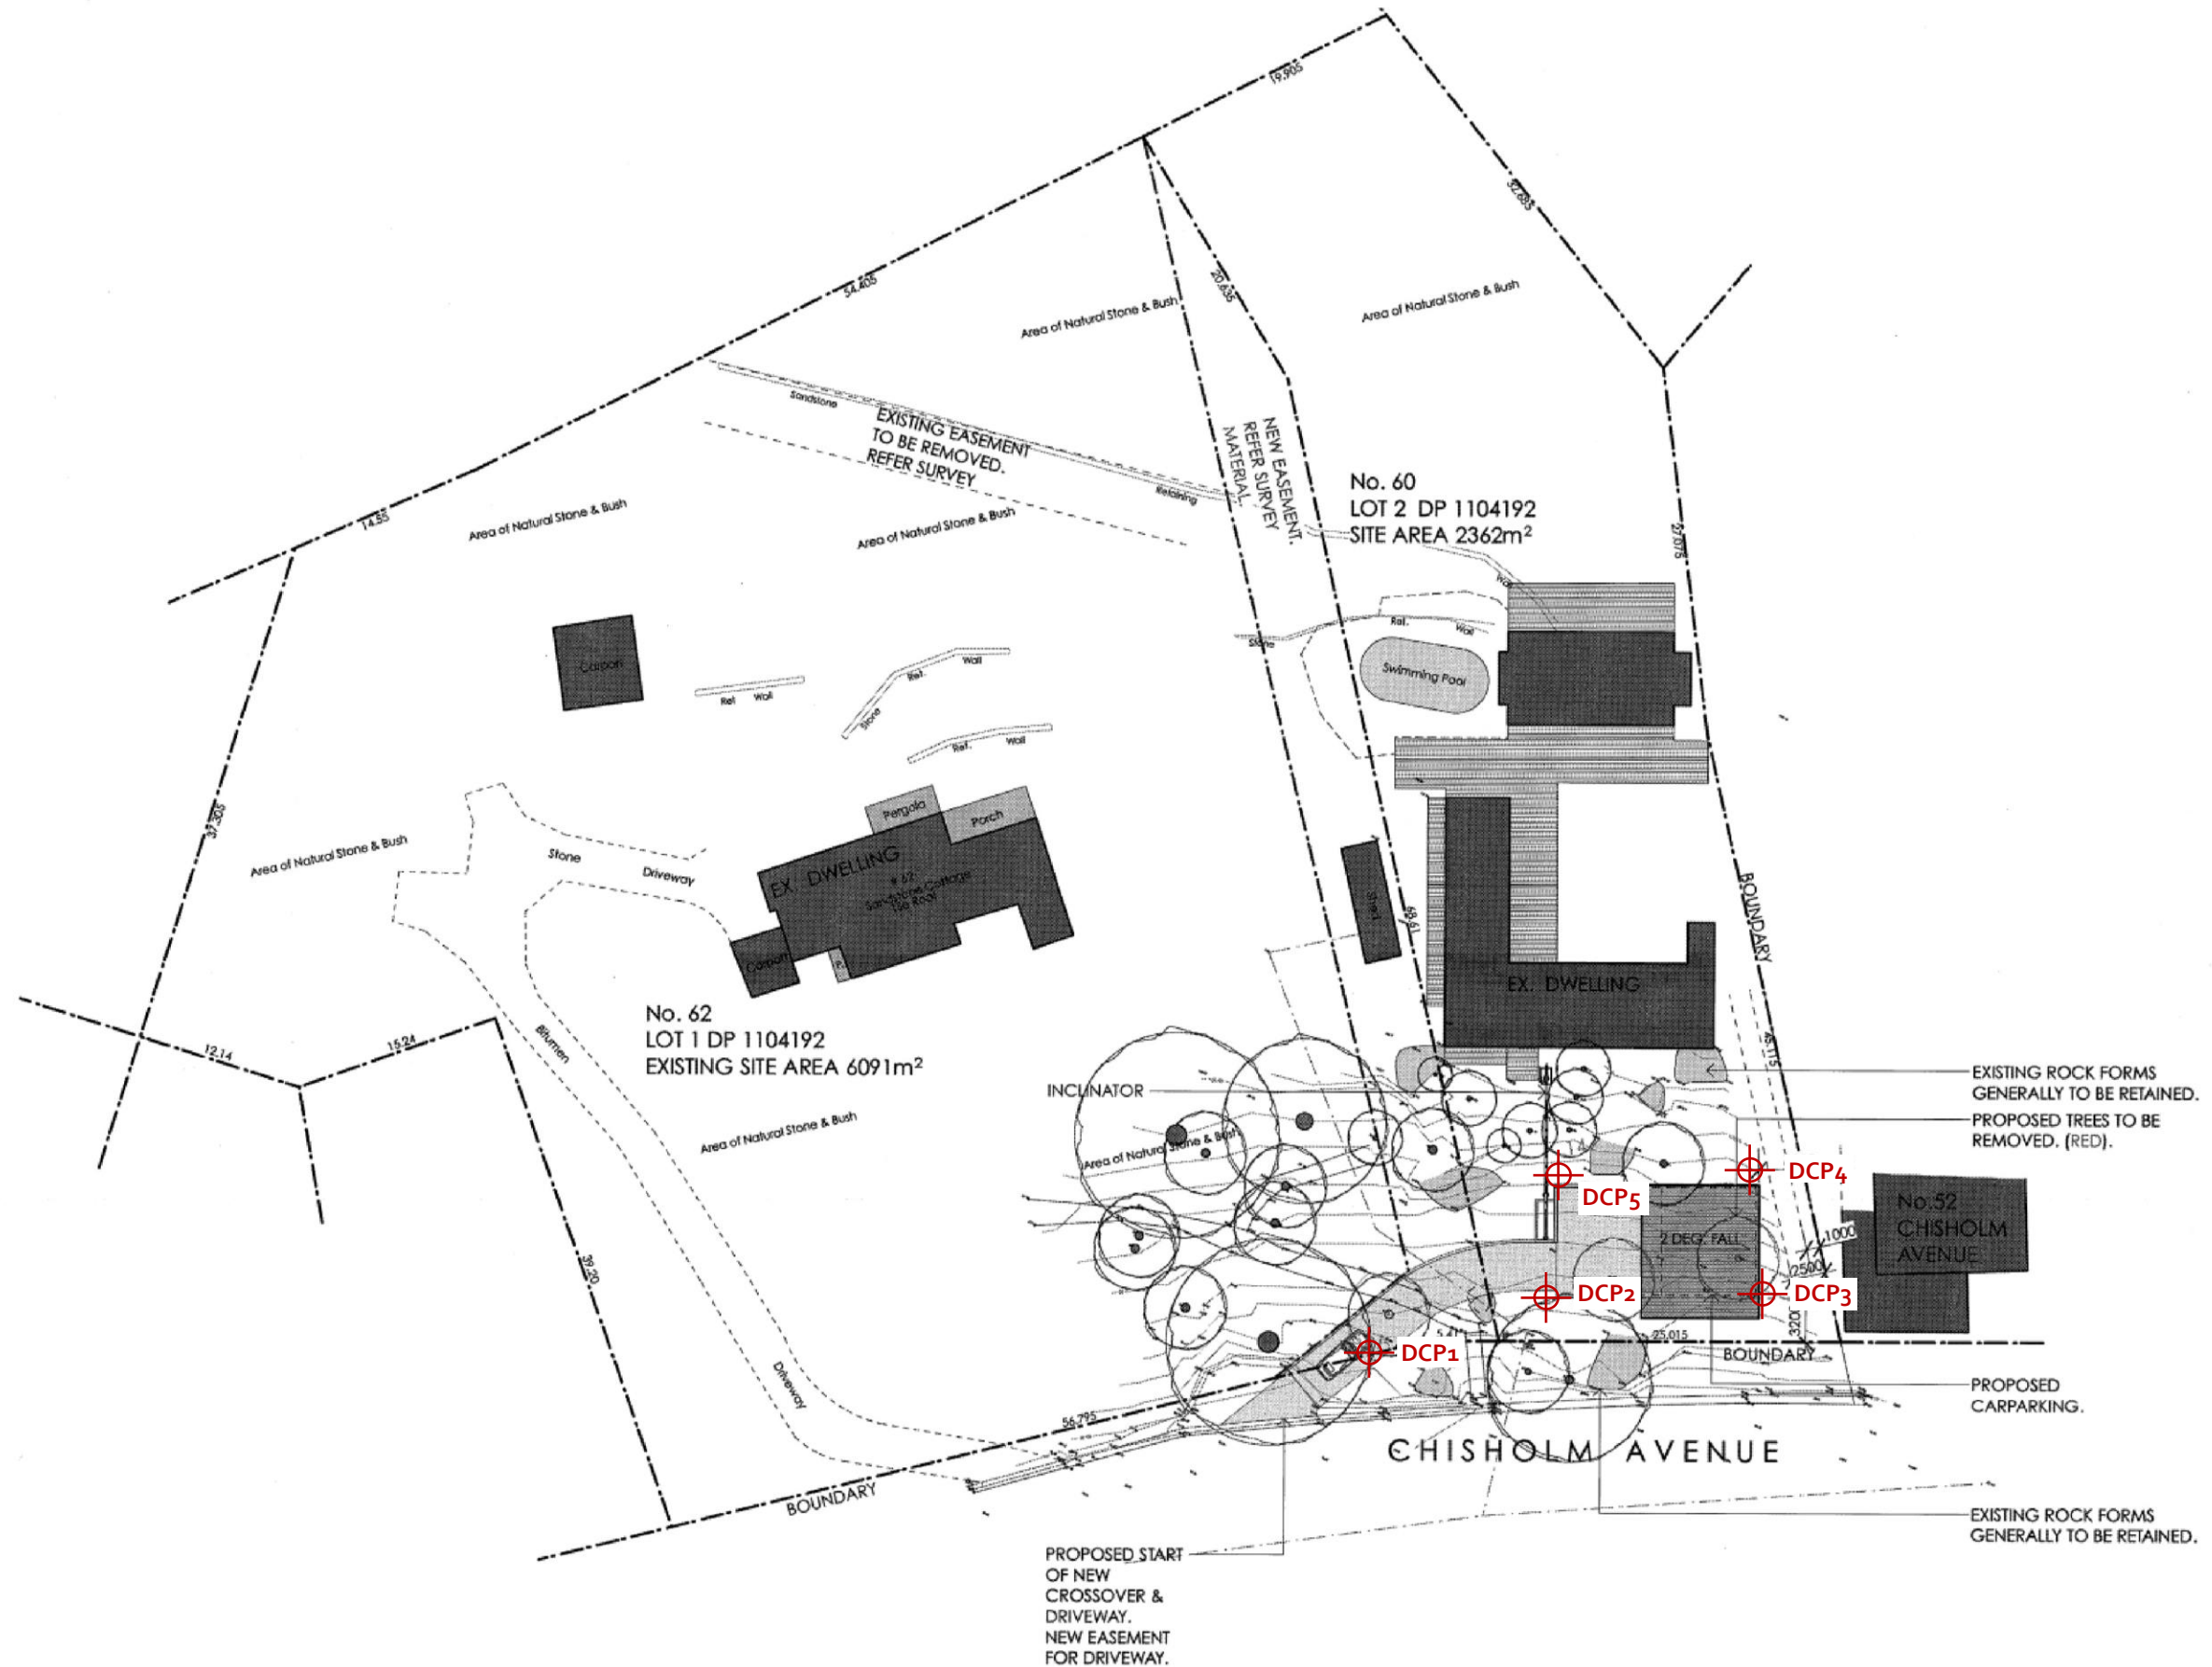
SITE PLAN – showing test locations

Five Dynamic Cone Penetrometer (DCP) tests were put down to determine the relative density of the overlying soil and the depth to weathered rock. The locations of the tests are shown on the site plan. It should be noted that a level of caution should be applied when interpreting DCP test results. The test will not pass through hard buried objects so in some instances it can be difficult to determine whether refusal has occurred on an obstruction in the profile or on the natural rock surface. This is not expected to be an issue for the testing on this site. But due to the possibility that the actual ground conditions vary from our interpretation there should be allowances in the excavation and foundation budget to account for this. We refer to the appended "Important Information about Your Report" to further clarify. The results are as follows:

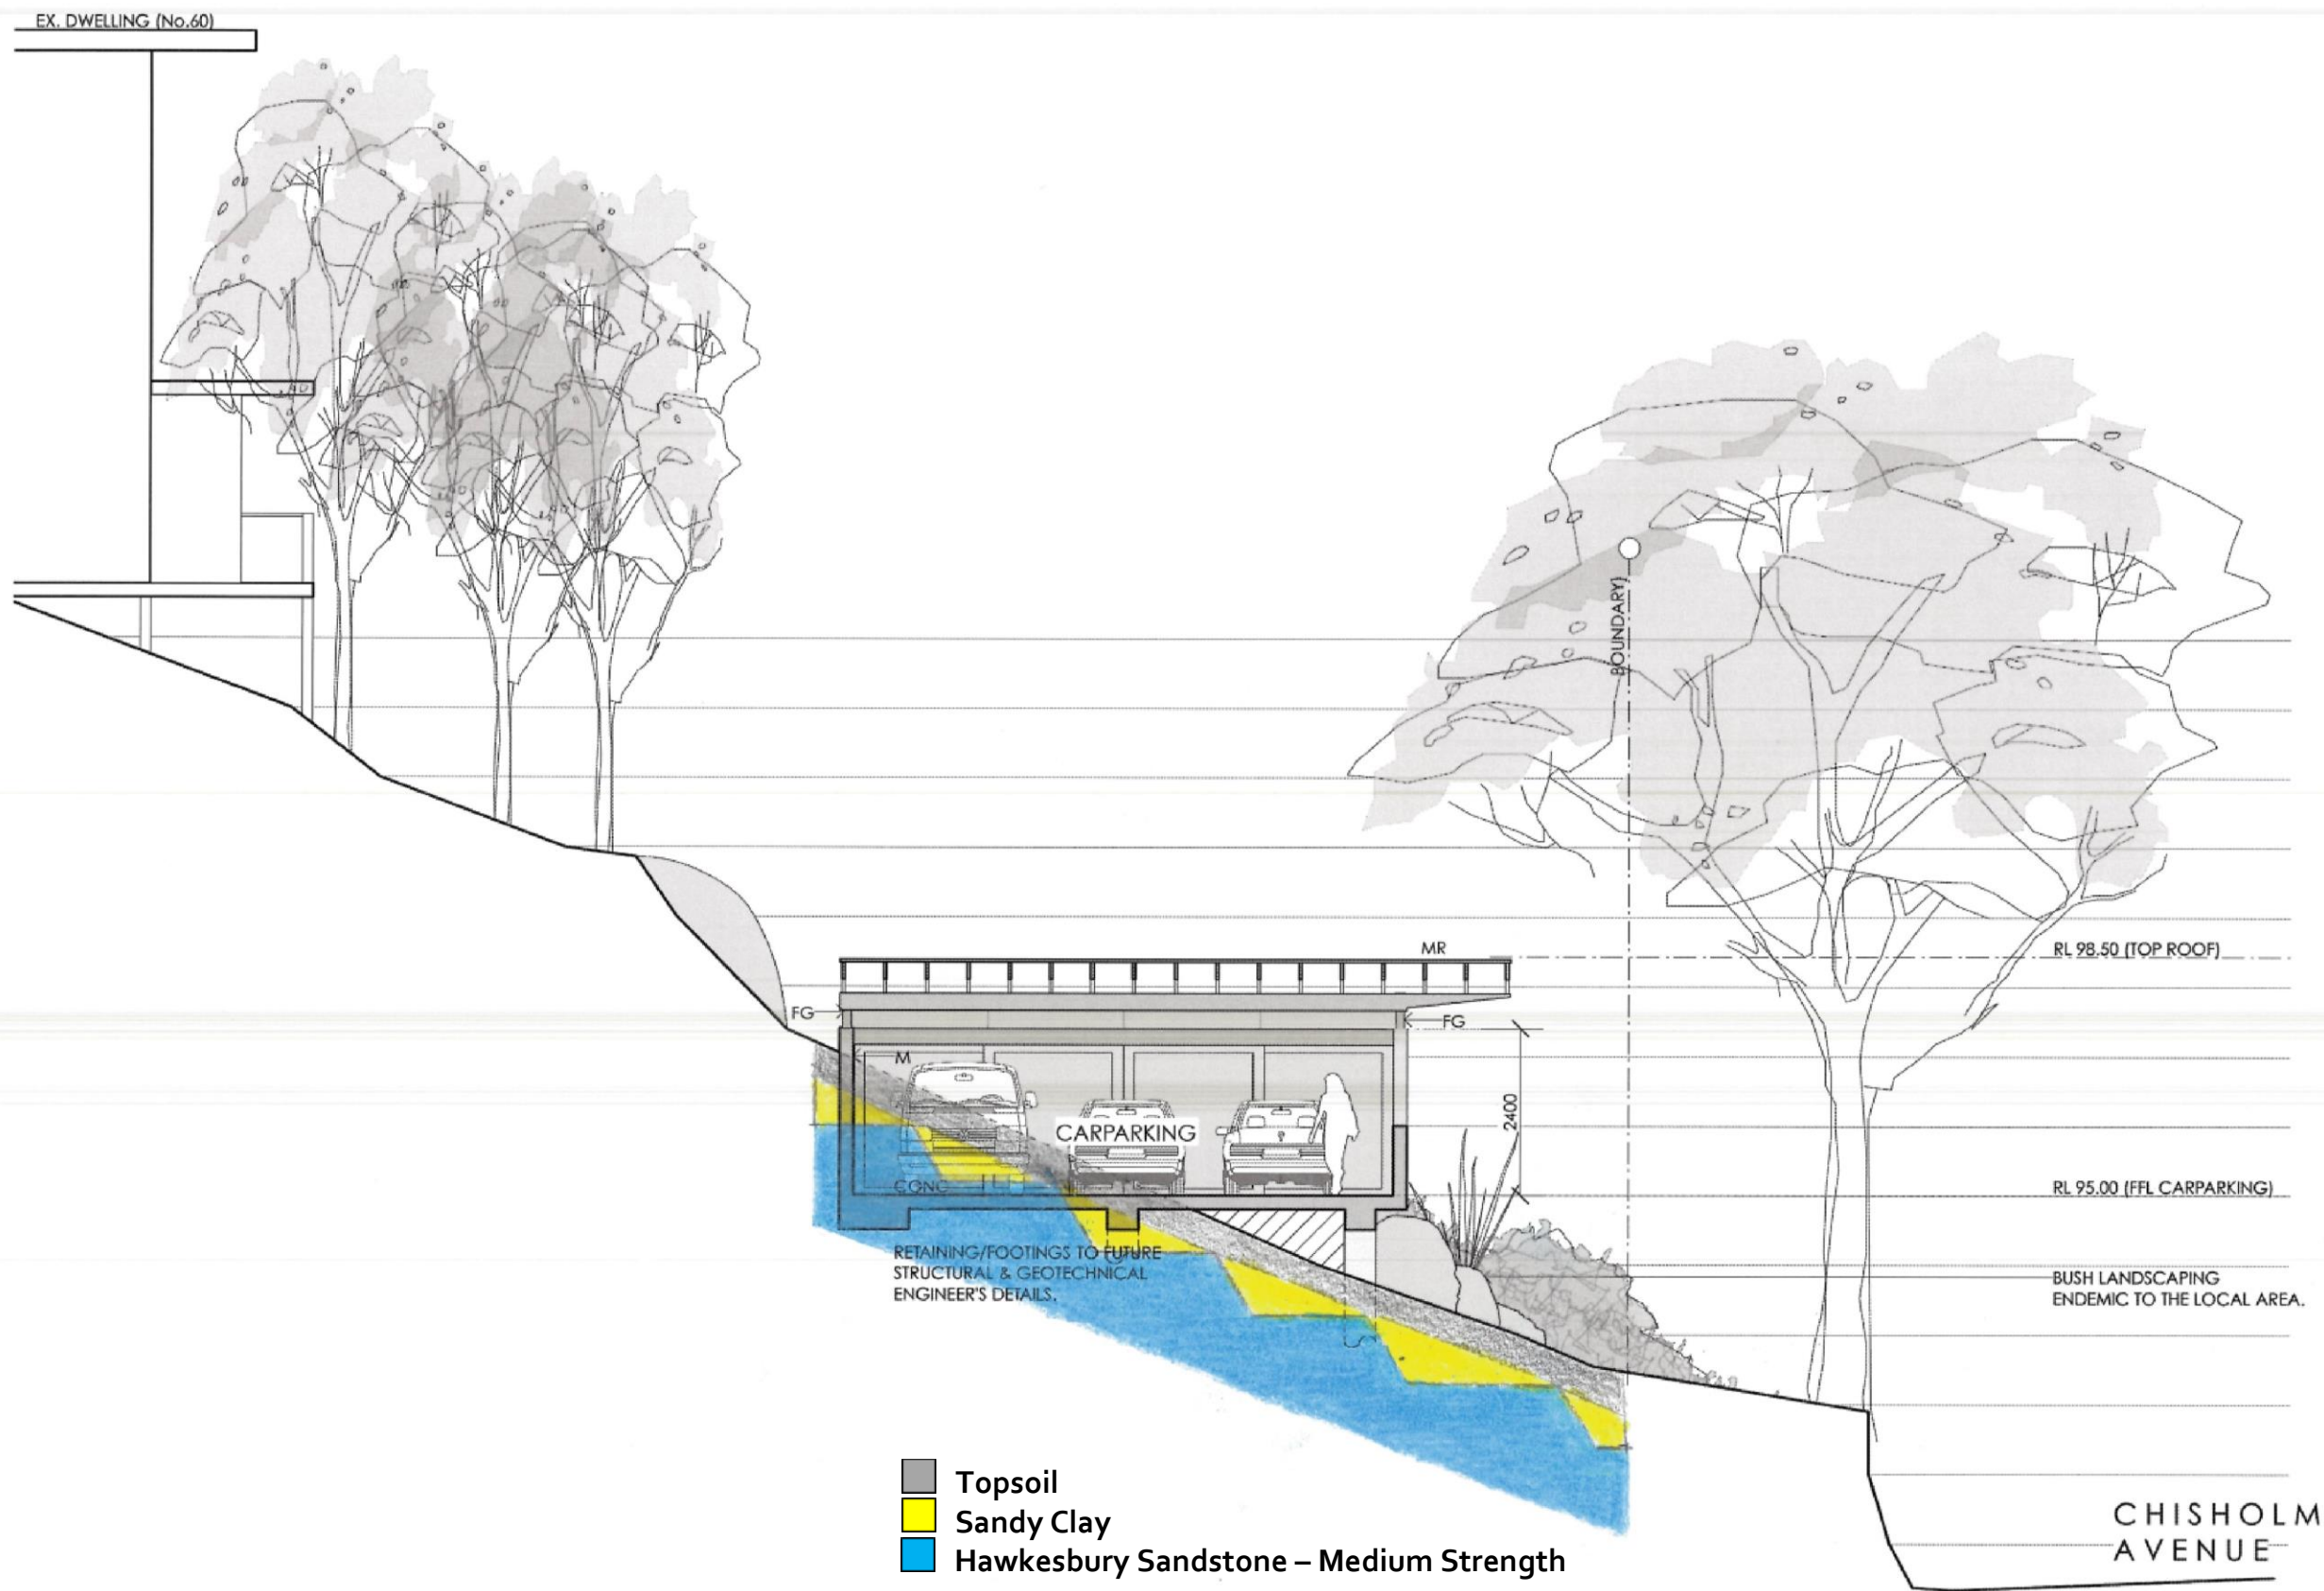
TYPE SECTION – Diagrammatical Interpretation of expected Ground Materials

The surface features of the block are controlled by the underlying sandstone bedrock that steps down the property forming sub-horizontal benches between the steps. Where the grade is steeper, the steps are larger and the benches narrower. Where the slope eases, the opposite is true. The rock is overlain by fill, topsoil and sandy clays that fill the bench step formation. Fill provides level platforms for lawn and garden areas across the properties. In the test locations, the depth to rock ranged from between ~0.8m to ~1.2m below the current surface. The sandstone underlying the property is estimated to be Medium Strength or better. See Type Section attached for a diagrammatical representation of the expected ground materials.
