**Re: Development Consent No. NO866/04
Construction Certificate No. 2005/737B**

Determination of a Final Occupation Certificate Application

Final Occupation Certificate No: 2005/737B

Address: 117 Mona Vale Road, Ingleside

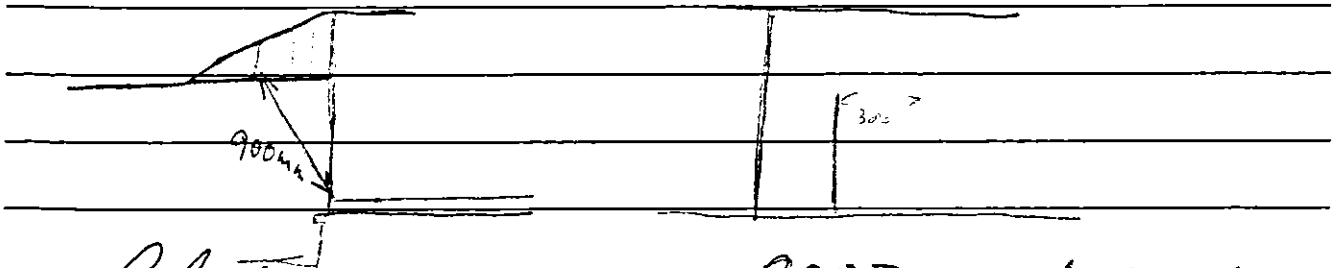
Cover up eliminable section as shown below.

Now satisfactory
