ARBORICULTURAL IMPACT ASSESSMENT

**24 Cabarita Road,
Avalon Beach
NSW**

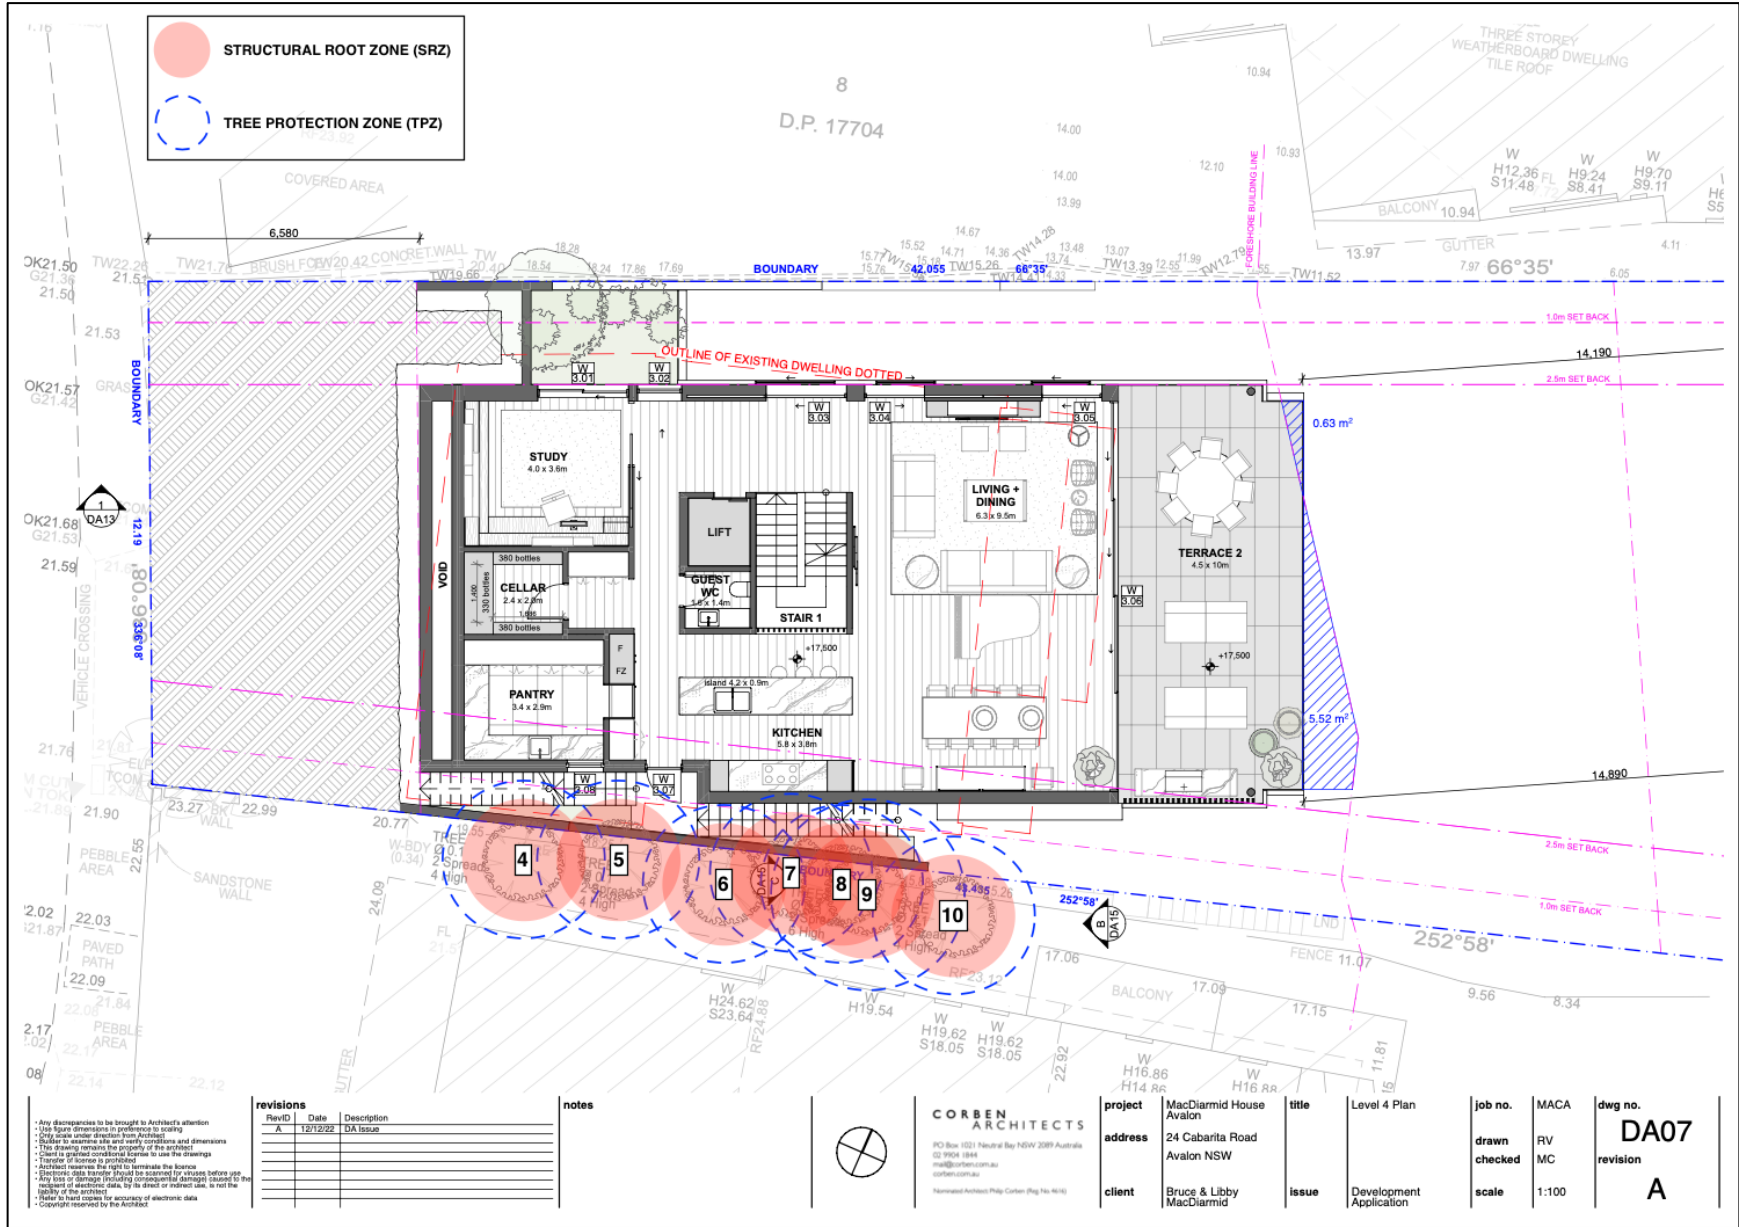
PLAN 2: Level 4 Plan – Calculated SRZ & TPZ for retained third-party trees (Plan supplied by client December 2022).

Tree 4's calculated SRZ and TPZ extends into the subject site. Significant surface roots can be seen adjacent to the site's boundary fence, which extend underneath the existing external wooden staircase.

Tree 5's calculated SRZ and TPZ extends into the subject site. Significant surface roots can be seen adjacent to the site's boundary fence, which extend underneath the existing external wooden staircase.

Tree 6's calculated SRZ and TPZ extends into the subject site. Significant surface roots can be seen adjacent to the site's boundary fence, which extend underneath the existing external wooden staircase.

Tree 7's calculated SRZ and TPZ extends into the subject site. Significant surface roots can be seen adjacent to the site's boundary fence, which extend underneath the existing external wooden staircase.

Tree 8's calculated SRZ and TPZ extends into the subject site. Significant surface roots can be seen adjacent to the site's boundary fence, which extend underneath the existing external wooden staircase.

Tree 9's calculated SRZ and TPZ extends into the subject site. Significant surface roots can be seen adjacent to the site's boundary fence, which extend underneath the existing external wooden staircase.

Tree 10's calculated SRZ and TPZ extends into the subject site. Significant surface roots can be seen adjacent to the site's boundary fence, which extend underneath the existing external wooden staircase.

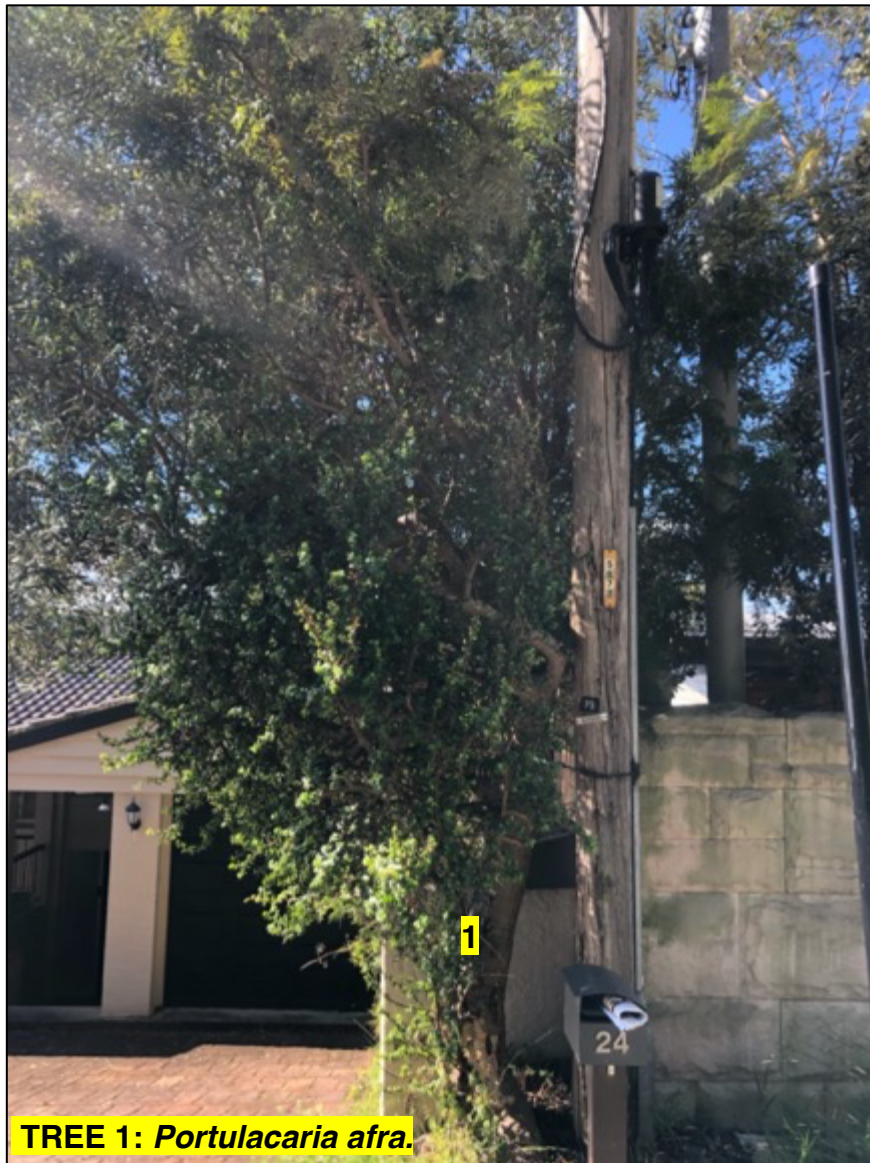
Tree 1 is a succulent growing on the south-western corner of the subject site.

Tree 1 is not actually a tree by definition. Refer to Image 1 for further details.

Tree 1 is to be removed to facilitate the proposed 'rubbish bin storage location'.
