# 38 Lindley Avenue, Narrabeen

Geotechnical Comments for New DA

# **GEOTECHNICAL INVESTIGATION:**

### New house at 38 Lindley Avenue, Narrabeen

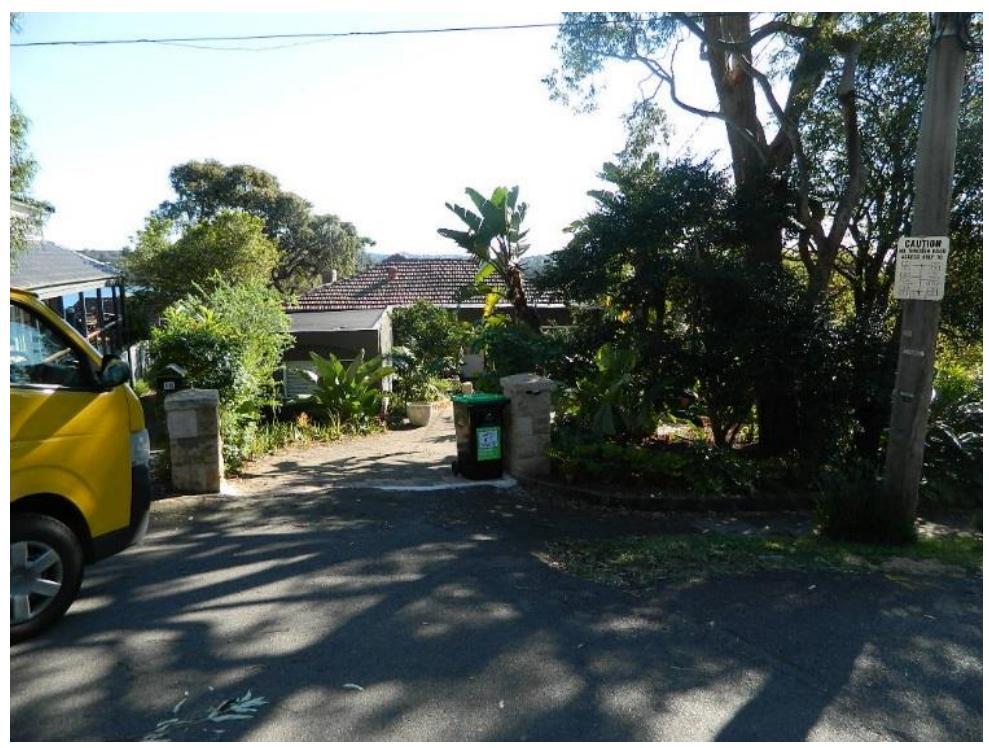
#### Photo 1

**2.3** At the road frontage a paved driveway runs to a parking area above the house (Photo 1 & 2). The single storey rendered brick house is in good condition for its age. One of its supporting brick piers is tilting ~5° downhill (Photo 3). This type of settlement is common in houses of a similar age. The house is estimated to be 30 years old and the movement probably occurred in the years immediately after construction. Any further movement is expected to be minor and the pier is currently considered stable. The remaining brick piers and walls display no signs of movement. A fill has been placed on the downhill side of the house to create a level lawn (Photo 4). It is supported by an old mortared sandstone flagging wall that appears well constructed (Photo 5). This wall also supports a cut for the right of carriageway that extends beside the eastern boundary of the subject property. Another right of carriageway extends beside the western boundary of the property to service the neighbouring property below. The cut batter for this

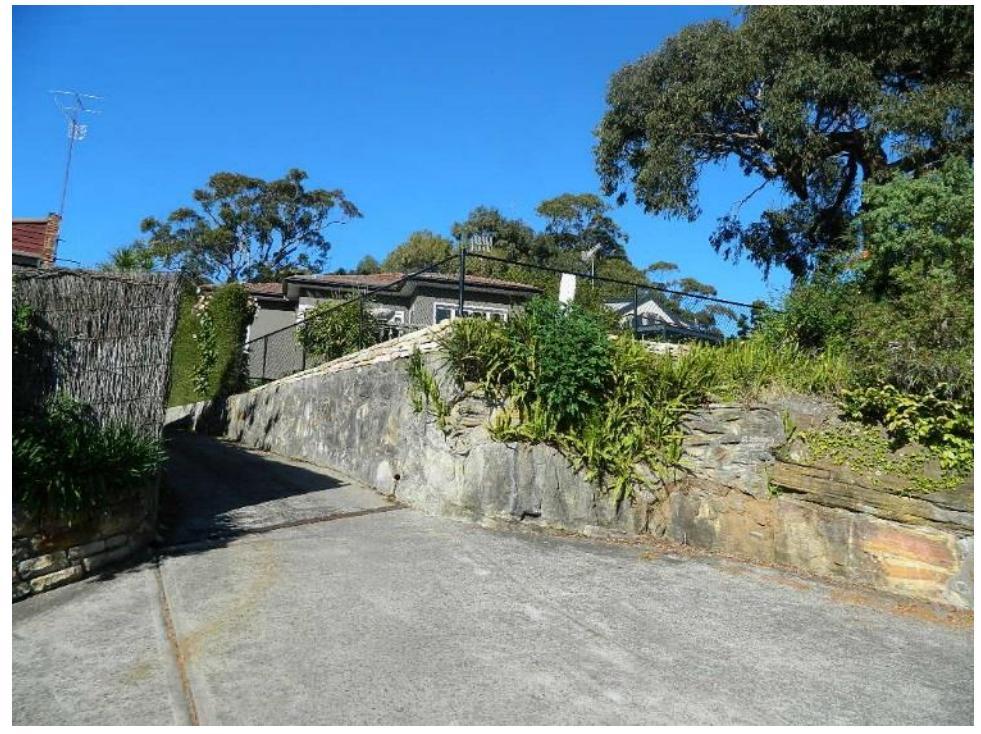
Photo 5

The lower edge of the proposed pool will be ~0.5m away from the E common boundary where the slope drops away. It is supported by an old mortared flagging retaining wall (Photo 5). To ensure no additional loads are transferred onto wall the proposed pool structure it is to be supported on piers taken to extremely low strength shale. The piers are to be taken below the walls zone of influence. In this instance the zone of influence is the area above a theoretical 45° line from the base of the wall towards the proposed footings.

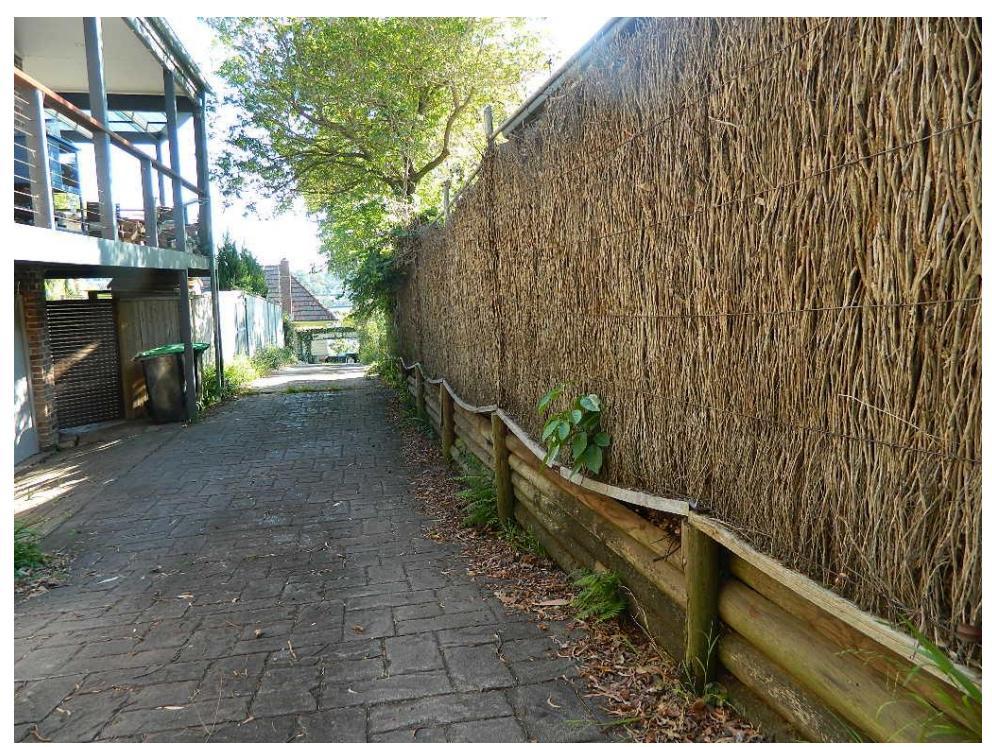
Photo 6

carriageway is supported by an old, low elevation, treated pine retaining wall that will be replaced as part of the proposed works (Photo 6).
