James Taylor and Associates Pty Ltd 301/115 Military Road Neutral Bay, NSW 2089 Project 232711.00 12 November 2024 R.001.Rev0 RM

# Report on Geotechnical Testing Proposed Residential Development 3 Lauderdale Avenue, Fairlight, NSW

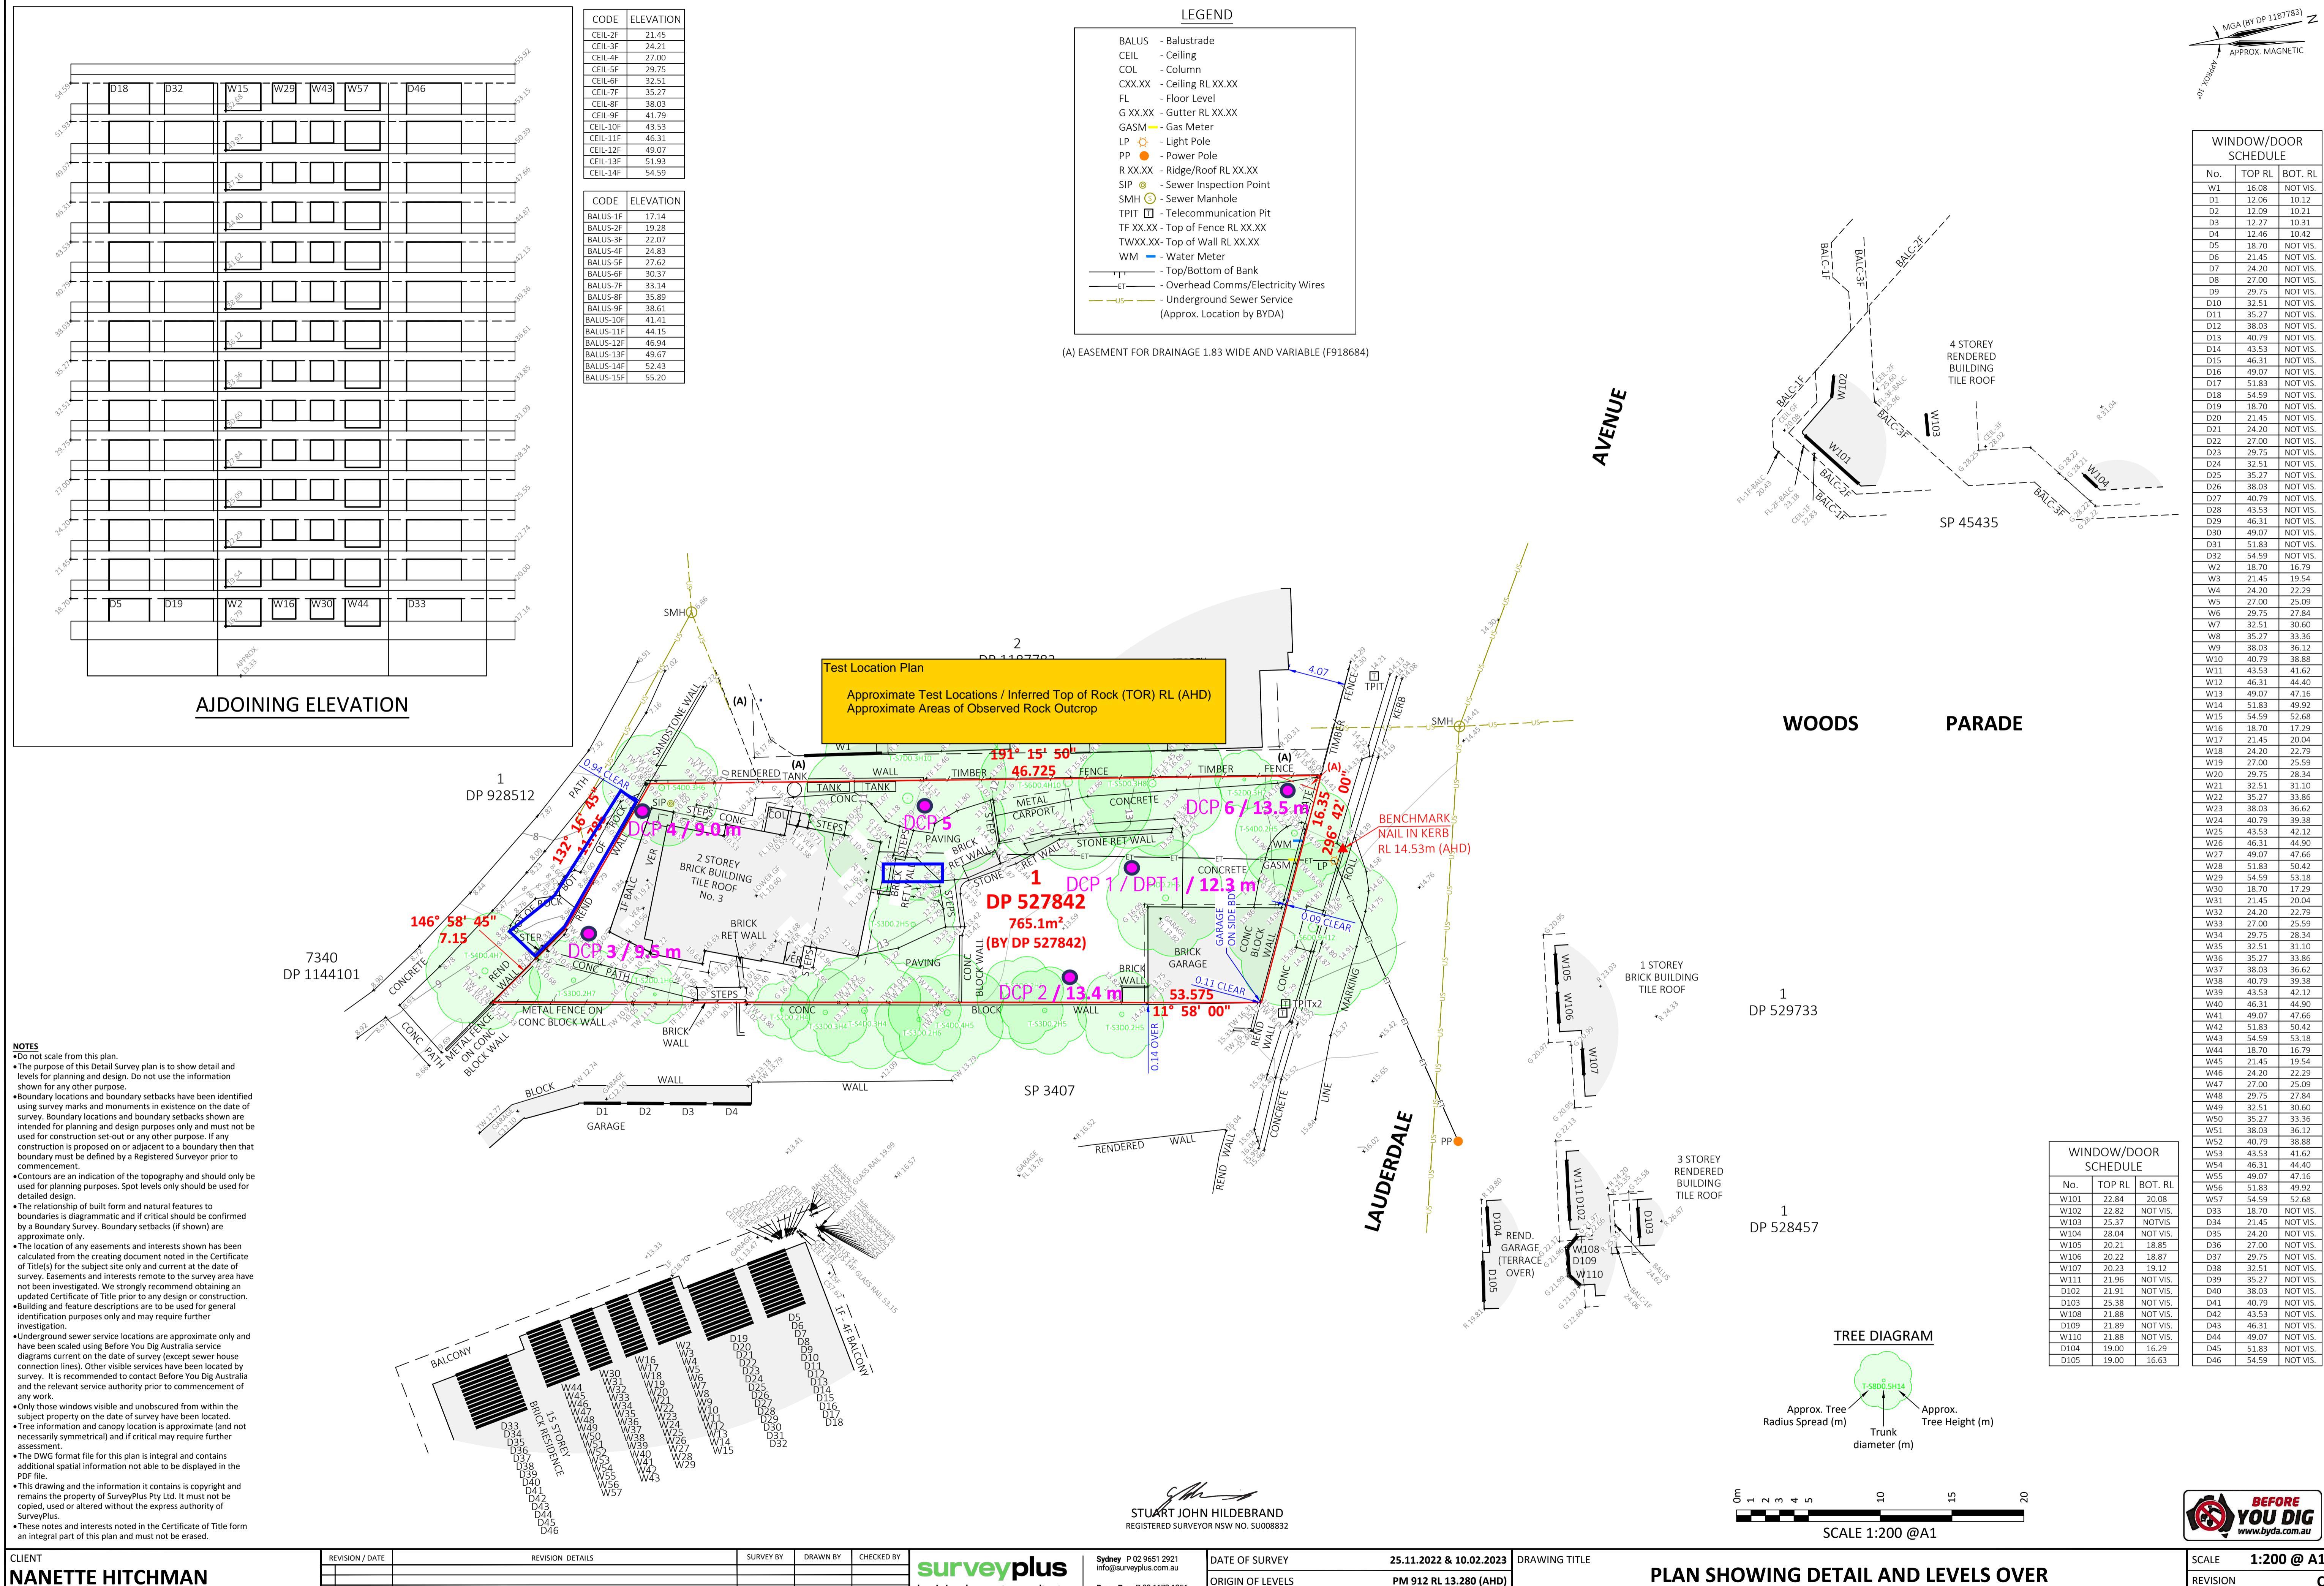
The ground surface levels at the borehole locations were measured relative to AHD using a differential global positioning system (dGPS) receiver, which is generally accurate to within  $\pm 0.1$  m. The approximate locations of the borehole and penetrometer tests are shown on the attached annotated survey drawing.

Penetrometer tests (DCP 1 to 6 and DPT 1) were conducted at 7 accessible locations across the site, as shown in the attached annotated drawing, where each penetrometer test encountered bouncing hammer refusal at depths ranging from 0.2 m to 1.15 m, with the exception of DCP 5 which refused on brick pavers underlying a garden bed. The DPT test was undertaken at test location 1 where a relatively deep soil profile was identified. The result indicates the sandy fill is of variable consistency, generally equivalent to a loose to medium-dense sand, with higher blow counts interpreted as gravel and cobble inclusions within the soil fill. The bouncing hammer refusal for the DCPs/DPT indicates hard material, inferred as at least low strength sandstone bedrock. However, it is possible that the refusal was on buried obstructions in the fill, such as boulders or concrete.

The penetrometer results are attached, as well as a test location plan. The level of penetrometer refusal (in RL m), inferred as the top of rock (TOR), is also shown in the attached drawing and at the bottom of the penetrometer test results sheet. It is noted that these TOR levels are indicative only and based on interpretation of the penetrometer results. Boreholes or test pits on site would be necessary to accurately identify the top of rock.
