ARBORICULTURAL IMPACT ASSESSMENT (AIA) REPORT

Prepared For: Mr. Anthony and Mrs. Sue Jeffcoat
C/- Marston Architects
Site Address: 22 Hay Street, Collaroy NSW, 2097
Inspection Date: 8/7/2019
Report Date: 5/08/2019

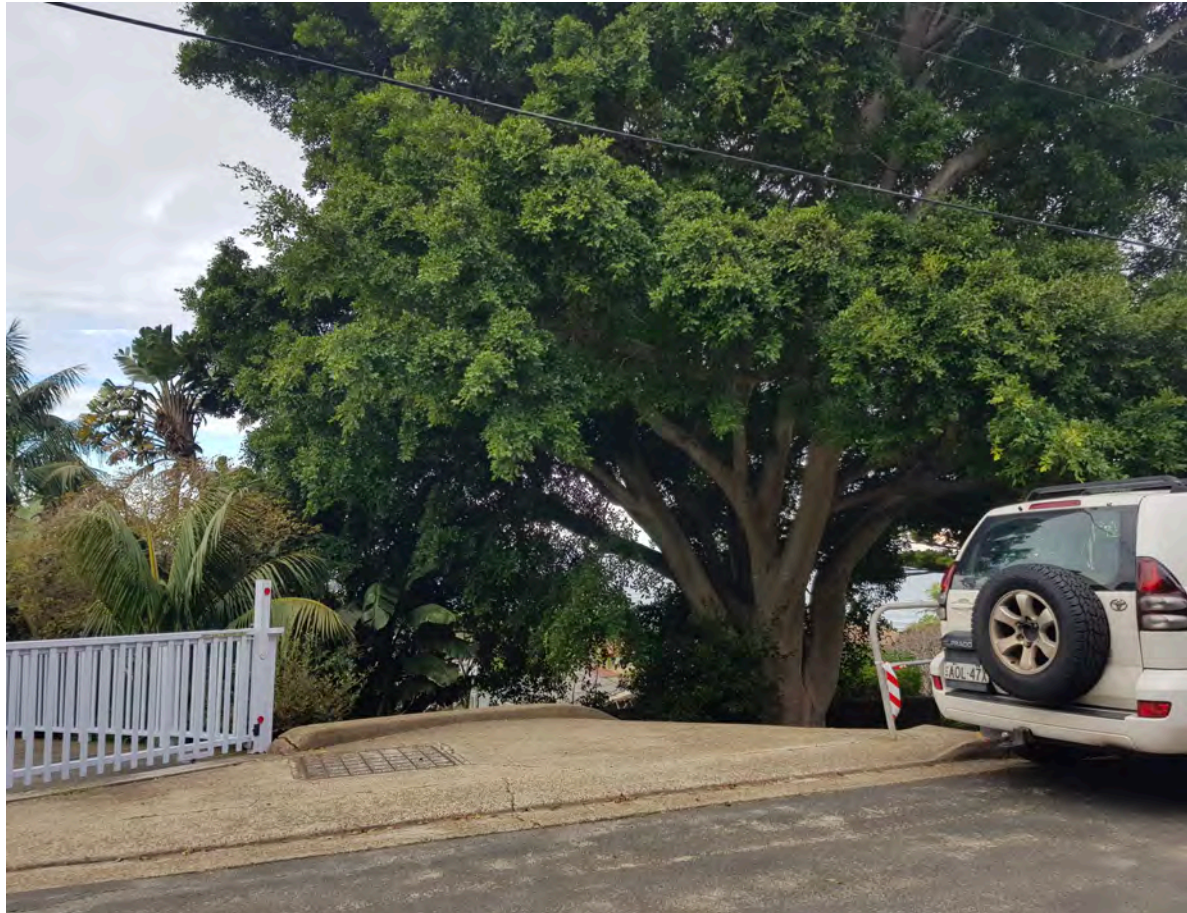
3.3.1 Tree 1, Hills Fig, was located outside the rear boundary presented in excellent health and condition. A large number of surface roots were visible within the property and will require protection during construction. This is a council owned tree and any required works will be require subject to a tree works request from Council. Refer to Image 1.

Image 1: The property as viewed from Lancaster Ave. Note large canopy spread of T1 - A Significant specimen.

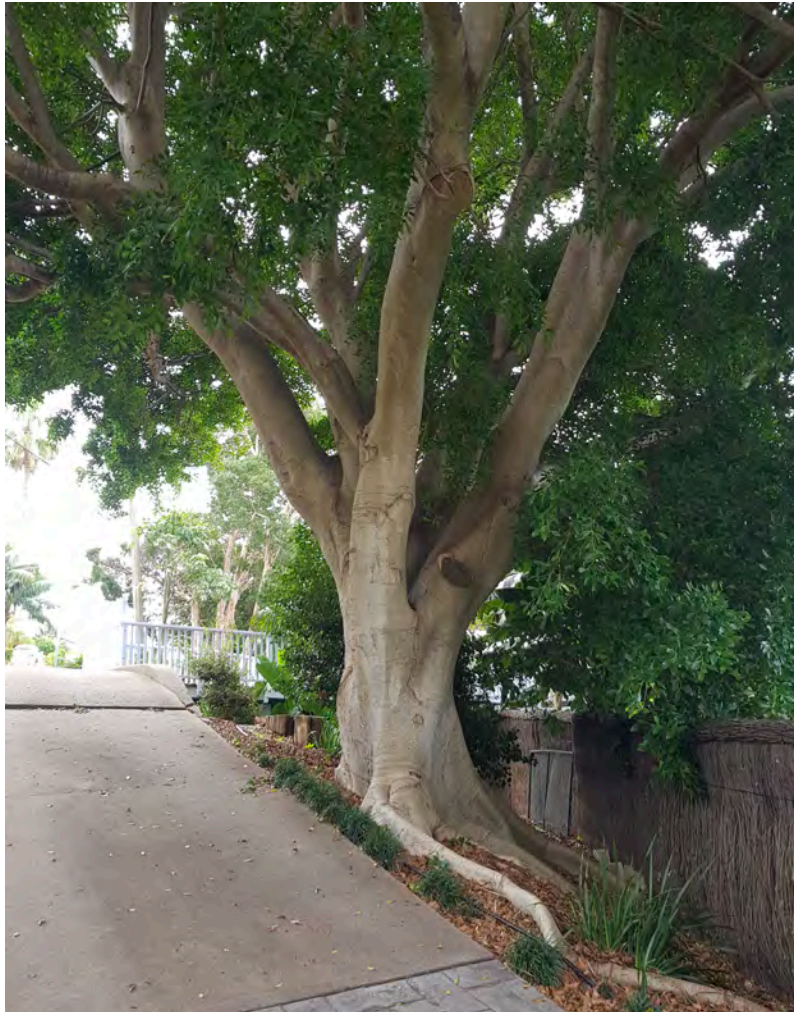
3.2.2 A road reserve exists at the rear of the property providing vehicular access to 1-3 Lancaster Avenue. Refer to Image 2.

Image 2: T1 in relation to the local road reserve and western boundary. Extensive first order roots are visible.

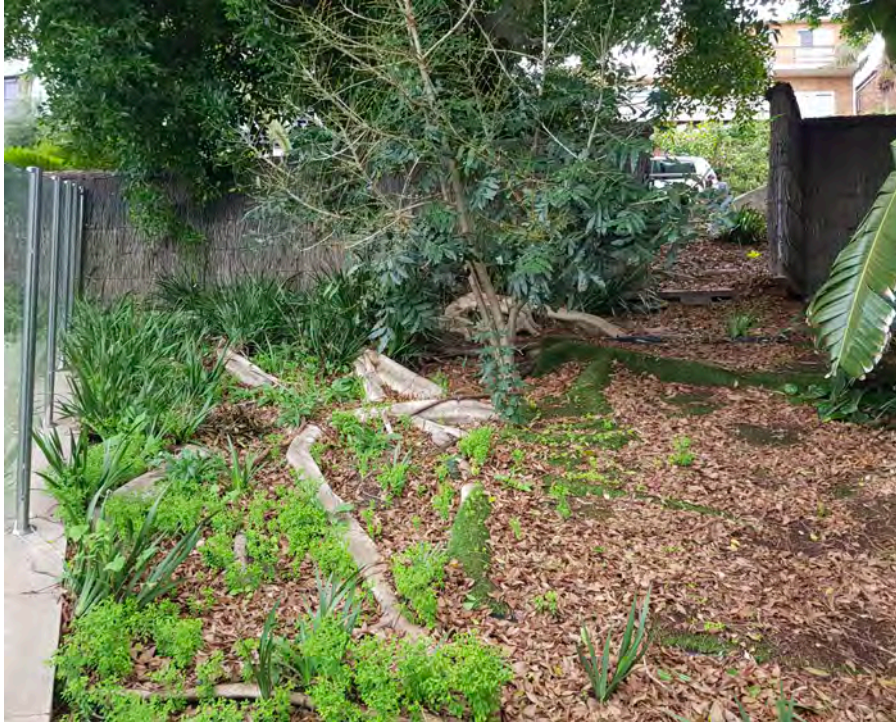
This tree will experience minor encroachment due to the necessary excavation for footings. Engineering detail of these piers was not available for the writing of this report however it is assumed that 450mm diameter piers will be required beneath the footprint of the carport and connecting rampway. Images 3-5 highlight significant roots observed.

Image 3: Surface roots belonging to T1 Located within the rear yard of the property. Piers will need to be located in-situ with these roots to minimise impact to the tree.

- 4.1.4 Pier locations requiring the severance of structural roots will pose a risk of tree impact and possible destabilisation. Where practical, pier locations should remain flexible to accommodate structural roots, where discovered. Alternatively, as recommended, cross referencing of proposed pier locations with observed roots will significantly reduce impacts attributed by development.

- 6.1.1 It is recommended that Tree 1 is retained and protected as part of this development. A methodology for tree protection can be found in section 7.
- 6.1.2 It is recommended that pier locations remain flexible in location to enable strategic placement around significant roots belonging to Tree 1. Cross referencing proposed pier locations with root locations will allow for better placement of piers without causing impact to the tree.
- 6.1.3 It is recommended that significant roots with a diameter of 50mm or more are protected during development; such roots are seen in Images 3-5 and shall be protected. Roots shall not be severed or cut without consultation with the site arborist.
- 6.1.4 Tree 2 is unretainable under the proposed development and its removal is supported due to the tree's presentation of poor health.

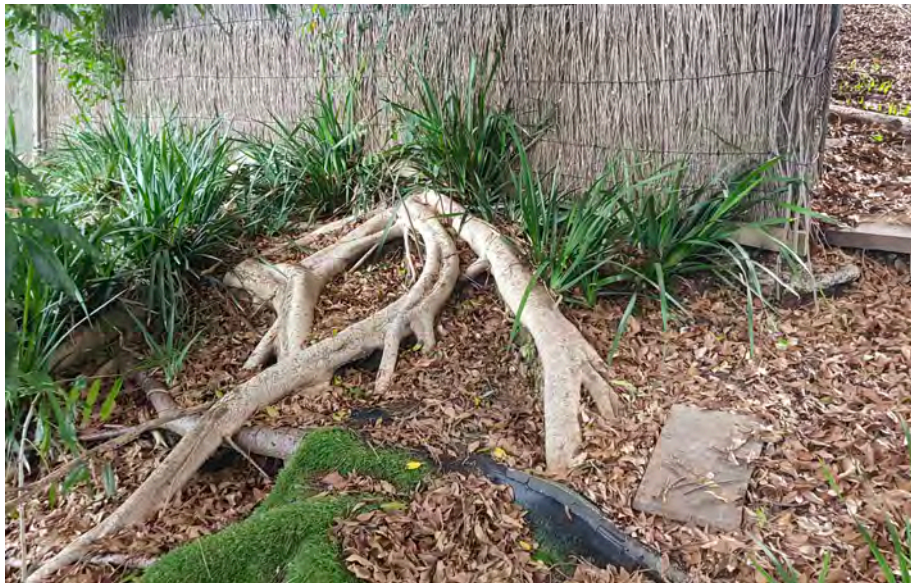
Image 4: Further imagery of surface roots of T1.

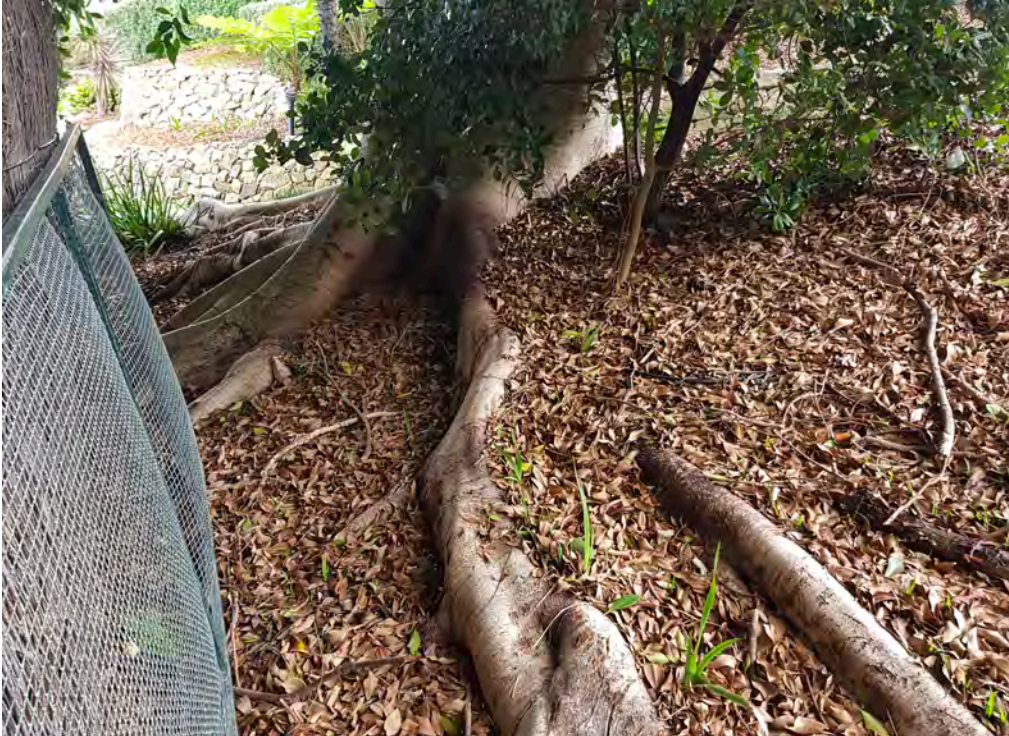
Image 5: Significant roots were also noted outside the property boundary.

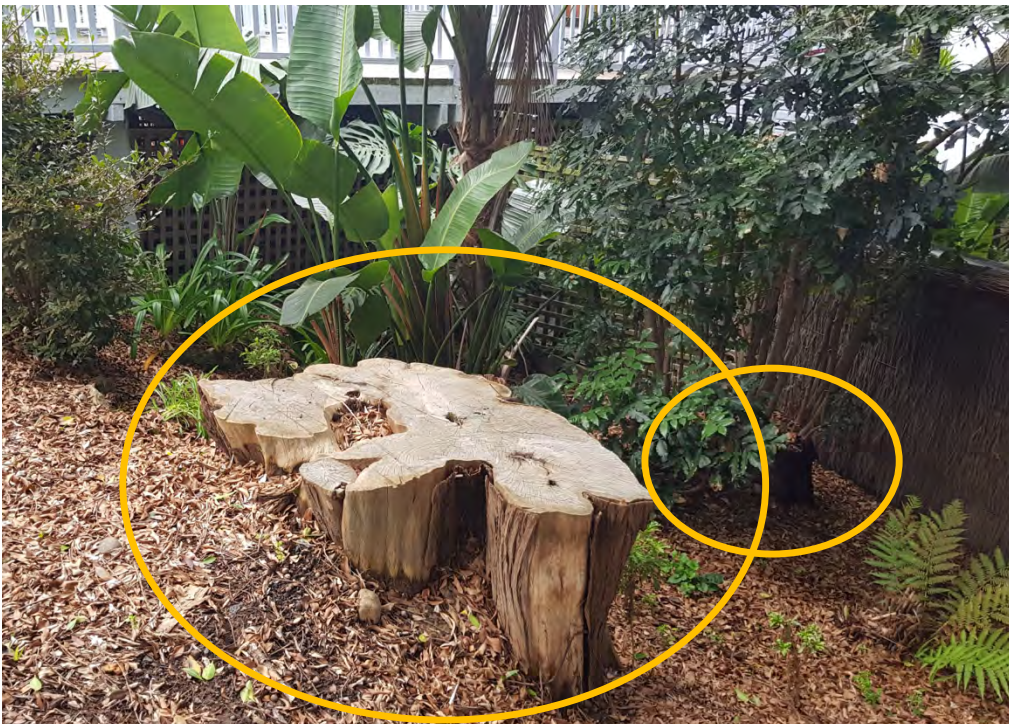
Image 6: Two tree stumps were observed outside the property boundary as indicated.

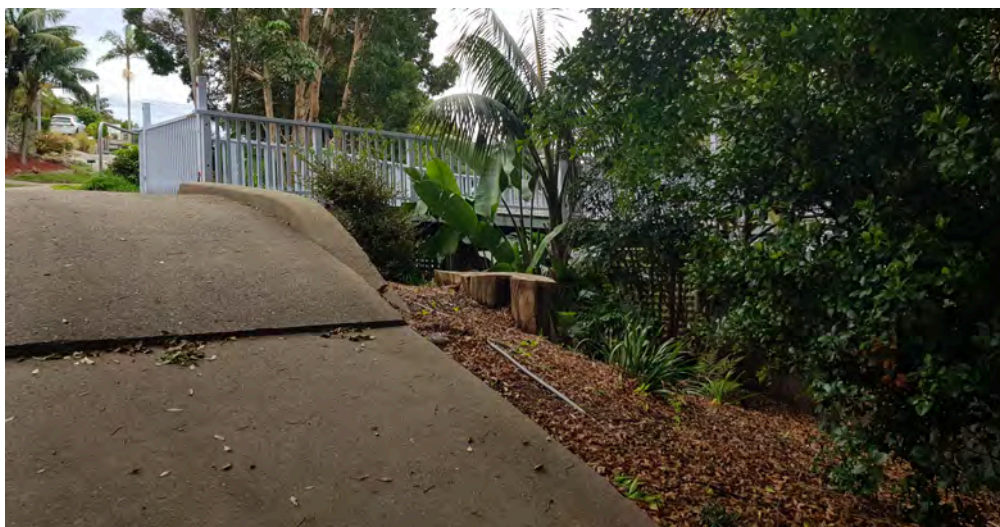
- 3.4.1 Alterations of the existing dwelling are proposed and focus primarily on internal features with no external construction occurring near trees.
- 3.4.2 A new carport is proposed and is to be constructed entirely above grade with isolated piers at the rear of the property. Image 8 depicts slope of the land and the need for an elevated structure.

- 4.1.1 The distinct easterly aspect with a gradient of approximately 33% presents a challenge for the transport of excavation equipment into site. As mentioned in section 7, particular attention to ground and root protection measures will be required.

Image 8: A perspective of the road reserve depicting the significant slope of the land. The development is proposed to be constructed above grade at this point
