**GEOTECHNICAL INVESTIGATION  
PROPOSED POOL HOUSE, SWIMMING POOL AND ART STUDIO  
90 CABBAGE TREE ROAD, BAYVIEW, NEW SOUTH WALES  
MS YASMINA ELSHAFEI AND MR FORD ENNALS**

**MMGEO2025YEFE\_AB Revision A  
MARCH 2025**

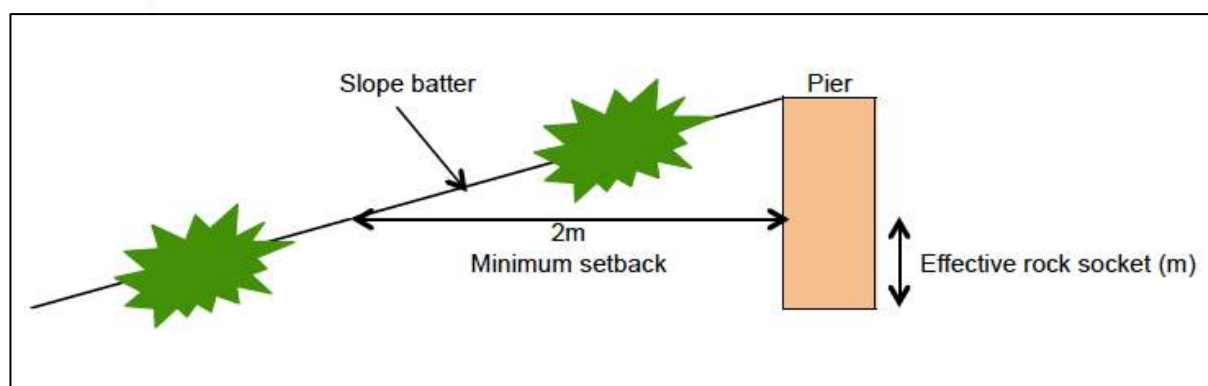
**Diagramme 13.1: Required Minimum Setback for Calculation of Effective Rock Socket**

To prevent slope instability and reduced bearing capacity from occurring, your attention is drawn to the need of applying the setback criteria shown in Diagramme 13.1 for calculation of effective rock socket length. Otherwise, there would be a need to downgrade the bearing pressure values given in Table 13.1 by a factor of 0.5.

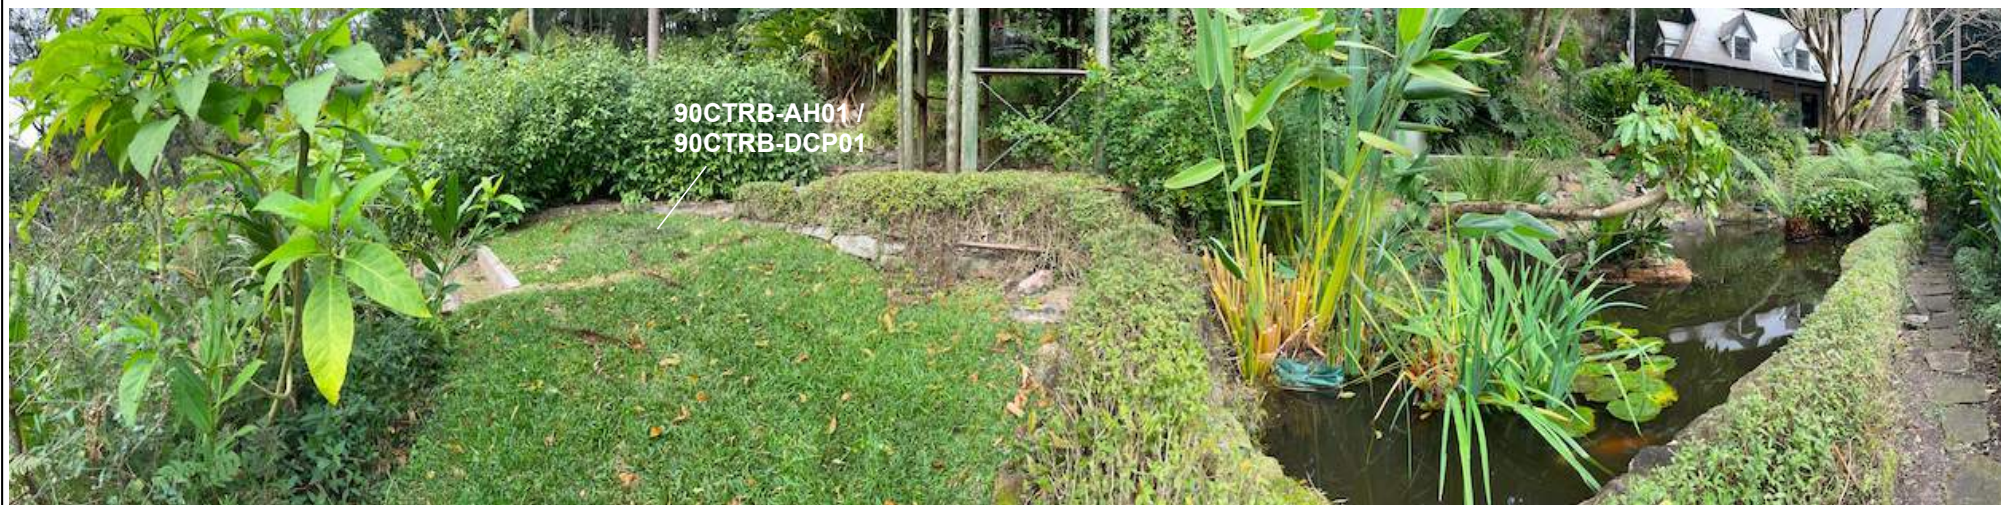
**PHOTOGRAPH 1 - APPROXIMATE LOCATION OF 90CTRB-AH01 AND 90CTRB-DCP01 (VIEW TO SOUTH)**

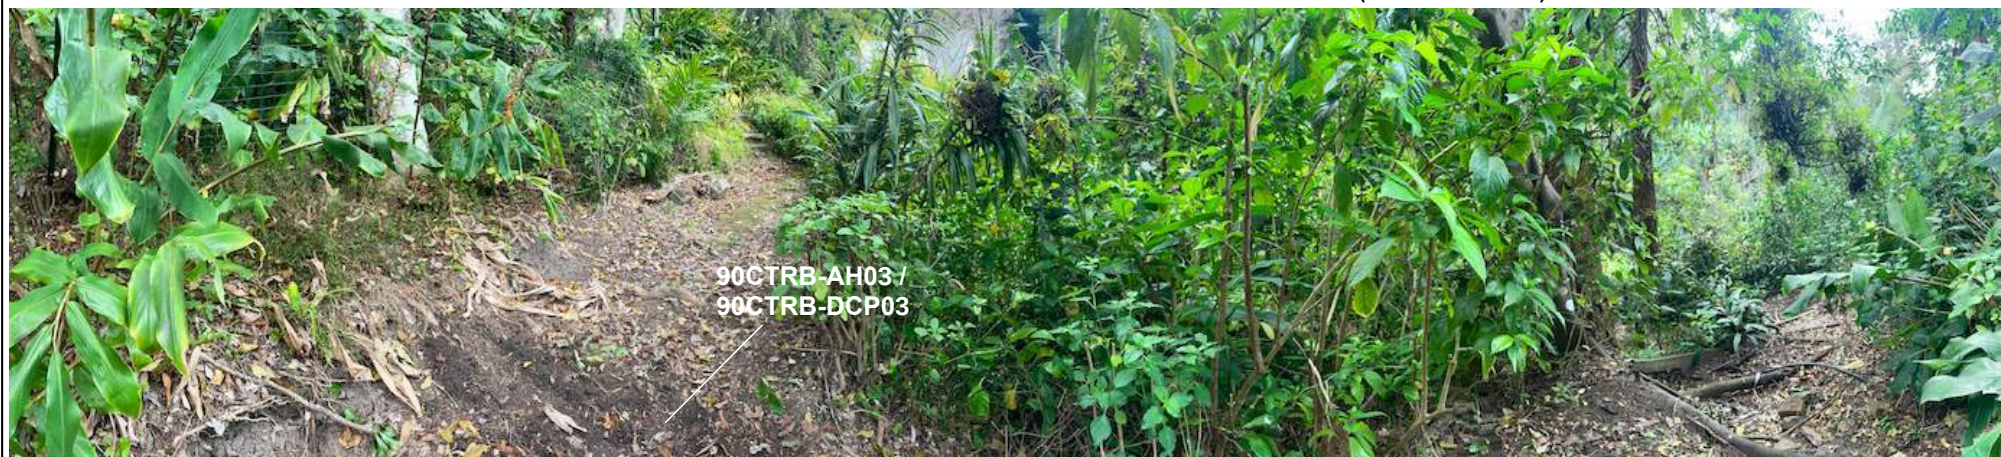
**PHOTOGRAPH 2 - APPROXIMATE LOCATION OF 90CTRB-AH03 AND 90CTRB-DCP03 (VIEW TO WEST)**

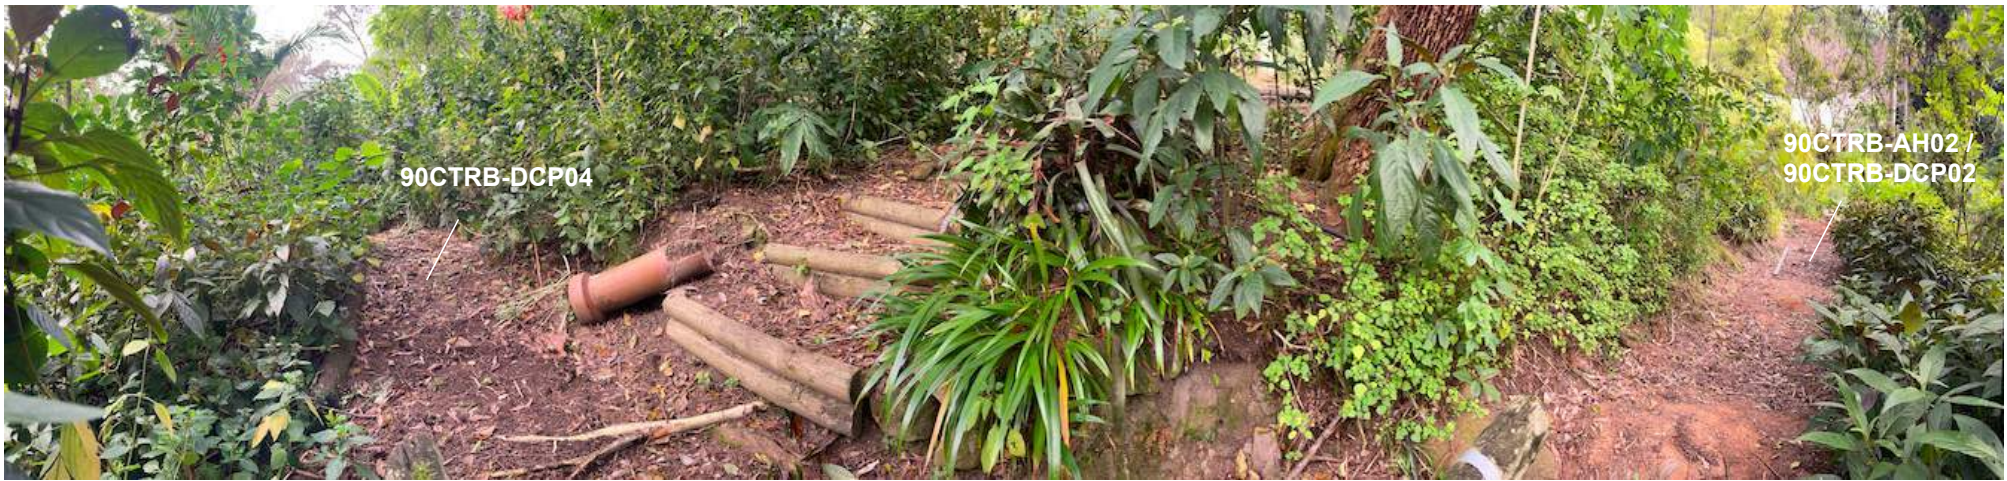
**PHOTOGRAPH 3 - APPROXIMATE LOCATIONS OF 90CTRB-AH02, 90CTRB-DCP02 AND 90CTRB-DCP04 (VIEW TO SOUTH)**

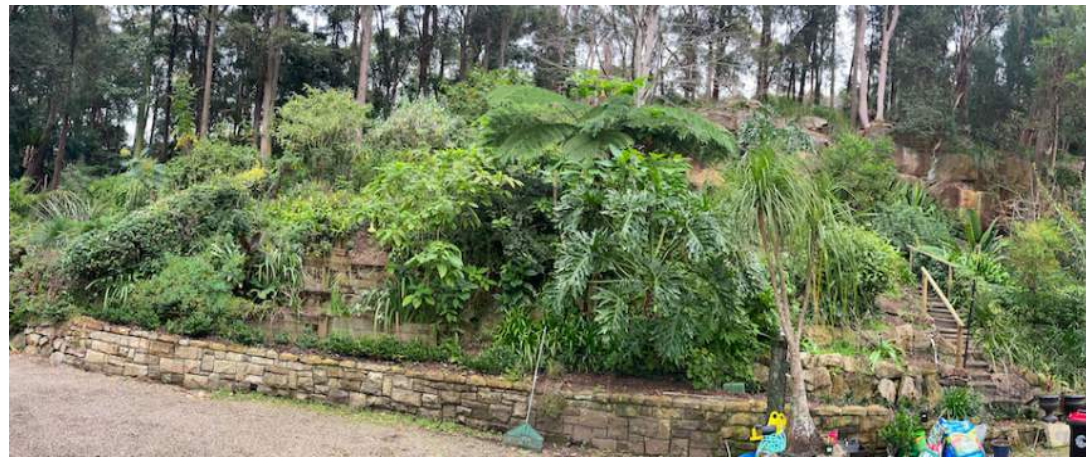
**PHOTOGRAPH 4 - SANDSTONE CLIFF (VIEW TO SOUTH)**

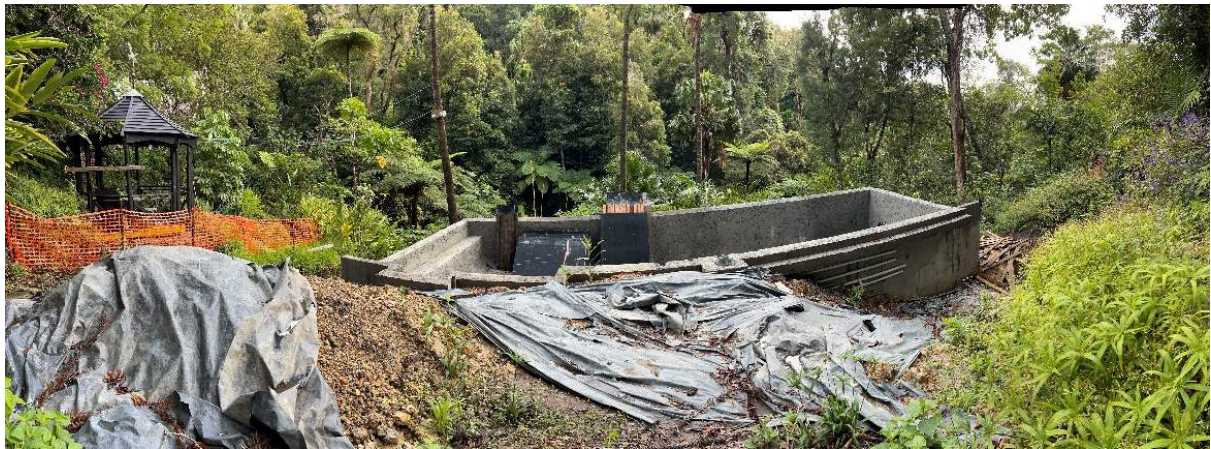
The latest site observations we made on 12 March 2025 prompted alignment with the findings from the geotechnical investigation in respect to the ground conditions at the proposed locations of the pool house and the art studio and that there were no significant changes to the site conditions.

PHOTOGRAPH 5 - THE CONSTRUCTION OF THE PROPOSED SWIMMING POOL (VIEW TO NORTH)

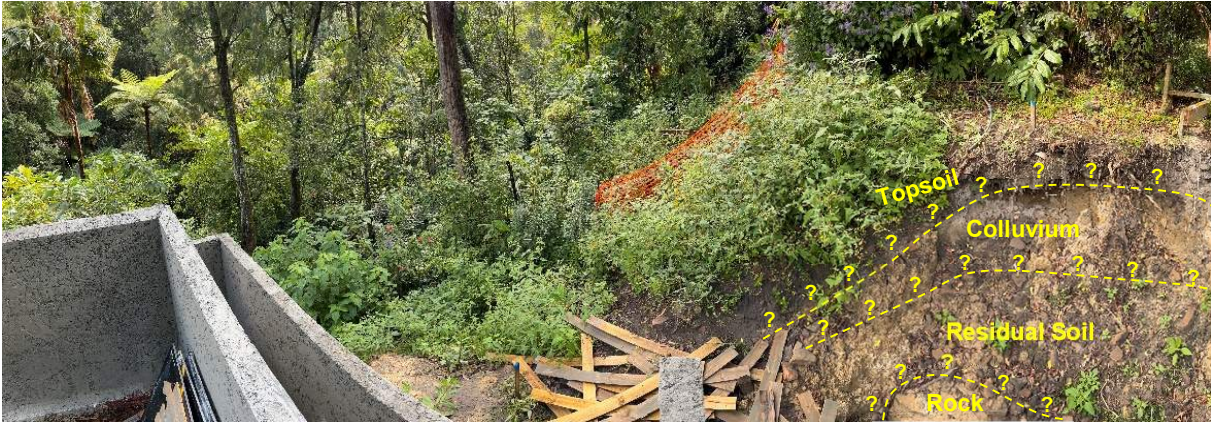
PHOTOGRAPH 6 - EXPOSED GROUND CONDITIONS AT THE LOCATION OF THE ART STUDIO (VIEW TO NORTHEAST)
